AIRCRAFT ACCIDENT REPORT AND EXECUTIVE SUMMARY

Reference:	CA18/2/3/9854	
Aircraft Registration	ZS-IRW	Date of Accident	20 January 2020		Time of Accident	1600Z
Type of Aircraft	Grumman G-164A		Type of Operation	Agricultural (Part 137)		
Pilot-in-command Licence Type	Commercial Pilot Licence		Age	26	Licence Valid	Yes
Pilot-in-command Flying Experience	Total Flying Hours		1757.3		Hours on Type	238
Last Point of Departure	Middelburg Aerodrome (FAMB): Mpumalanga Province					
Next point of Intended Landing	Middelburg Aerodrome (FAMB): Mpumalanga Province					
Location of the accident site with reference to easily defined geographical points (GPS readings if possible)						
Farm land, approximately 7.2 nautical miles (NM), NNE of Middelburg Airport (FAMB) next to N11 highway						
Meteorological Information	Wind direction: 140°, Wind speed: 3kts, Visibility: >10km, Temperature: 21°C					
Number of People On-board	1+0	No. of People Injured	0	No. of People Killed	0

Reference Number : CA18/2/3/9854
Name of Owner/Operator : Platorand Lugbespuiting
Manufacturer : Grumman Aerospace Corporation
Model : G-164A
Nationality : South African
Registration Marks : ZS-IRW
Place : Farm land, approxima

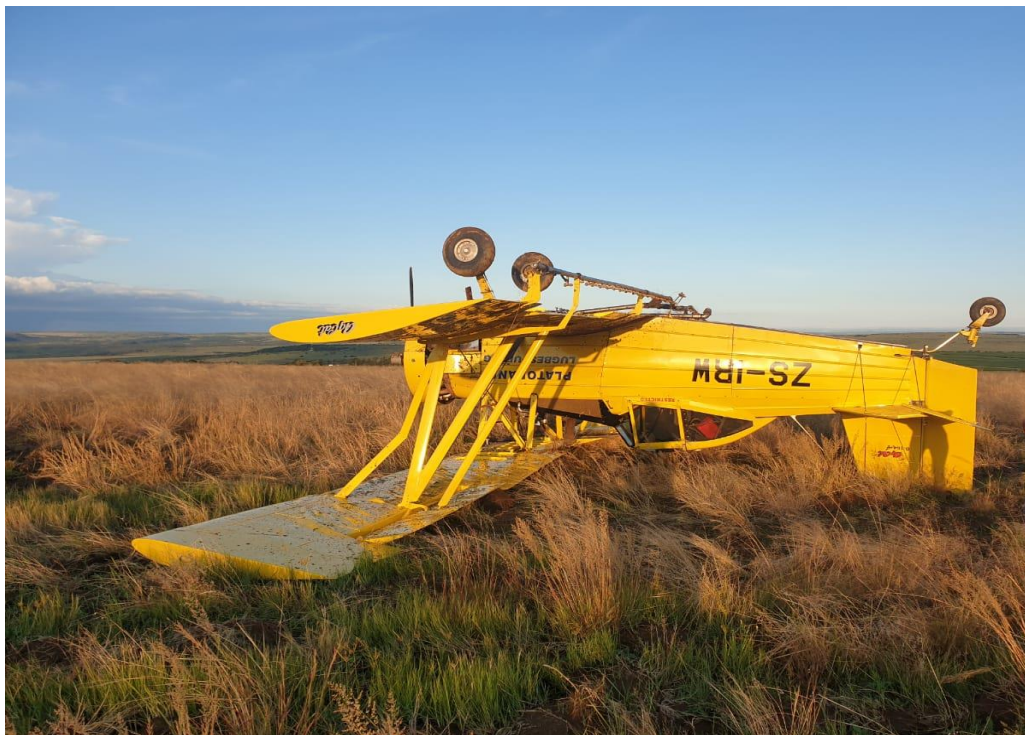
1.3.1 The aircraft was substantially damaged during the accident sequence.

Figure 2: The aircraft in an inverted position post-accident.

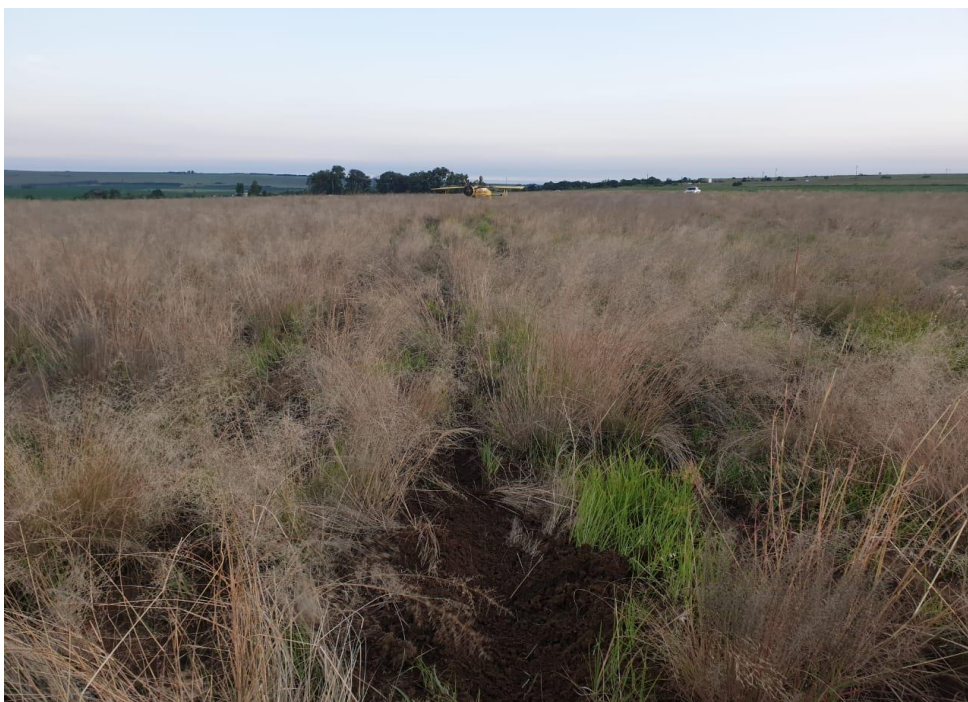
1.12.1 The aircraft landed and rolled approximately 60 metres (m) on soft soil before it flipped over, coming to rest in an inverted position. Damage to the aircraft was limited to the wings, the ailerons, the wings support struts, vertical stabiliser and the propeller.

Figure 4: The spot where the aircraft touched down.

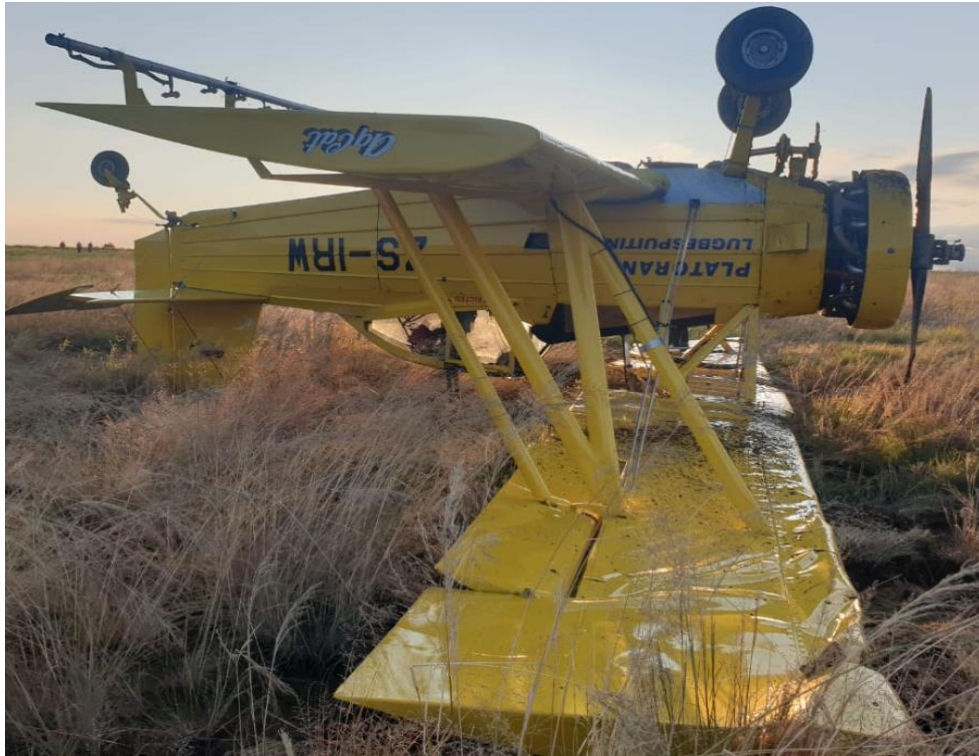
Figure 5: The aircraft in an inverted position.

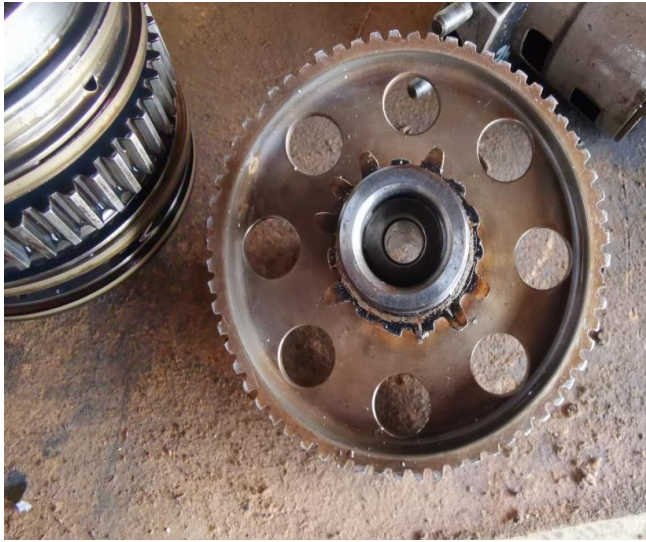
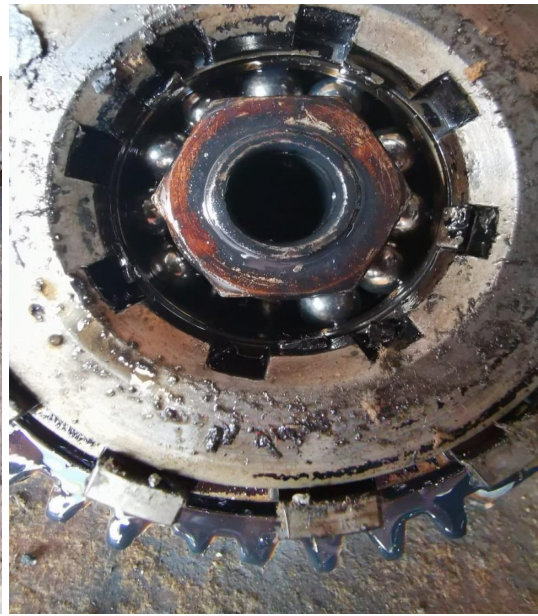
1.16.1 On 7 February 2020, the Pratt & Whitney R1340-AN-1 engine Serial Number: ZP103488 was transported to a SCAA-approved engine overhaul facility AMO situated at Springs Aerodrome for teardown inspection. The rear engine case was opened for inspection and it showed evidence of missing gear teeth on the impeller intermediate drive and a failed impeller bearing.

Figures 6 & 7: The missing gear teeth on the impeller intermediate drive (left) and a failed impeller bearing (right).

With power case removed from rear case. Evidence of teeth missing on impellor intermediate drive.

Appears as if the impellor bearing failed, which caused the Supercharger to malfunction and eventual engine failure.

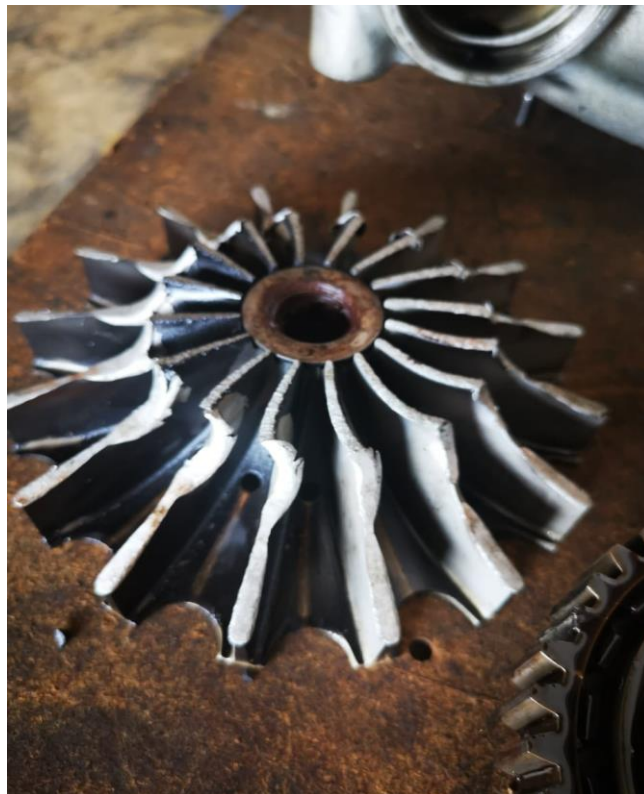
1.16.2 The rear case was consequently removed from the blower case and further damage was noticed on the impeller.

Figure 8: The damaged impeller.

Removal of the Rear Case from the Blower Case, damage was found on the impellor and case.

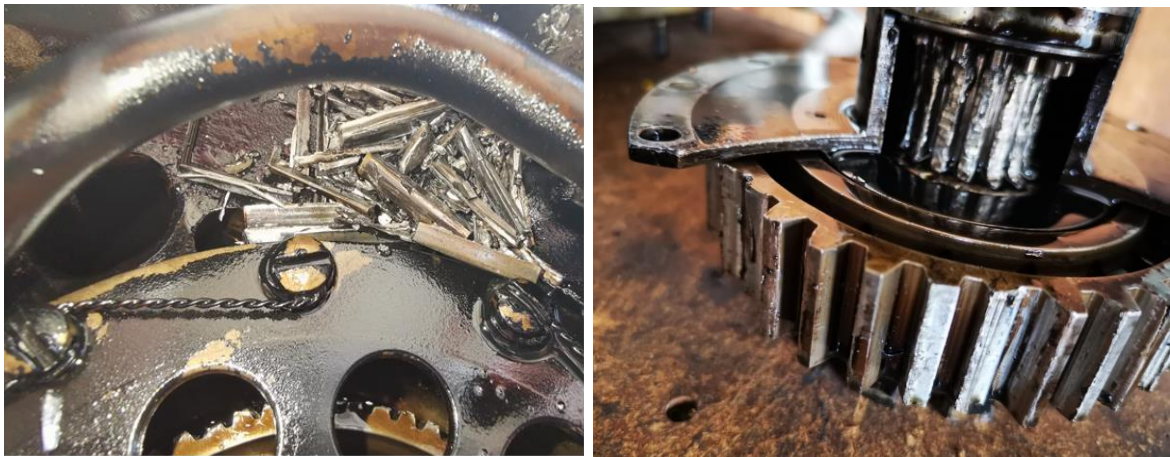
1.16.3 The failure had caused the supercharger to malfunction, which resulted in an engine failure (see Appendix 5.2 - engine report).

Figure 9 & 10: The gear teeth shavings (left) and the impeller drive shaft with missing gear teeth (right).
