The South African Civil Aviation Authority
Aircraft Accident Investigation
Final Report

Cessna S550 (ZS-CAR)
George Aerodrome (FAGG) January 23, 2020

AIID Ref No: CA18/2/3/9855
November, 2021

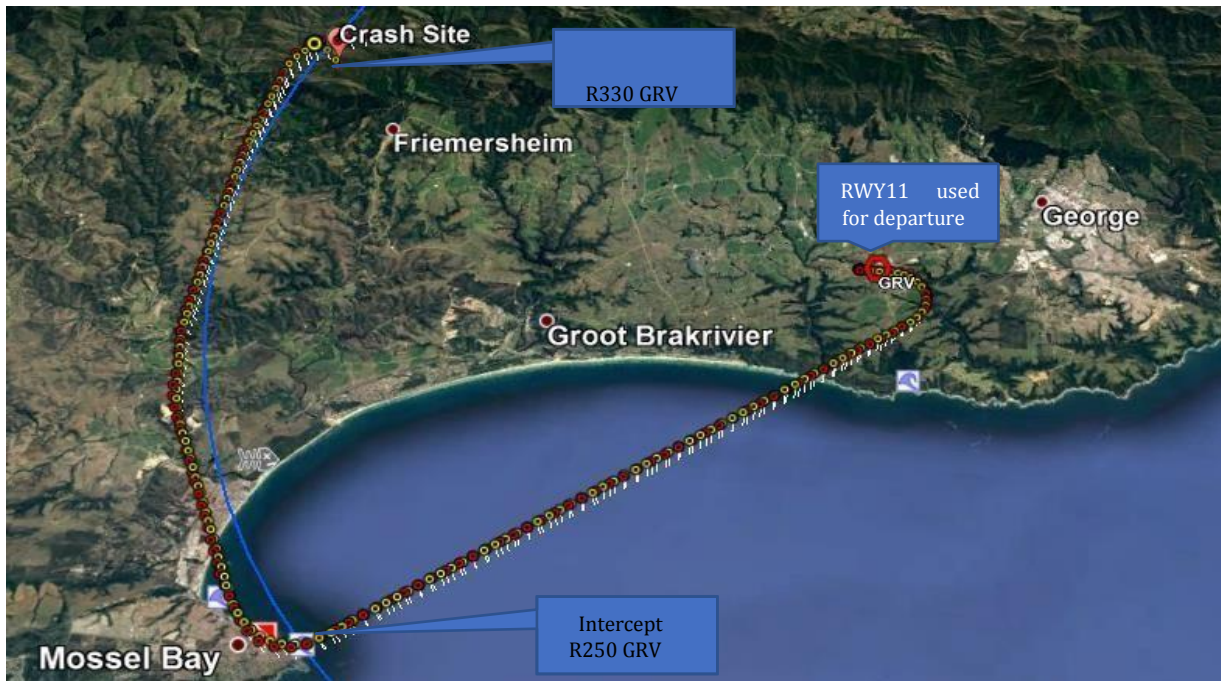
The crash site found at the top of the Outeniqua mountains, near the town of Friemersheim, at Global Positioning System (GPS) co-ordinates 33°55'24" South 022°06'30" East, at an elevation of 2192ft. The aircraft was found destroyed on impact and all occupants were fatally injury.

Figure 1: The routing of the aircraft prior to impact based on radar data (Source: Google Earth and ATNS)

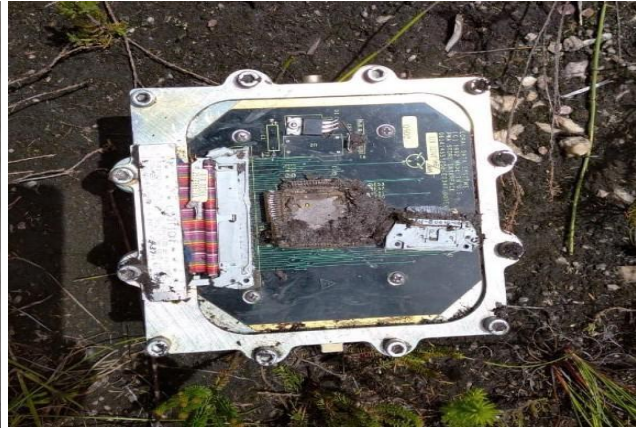
Figure 8: ZS-CAR - Recorder opening & read-out - BEA - 3rd Feb 2020

The FDR was visually examined. The chassis was missing, and only the FCSSU was brought to BEA. The PCB card was damaged and the FCSSU seemed compressed. The connector was dirty and the plastic package was broken.

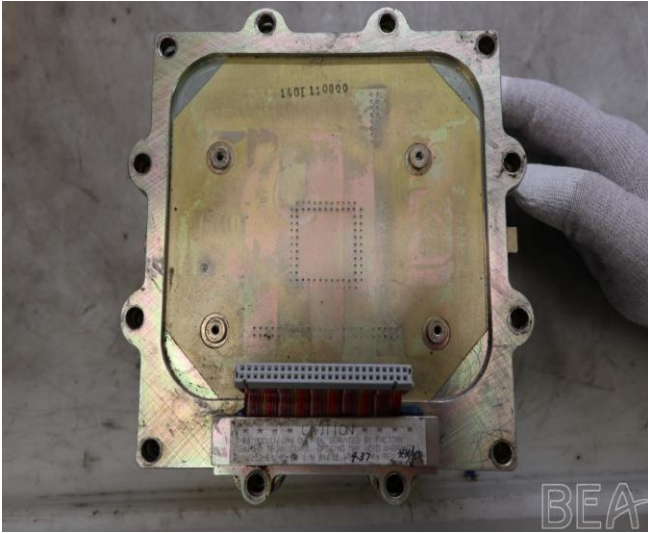
The FCSSU was opened. The main electronic board was extracted. It was in good condition. Inside the FCSSU, the electrical flat ribbon seemed in good condition. It was decided to perform a first electrical check with the connector of the event.

Figure 9: FCSSU Internal Check

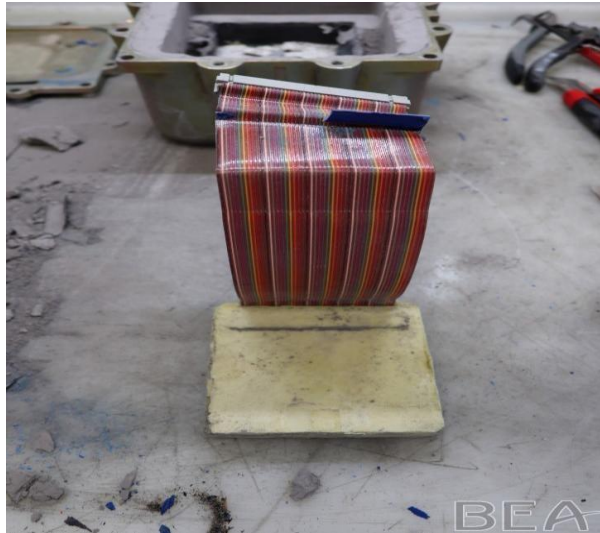
Figure 10: Electrical Flat Ribbon

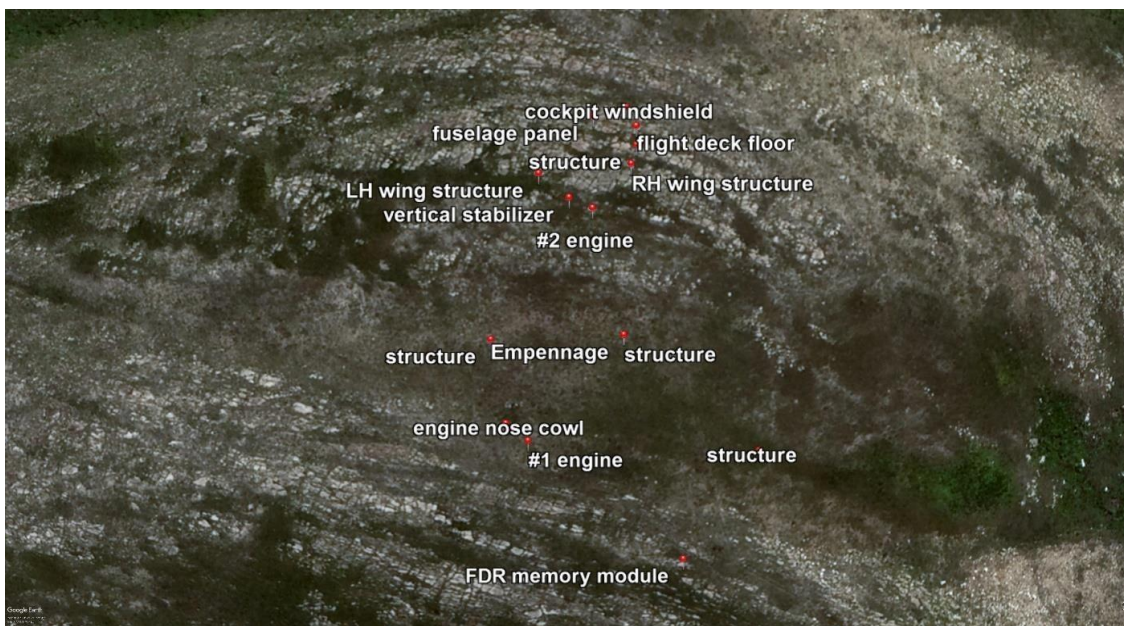
According to the available FDR graph plot, the aircraft impacted the terrain at an indicated airspeed of approximately 286 knots. Figure-11 indicates the position of all main components found at the accident site.

Figure 11: The Layout of the Main Aircraft Components Field. (Source: Google Earth)

The Investigators group, assessing the accident site divided the accident debris field into three zones. The first zone spans from the point of initial impact to 90m, the second zone from 90m to 180m, and the third zone from 180m to 270m.

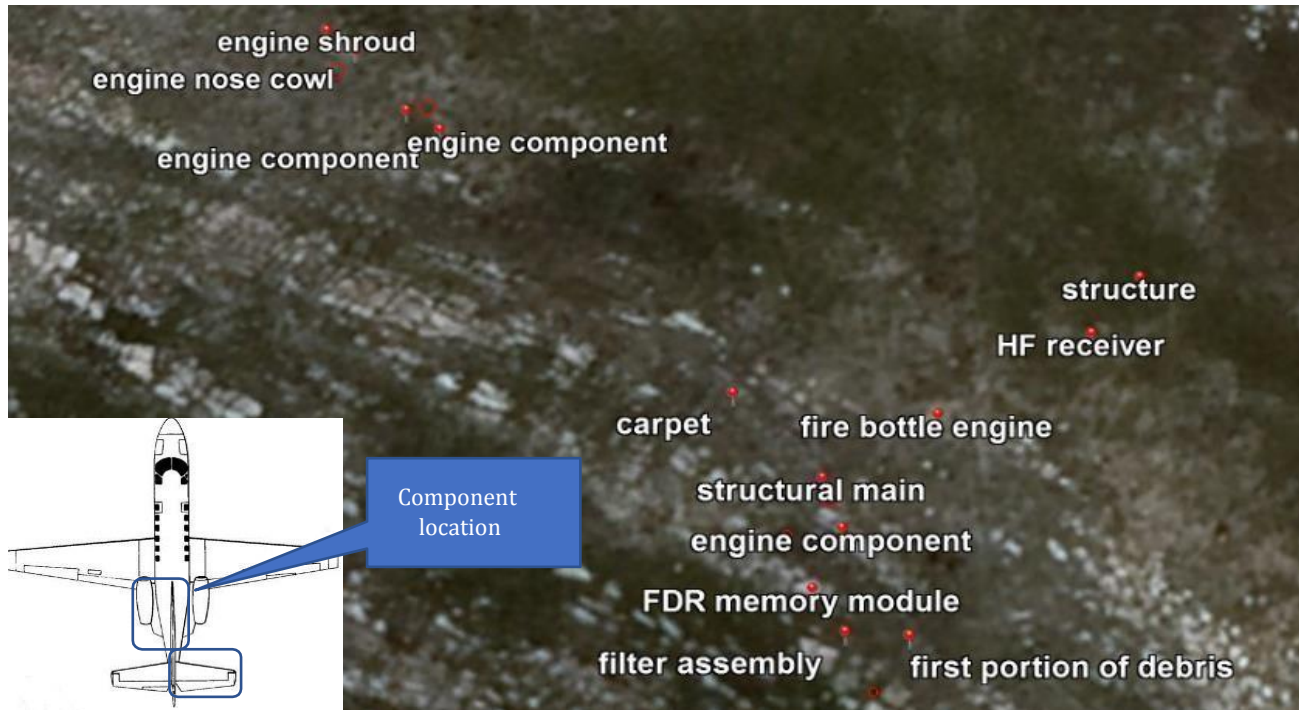
Debris in this zone consisted of empennage-related items such as the engine fire extinguisher bottles, the FDR and the high frequency (HF) receiver. The first portion of the rear cabin interior was found approximately 35m from the point of initial impact.

The upper left portion of this zone includes debris from engine No 1 nose cowl, shroud and piping.

Figure 12: First Spread of Debris. (Source: Google Earth)

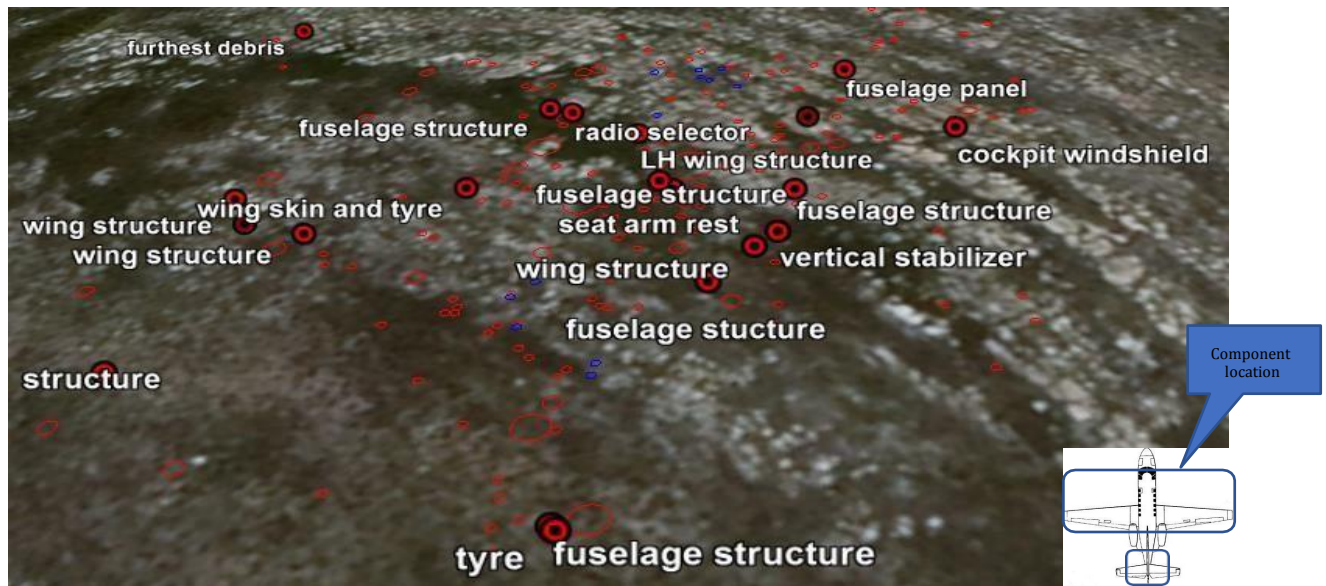
Zone two (refer to Figure 13)

This portion of the debris field formed the main area of debris spread and consisted largely of the fuselage and wing structure. Cabin items such as arm rests and carpets were also located in this area. The left wing remained largely intact and the right wing had severe damage and was highly fragmented. The left-hand elevator was destroyed, and the vertical stabilizer came to rest approximately 125m from the initial point of impact. This portion of debris experienced post-impact fire damage.

Figure 13: Second spread of debris. (Source: Google Earth)

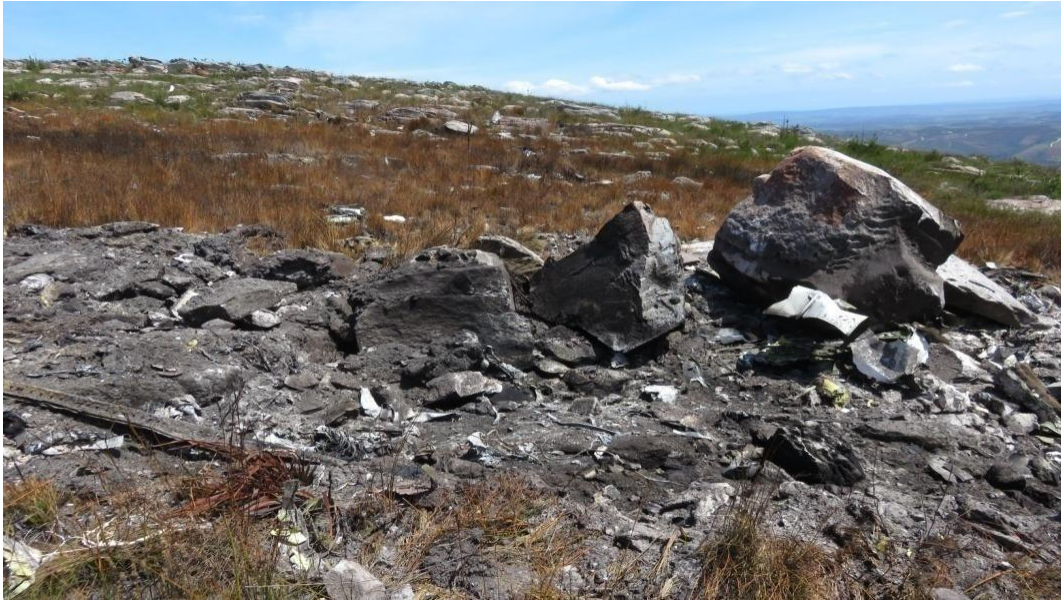
The aircraft sustained a post-impact fire.

Figure 14: The Close-Up View of the Red Circled Area in Figure 14 below

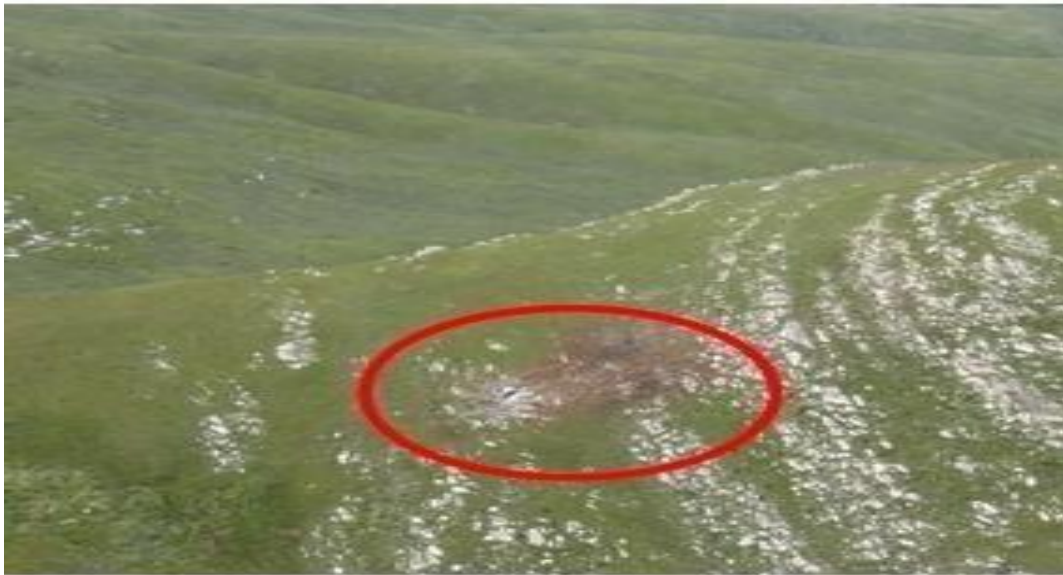
Figure 15: The Red Circle Indicates the Fire Damage on the Surrounding Vegetation.

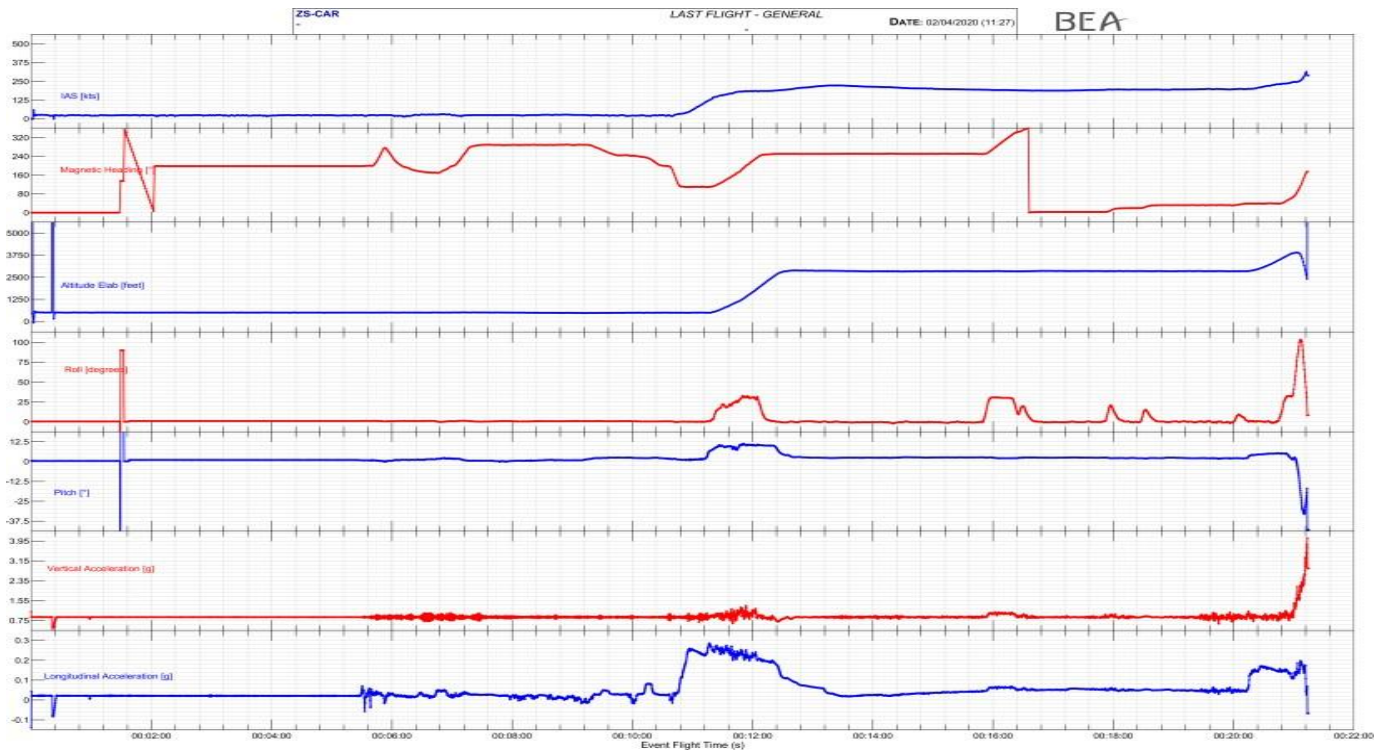
- The aircraft pitch increased from +5 and decreased to +2 degrees.
- The aircraft altitude increased from 2900 ft to 3900 ft
- The aircraft airspeed increased from about 210 to 245kts.
- The aircraft magnetic heading was generally constant at 37.5 degrees until about 00:20:45 when it increased to 67.5 degrees
- The aircraft roll was about zero degrees and began to increase to 35 degrees at 00:20:45.

In the first phase of flight the aircraft pitch decreased from 5⁰ degrees to two degrees with an increase of its speed to 245kts at the same time the altitude increased from 2900ft to 3900ft. In this phase the aircraft roll was about zero degree but immediately it began to deviate to 35⁰degrees even if the aircraft magnetic heading was constant (37.5⁰) at about 00:20:45 it changed to nearly double of the first heading which is plotted on the graph.

Figure 16: General View of the FDR Analysis

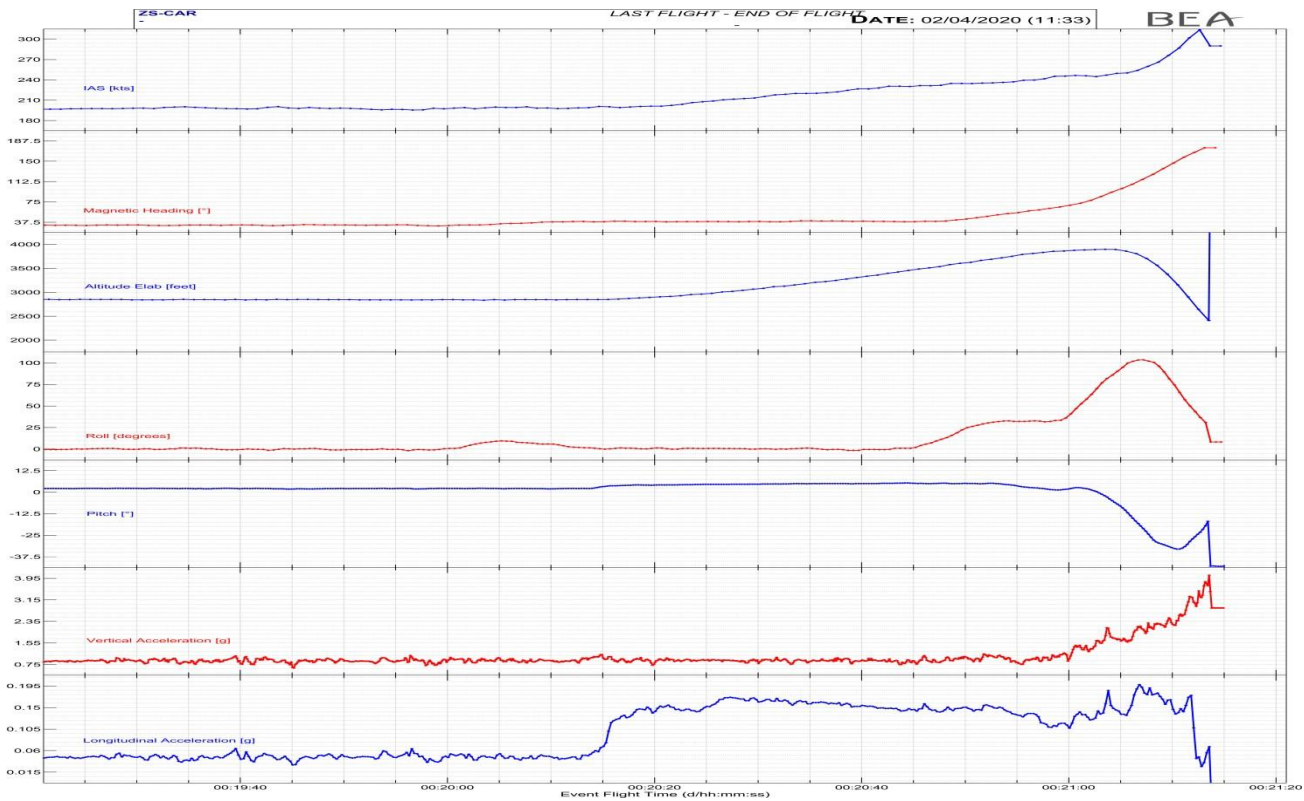
- The aircraft pitch decreased from about +2 to -10 degrees from 00:21:02 to 00:21:05 and over the next 5s decreased to -32.5 degrees.
- The aircraft altitude decreased from 3900 to 3200 ft between 00:21:00 - 00:21:05 and the next 5s decreased to 2800 ft.
- The aircraft airspeed increased from 245 to 275 kts.
- The aircraft magnetic heading increased from 67.5 to 150 degrees.
- The aircraft roll increased from about 35 to 105 degrees during the period of 0:21:00 - 00:21:07 and then over the next 3s decreased to 75 degrees.

In the second phase of flight the aircraft was flying with nose down to -32.5 degrees decreasing its altitude to 3200ft and 2800ft. The aircraft heading changed to 150degrees and its roll to 105 degrees which was overbanked and immediately changed to 75⁰; which can't be determined why the roll of the aircraft suddenly changed from 35 to 105 degrees and then to 75⁰.

Figure 17: Last Event Flight
