<b>AIRCRAFT ACCIDENT REPORT AND EXECUTIVE SUMMARY</b>
---

Reference:	CA18/2/3/9860	
<b>Aircraft Registration</b>	ZU-DJU	<b>Date of Accident</b>	2 February 2020		<b>Time of Accident</b>	0615Z
<b>Type of Aircraft</b>	Bantam B22J		<b>Type of Operation</b>	Private (Part 94)		
<b>Pilot-in-command Licence Type</b>	National Pilot Licence		<b>Age</b>	58	<b>Licence Valid</b>	Yes
<b>Pilot-in-command Flying Experience</b>	Total Flying Hours		117	<b>Hours on Type</b>	79.3	
<b>Last Point of Departure</b>	Pietersburg Civil Aerodrome (FAPI), Limpopo Province					
<b>Next Point of Intended Landing</b>	Pietersburg Civil Aerodrome (FAPI), Limpopo Province					
<b>Location of the accident site with reference to easily defined geographical points (GPS readings if possible)</b>						
Approximately 5 nautical miles (nm) south-east of Pietersburg Civil Aerodrome (FAPI) at GPS co-ordinates determined to be 23°56'40.38" S 029°35'72" E at an elevation of 4348ft						
<b>Meteorological Information</b>	Wind: 130° at 5kt; Visibility: 9999m; Clouds: NIL; Temperature: 24°C; Dew point: 14°C and QNH: 1024

**Reference Number** : CA18/2/3/9860  
**Name of Owner/Operator** : Marius Potgieter  
**Manufacturer** : Mi

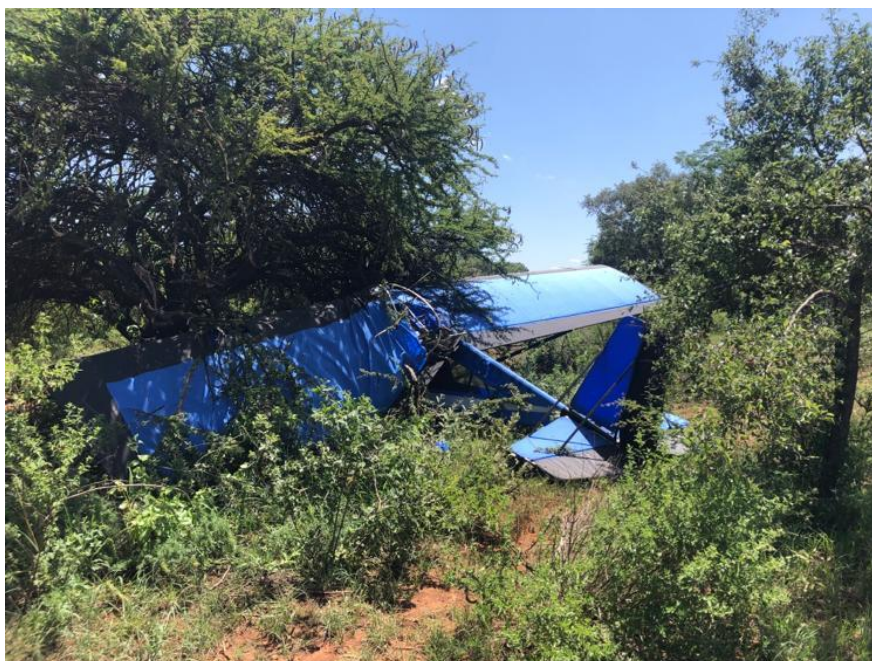
- 1.3.1 The aircraft was substantially damaged during the accident sequence. Moreover, the wreckage was subjected to the elements such as rain before it was recovered from the accident site.

**Figure 2:** The aircraft after it came to rest at the accident site. (Source: Pilot)

1.12.3 The wreckage was contained in one place (area) with the nose slightly raised. The windshield appeared shattered, wings damaged, the nose and main gears damaged. The damage on the airframe was due to the impact force (see Figure 2).

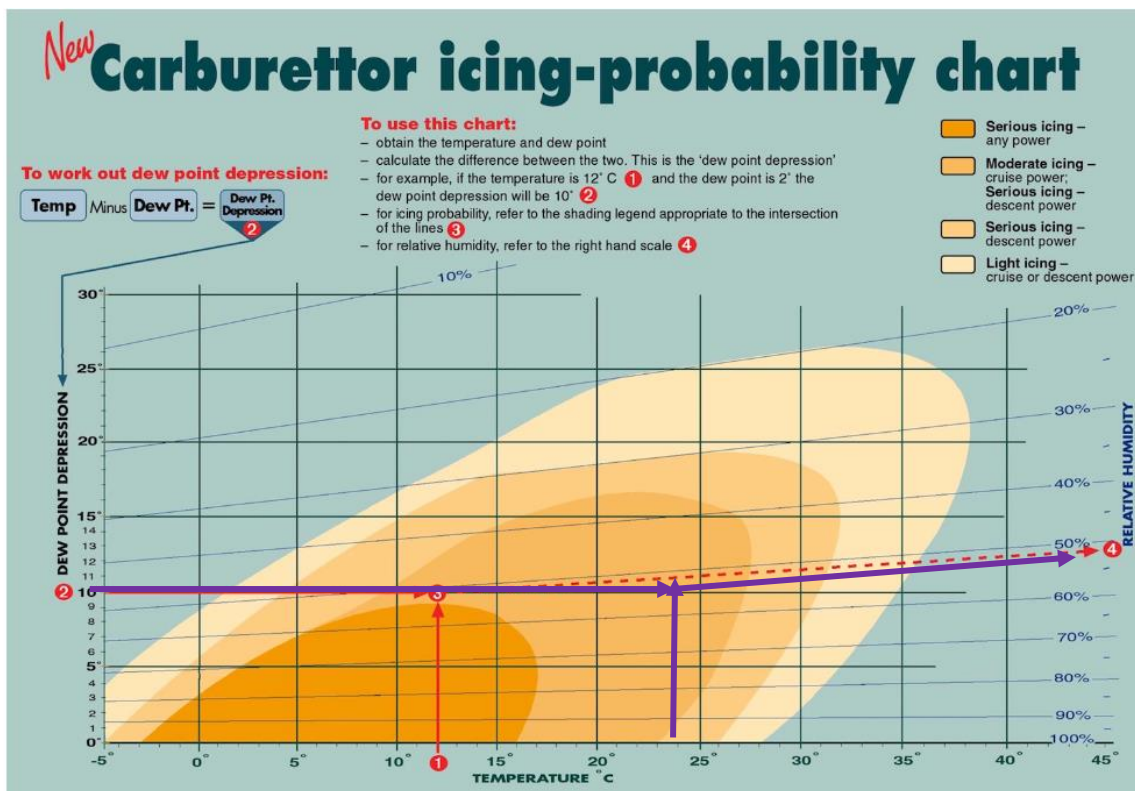
**Figure 3:** The carburettor icing chart showing a calculated icing probability in the FAPI area. (Source: <https://foxbatpilot.files.wordpress.com/2017/01/carburettor-icing-chart.jpg>)

1.7.2 According to the chart (Figure 3), the relative humidity in the area around FAPI was at approximately 52% with the temperature of 24°C, and dew point depreciation of 10°C; the result will be a moderate icing condition at cruise power with serious icing on descent. The relative humidity was less than 52%, therefore, carburettor icing was not a factor.

2.2.4 There was enough fuel in the aircraft and no visual contamination. The relative humidity was at approximately 52% with the temperature of 24°C and dew point depreciation of 10°C, therefore, the result will be a moderate icing condition at cruise power with serious icing on descent; thus, it was unlikely that the carburettor icing was a factor.

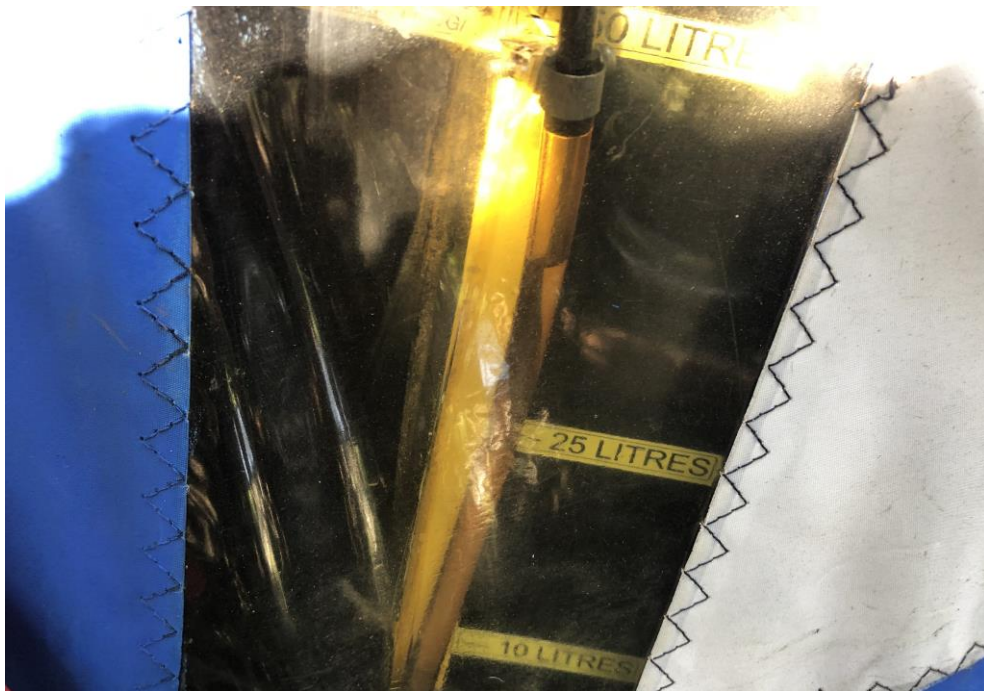
According to the pilot's statement, he took off with 35 litres of fuel and flew for approximately 15 minutes. According to the Bantam Pilot Operating Handbook (POH), fuel consumption is 15 litres per hour. This meant that the aircraft had a total of approximately 31 litres of fuel remaining (see Figure 4).

1.12.4 On-site observation found that there was 31 litres of fuel in the fuel tank as reflected on the sight glass gauge and there was no visual contamination of fuel (see Figure 4).

**Figure 4:** Fuel gauge showing the amount of fuel remaining in the tank.  
(Source: Insurance assessor)

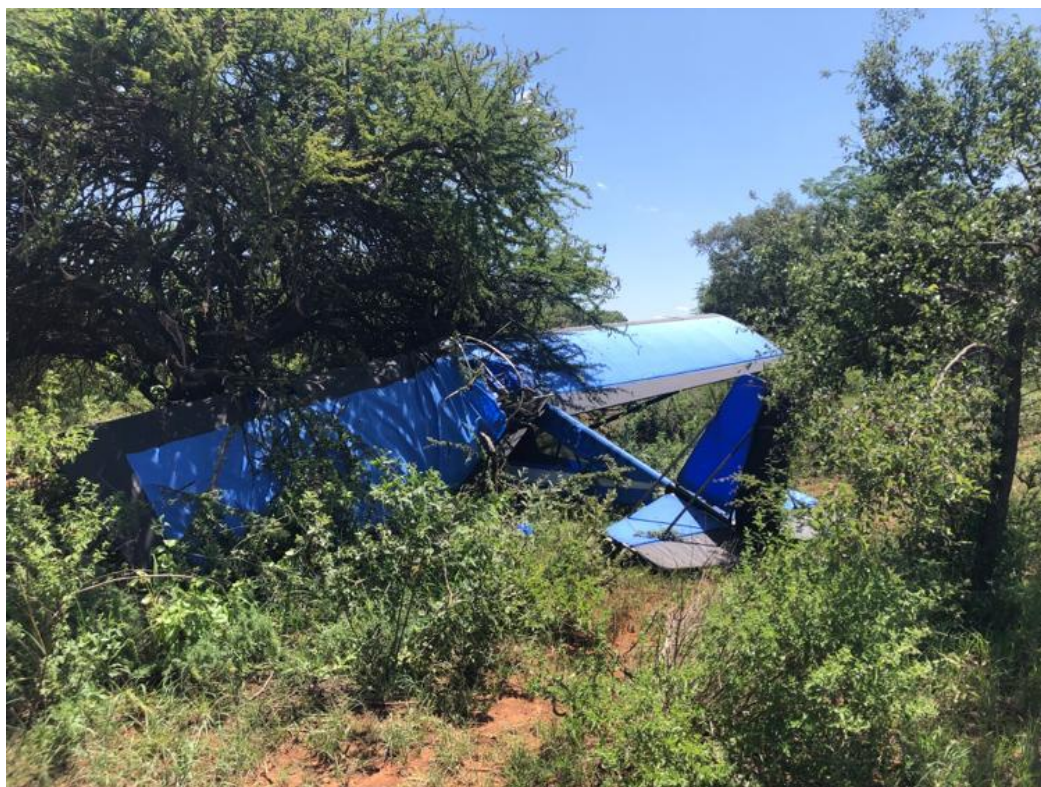
**Figure 5:** Post-accident image. (Source: Pilot)

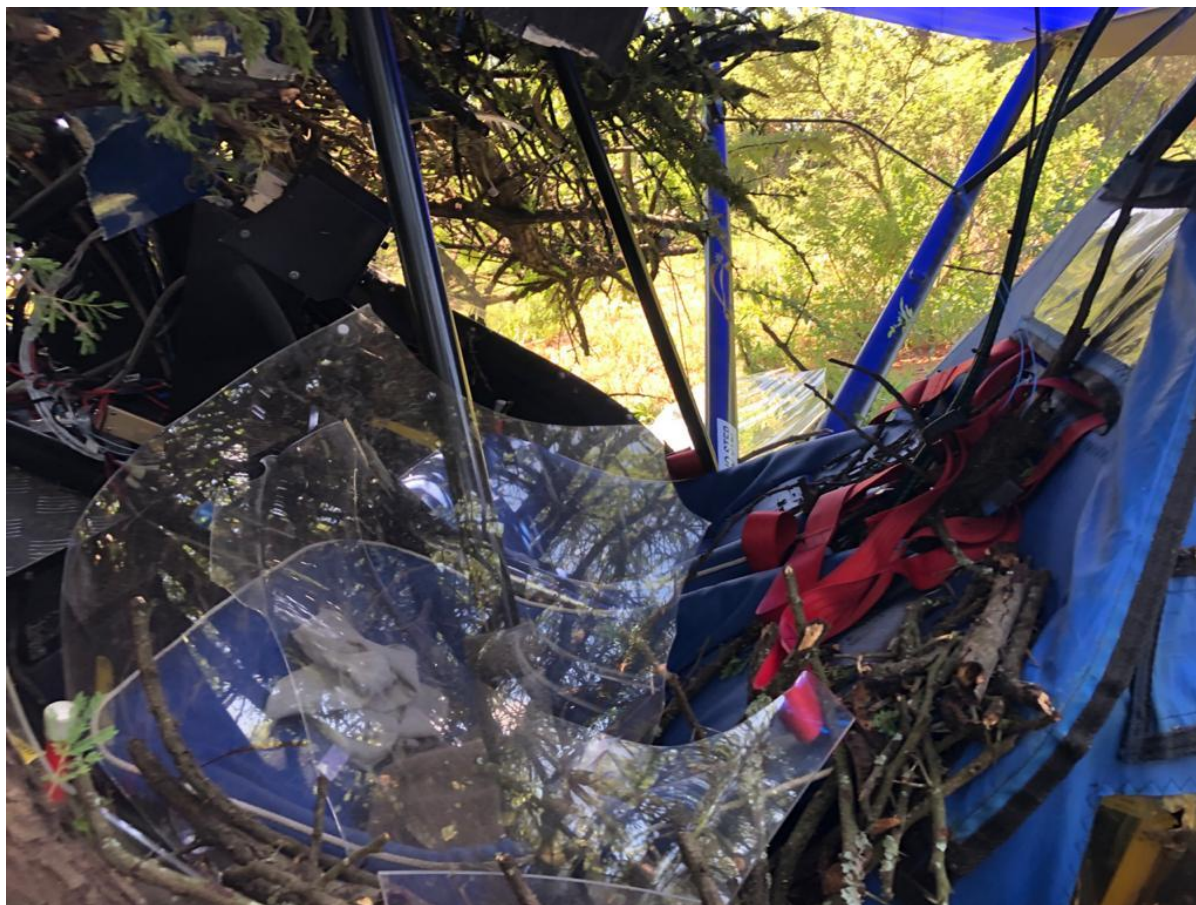
1.15.1 The aircraft accident was considered survivable as the cockpit area (where the two occupants were seated and strapped) did not sustain damage that could have injured them.

**Figure 6:** The cockpit cage and safety harnesses after the accident. (Source: Insurance assessor)
