AIRCRAFT ACCIDENT SHORT REPORT

CA18/2/3/9864: The left main landing gear axle failed and separated from the aircraft during the landing roll.

Date and time	: 30 January 2020, 1500Z
Aircraft registration	: ZU-BEA
Aircraft manufacturer and model	: Kit Planes for Africa, Bush-Baby
Last point of departure	: Plot 49 Klerksdorp, North West Province
Next point of intended landing	: Plot 49 Klerksdorp, North West Province
Location of incident site with reference to easily defined geographical points (GPS readings if possible)	: S26°49'31.21" E026°34'06.14", at an elevation of 4455 ft AMSL.
Meteorological information	: Wind: 330°/03 kt, Temperature 23°C, CAVOK
Type of operation	: Private (Part 94)
Persons on-board	: 1 + 1
Injuries	: Minor
Damage to aircraft	: Substantial

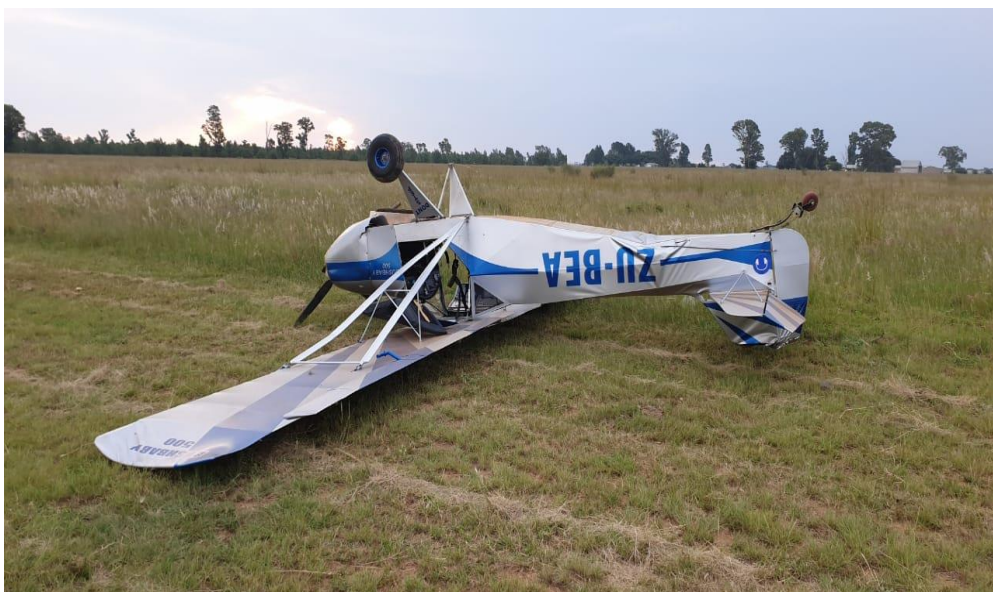
- 1.2. The pilot reported that after touch down during the landing roll, the left-hand main landing gear axle broke off inside the wheel bearing area. As a result, the gear strut dug into the ground and the aircraft nosed over, coming to rest in an inverted position.

Figure 1: The aircraft at the accident site post-accident. (Source: Pilot)

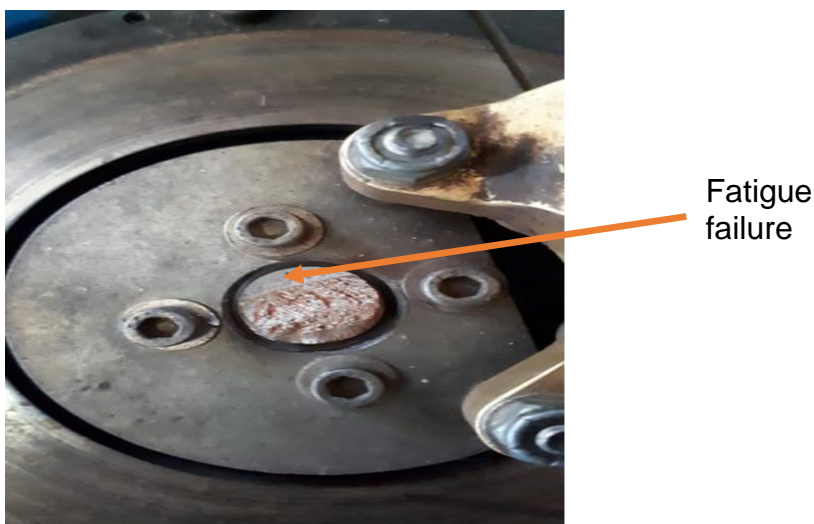
- 2.3. Post-accident inspection of the left gear showed a pre-crack condition on the in-board wheel bearing area where the failure had occurred (see Figure 2).

- 2.5. Figure 2 shows a pre-crack condition on the in-board wheel bearing area indicating that there was an existing crack which may have resulted from previous hard landings.

- 2.8. The axle pre-existing crack (Figure 2) could have occurred from previous hard landings. The pilot is responsible for reporting and recording hard landings so that the aircraft can be inspected for any possible damage. The AP reported that he was not aware of an existing crack.

Figure 2: Pre-crack condition on the in-board wheel bearing area. (Source: AP)

- 4.1. The investigation revealed that the left-hand landing gear failed due to fatigue possibly caused by a pre-existing crack on the wheel assembly in-board bearing area. The failure could be attributed to a possibility that over time, the main landing gear axle could have been exposed to hard landings which may have resulted in the overstress fracture of the left-hand main landing gear axle and, hence, the subsequent separation of the left main landing axle.

- 7.1. It is recommended to the DCA that the airworthiness division and manufacturer consider investigating the possibility of incorporating non-destructive testing (NDT) on the aircraft axle inspection of experimental aircraft to prevent a similar accident from recurring.
