AIRCRAFT ACCIDENT REPORT AND EXECUTIVE SUMMARY

Reference:	CA18/2/3/9878	
Aircraft Registration	ZU-IPS	Date of Accident	15 March 2020		Time of Accident	0914Z
Type of Aircraft	Sling 4 TSi		Type of Operation	Private (Part 91)		
Pilot-in-command Licence Type	National Pilot Licence		Age	54	Licence Valid	Yes
Pilot-in-command Flying Experience	Total Flying Hours		406.8		Hours on Type	81.6
Last Point of Departure	Groutville (Ballito) Airfield, Kwa-Zulu Natal Province					
Next Point of Intended Landing	Groutville (Ballito) Airfield, Kwa-Zulu Natal Province					
Location of the accident site with reference to easily defined geographical points (GPS readings if possible)						
UMkhomazi River Valley, KwaZulu-Natal at GPS co-ordinates S 30° 00' 59.1", E 030° 18' 48.8" and at a field elevation of 1540ft						
Damage to aircraft	Destroyed					
Meteorological Information	Wind: 30° at 0-5kts; Temperature: 29°C; Visibility: 10km					
Number of People On-board	1+0	No. of People Injured	0	No. of People Killed	1

Reference Number : CA18/2/3/9878
Name of Owner/Operator : Interrex Dealer CC
Manufacturer : Airplane Factory Pty Ltd
Model : Sling 4 TSi
Nationality : South African
Registration Marks : ZU-

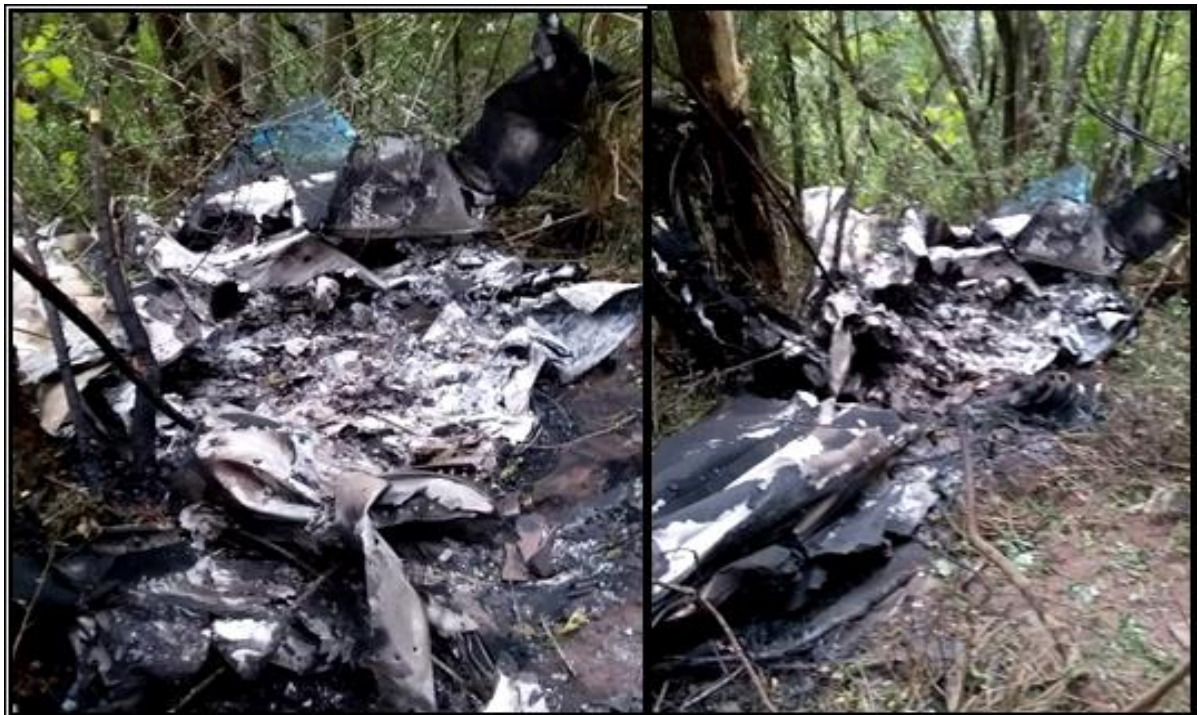
1.3.1 The aircraft was destroyed on impact and by post-impact fire during the accident sequence.

Figures 3 and 4: (left and right) Wreckage of the aircraft as it was found at the accident site.

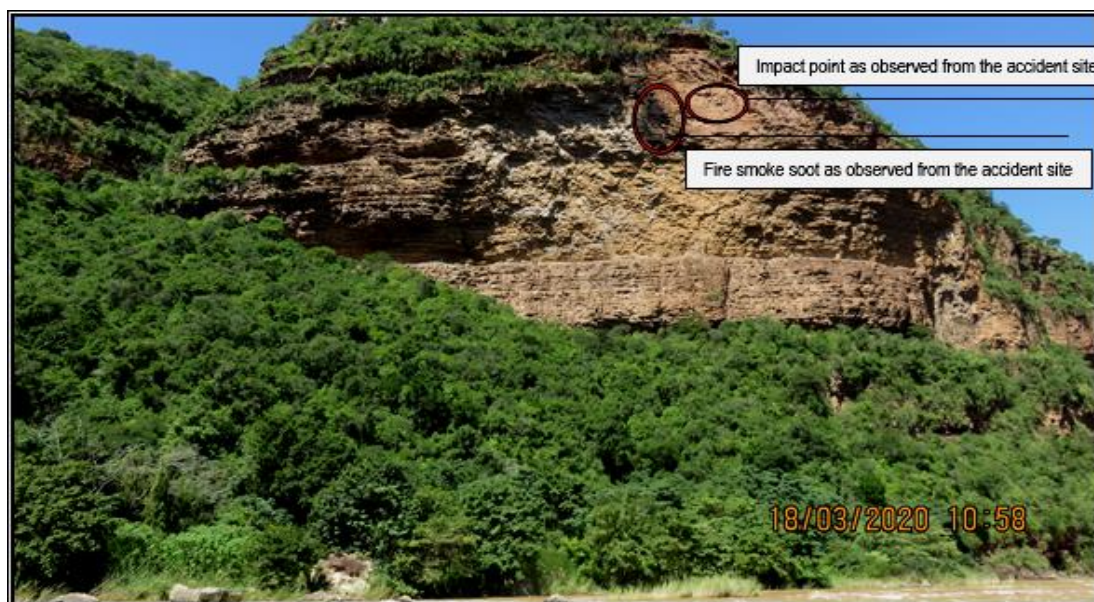
Figure 9: Soot left by an explosion at the place of impact.

1.12.2 According to the eyewitnesses, the aircraft approached from downstream and was flying at a height of approximately 350ft AGL which, when compared to the impact point, was slightly above the soot mark as observed on the surface of the cliff. After impact, there was an explosion, and the aircraft fell into a dense bushy terrain where it continued to burn. A video recording of the accident taken by one of the eyewitnesses with his cellular phone showed smoke emanating from the bush and the soot trace on the cliff edge.

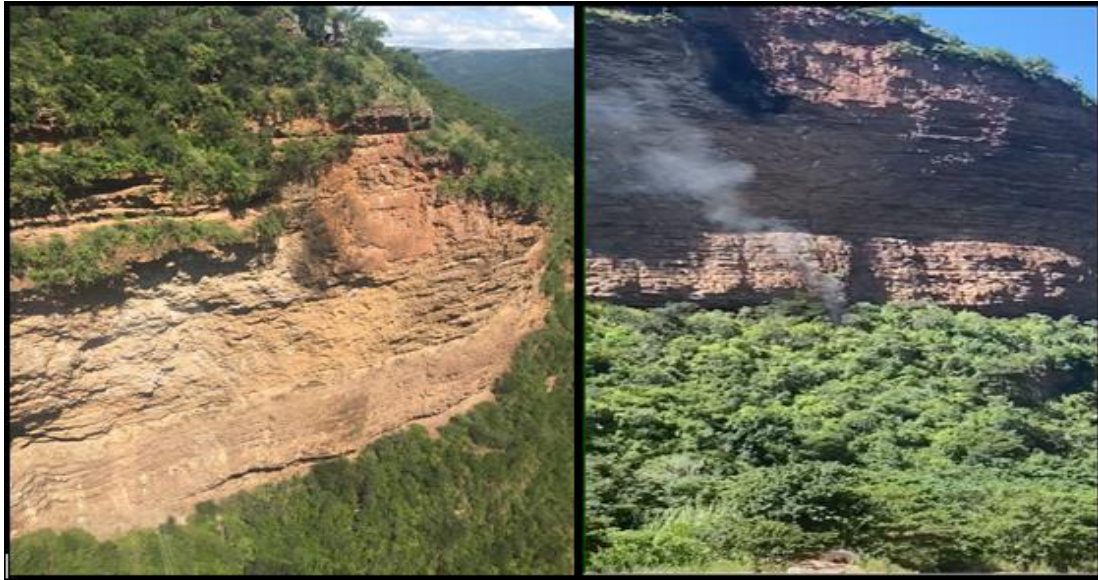
Figures 10 and 11: The location where the aircraft crashed. (Source: Eyewitness)

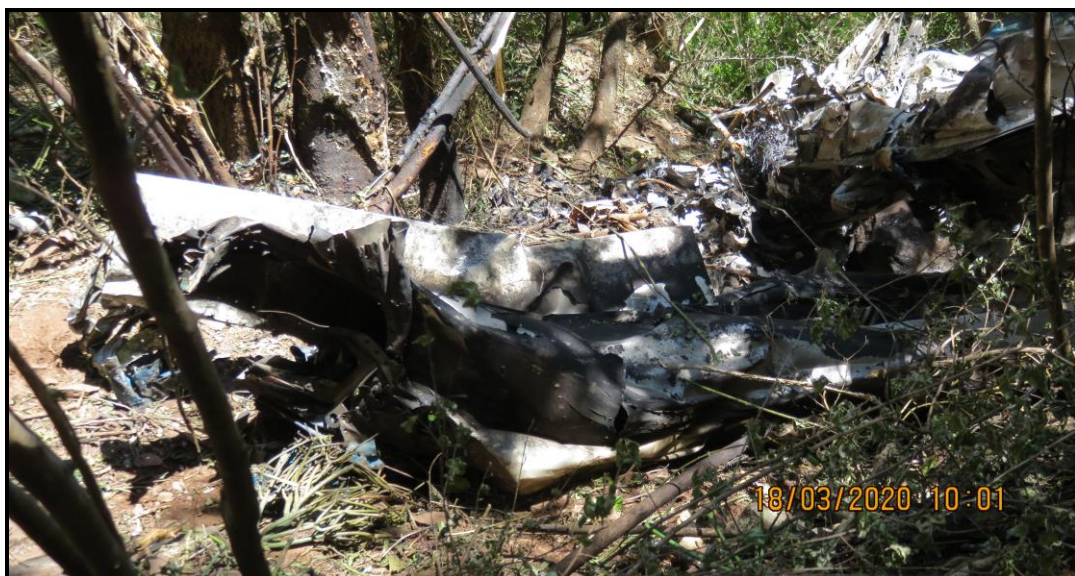
1.12.3 The aircraft was located in a bushy terrain at a height of approximately 230ft AGL with a slope incline of approximately 60° uphill. The aircraft was destroyed by both impact forces and the post-impact fire. The wreckage was found among bushes/shrubs facing downhill at a slight angle towards the west. Most of the electronic and avionic components were found scattered in the downslope. The nose landing gear strut and wheel, together with one of the main landing gears were found approximately 7 metres (m) below the main wreckage. One of the propeller blades was found approximately 3m slightly above the main wreckage and towards the right-side of it.

Figure 12: The wreckage as it was found at the accident site.

1.12.5 The engine was found still attached to the main wreckage and had impact and burnt damages. All three propeller blades had broken off during the initial impact on the cliff. The fuselage impacted the cliff and fell to the ground (bottom of the cliff). This is consistent with an object that crashes head on, on a cliff during a turn.

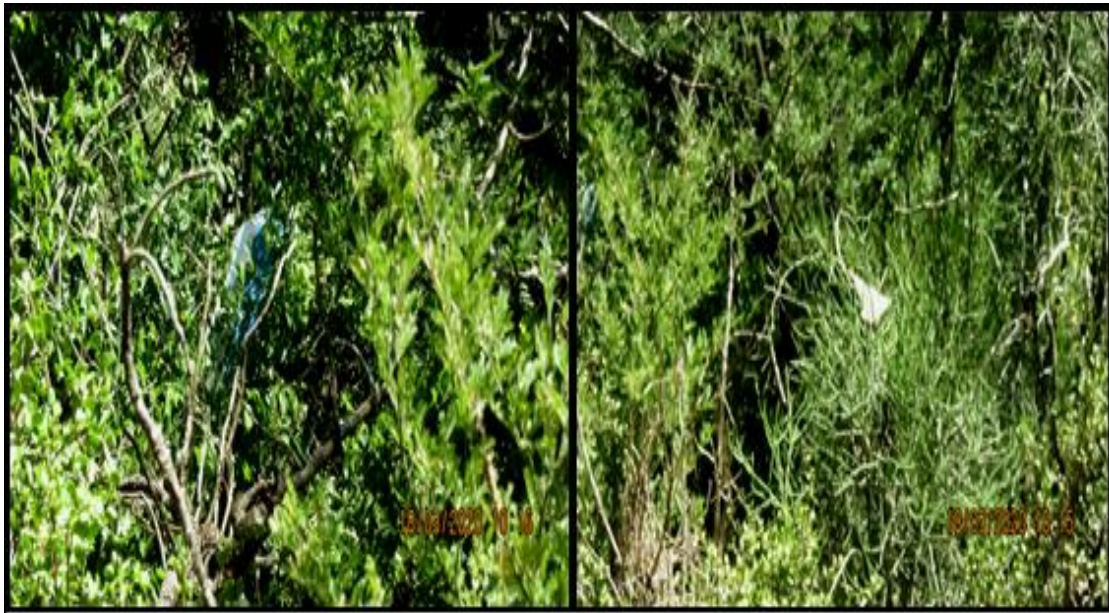
1.12.4 Debris of the aircraft's outer skin and cockpit instrument were found approximately 25m slightly towards the right-side of the main wreckage, above the bushes. The scattered pattern of the debris was consistent with debris that flung during the initial impact in the direction of inertia.

Figure 13 and 14: Scattered aircraft debris.
