**HELICOPTER ACCIDENT REPORT AND EXECUTIVE SUMMARY**

Reference:	CA18/2/3/9886	
<b>Helicopter Registration</b>	<b>ZS-RDI</b>	<b>Date of Accident</b>	1 August 2020	<b>Time of Accident</b>	1030Z	
<b>Type of Helicopter</b>	Robinson R44 Raven II			<b>Type of Operation</b>	Aerial Work (Part 137)	
<b>Pilot-in-command Licence Type</b>	Commercial	<b>Age</b>	35	<b>Licence Valid</b>	Yes	
<b>Pilot-in-command Flying Experience</b>	Total Flying Hours		2548.9	Hours on Type	2520.1	
<b>Last Point of Departure</b>	De Poort Private Farm near Colesberg, Northern Cape Province					
<b>Next Point of Intended Landing</b>	De Poort Private Farm near Colesberg, Northern Cape Province					
<b>Location of the accident site with reference to easily defined geographical points (GPS readings if possible)</b>						
Cypherkuil Private Farm, 10nm south-west of Colesberg, Northern Cape Province, at GPS co-ordinates determined to be 30°46'45.54" S 024°39'27.85" E at an elevation of 4583ft

**Reference Number** : CA18/2/3/9886  
**Name of Owner/Operator** : WP Smith  
**Manufacturer** : Robinson Helicopter Company  
**Model** : Robinson R44 Raven II  
**Nationality** : South African  
**Registration Marks** : ZS-RDI

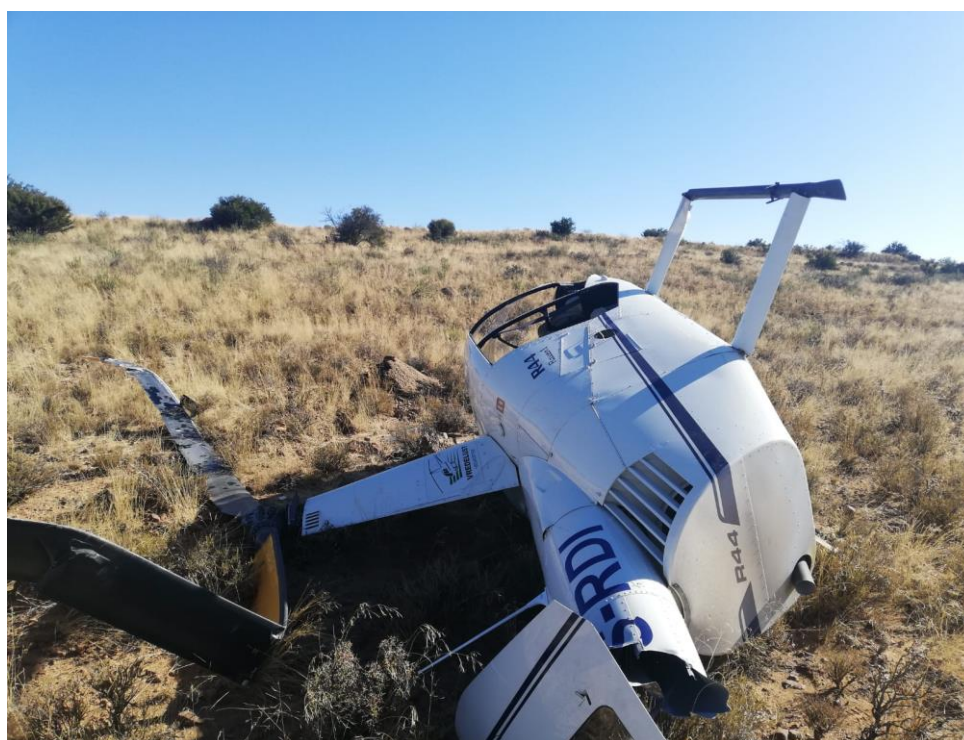
1.3.1 The helicopter sustained substantial damage during the accident sequence.

**Figure 2:** The wreckage post-accident.

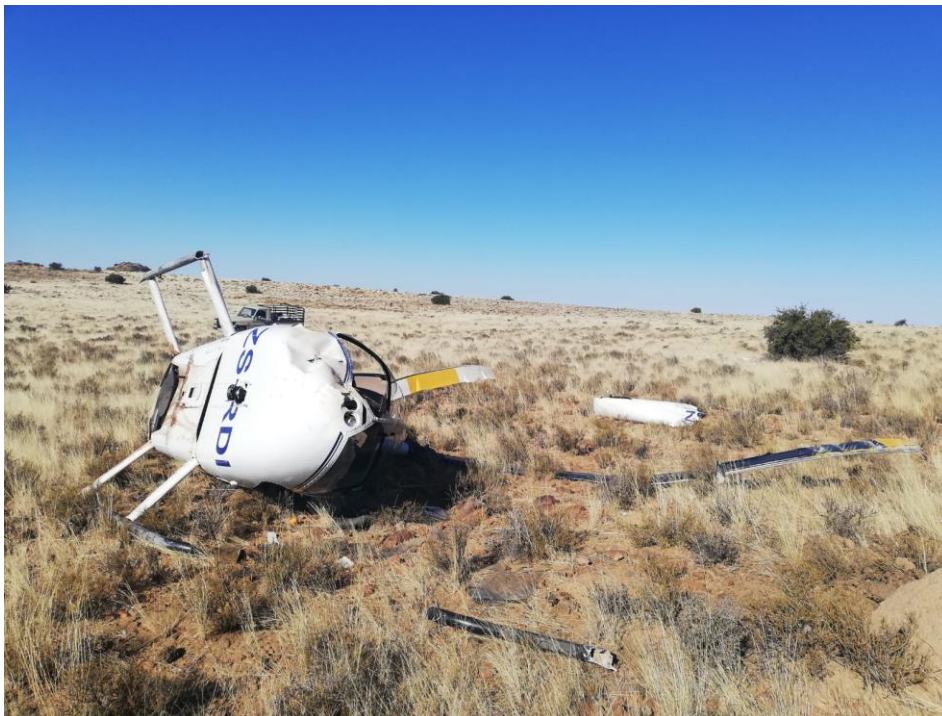
1.12.1 The helicopter landed hard on its skids following loss of tail rotor effectiveness and loss of control. The main rotor blades severed the tail boom and the helicopter rolled on its left-side before coming to a stop. The main wreckage was confined in one place with the tail boom found approximately 30 metres from the main wreckage.

**Figure 3:** The helicopter wreckage as it came to rest.

1.12.2 The helicopter was inspected and all the control surfaces were accounted for and continuity of the cables was confirmed. All damage was attributed to the accident sequence.
