AIRCRAFT ACCIDENT REPORT AND EXECUTIVE SUMMARY

Reference:		CA18/2/3/9891	
Aircraft Registration	ZS-EBC	Date of Accident	30 June 2020		Time of Accident	1048Z	
Type of Aircraft	Piper PA-28-180 Cherokee		Type of Operation		Training (Part 141)		
Pilot-in-command Licence Type	Student Pilot Licence		Age	16	Licence Valid	Yes	
Pilot-in-command Flying Experience	Total Flying Hours		24.14		Hours on Type	24.14	
Last Point of Departure	Wonderboom Aerodrome (FAWB), Gauteng Province						
Next Point of Intended Landing	Wonderboom Aerodrome (FAWB), Gauteng Province						
Damage to Aircraft	Destroyed						
Location of the accident site with reference to easily defined geographical points (GPS readings if possible)							
On a ploughed field behind Pretoria University Faculty of Veterinary Science Campus at GPS co-ordinates determined to be S25° 38' 55.5" E28° 10' 30.7" at an elevation of approximately 3991 feet above mean sea level (AMSL)							
Meteorological Information	Wind direction: 090°; Wind speed: 08 knots; Temperature: 19°C; Dew point: -02°C; Visibility: 9999m; QNH:1028hPa

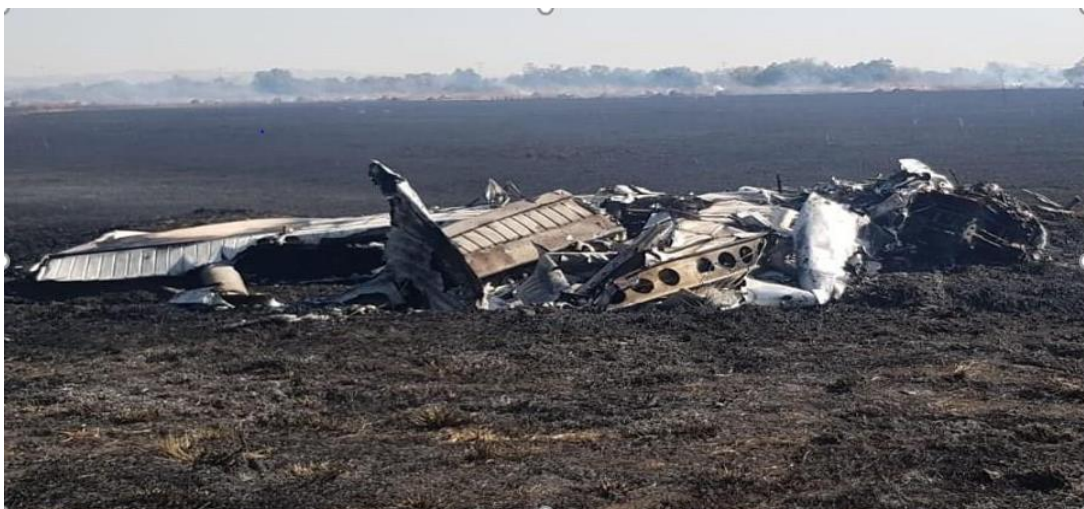
1.3.1 The aircraft was destroyed during the accident sequence.

Figure 3: The wreckage at the accident site after the fire was extinguished.

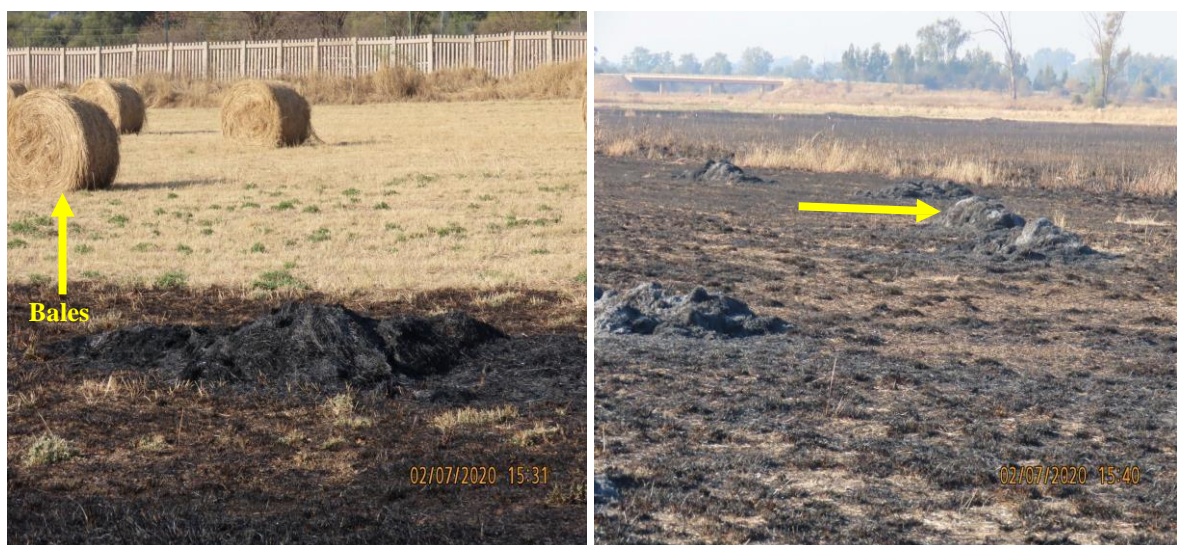
1.4.1 The farmer estimated that 400 bales of Teff Hay were destroyed in the fire.

Figures 5/6: Bales of hay that survived the fire (left) and some that were burnt (right).

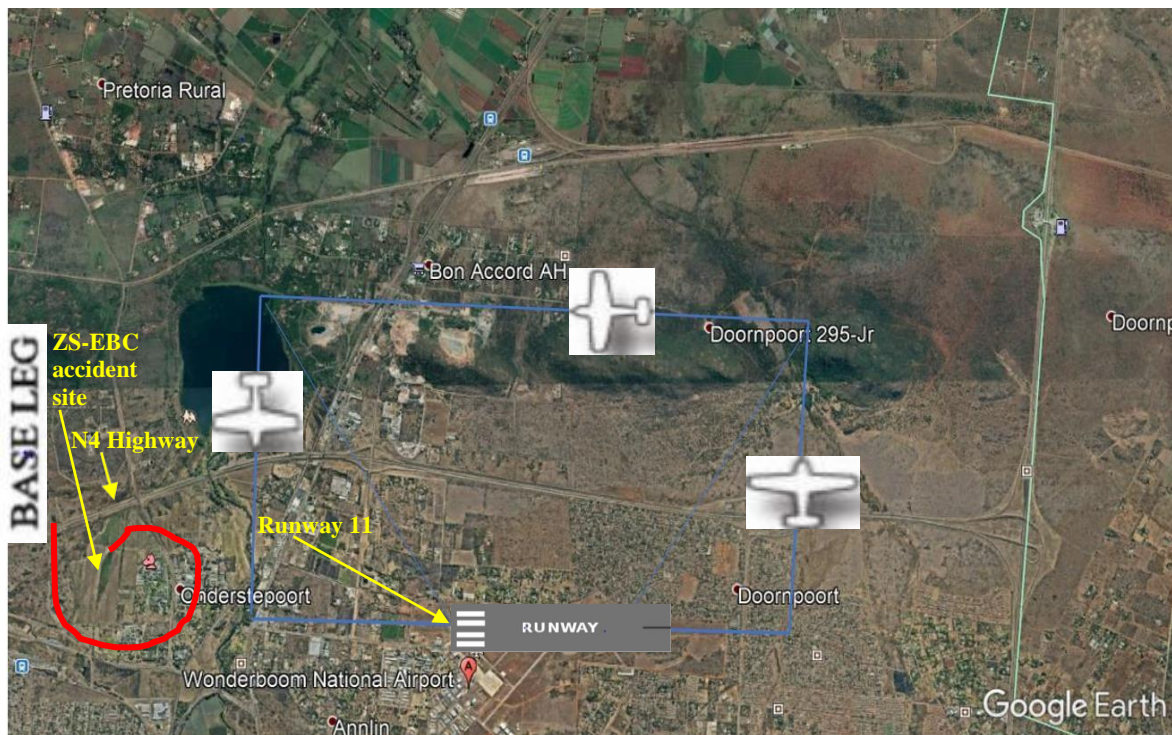
Figure 9: A map showing the standard training circuit pattern (blue colour) at FAWB, Runway 11. The red line shows the approximate flight path of ZS-EBC aircraft. (Source: Google Earth)

2.2.6 The investigation revealed that the aircraft flew an extended base leg and passed the extended centreline of Runway 11. To get the aircraft to the final approach path, the student pilot executed a steeper than normal turn and the aircraft entered into a torque roll, descending left spiral. To recover the aircraft from that condition, the student pilot had applied more power

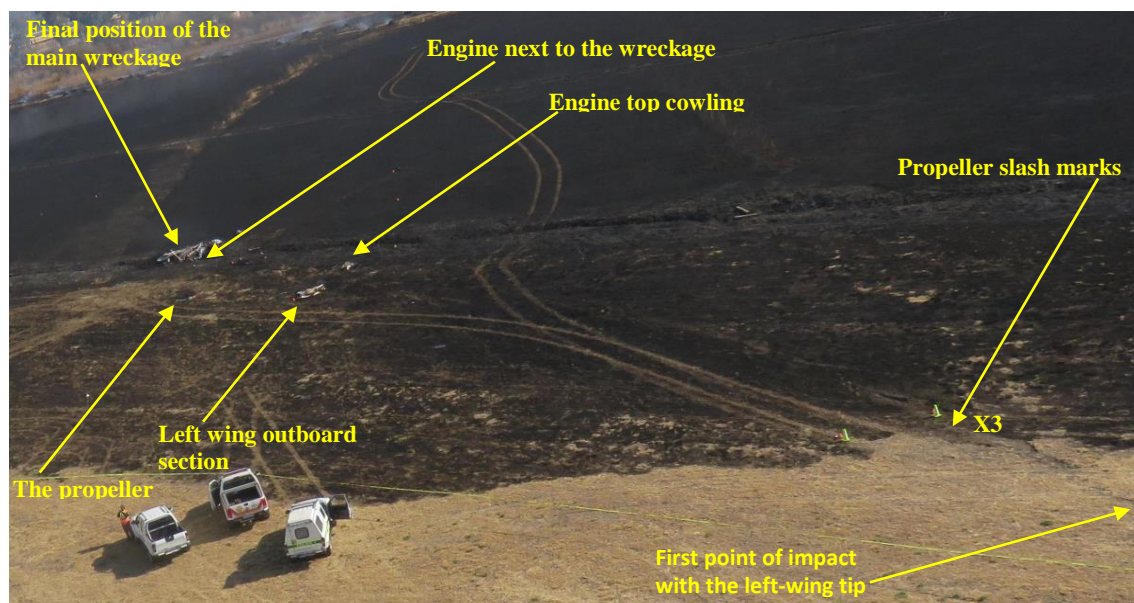
1.12.1 The accident occurred on a privately-owned farm situated behind the Pretoria University campus in the Onderstepoort area at 230° magnetic heading. The main wreckage came to rest approximately 98.8 metres from the first point of impact. The furthest item of the wreckage was the nose landing gear wheel assembly, which had travelled about 128m from the initial impact point. The main wreckage indicated no signs of in-flight break-up. The wreckage was contained in one area and exhibited severe structural damage consistent with high-speed impact. The single cabin entry door, located on the right-side of the aircraft, suffered impact damage and fire. However, it was noticed that part of the door frame which contained double latches engagement slot was damaged in a manner that suggested that the door had burst open during the accident sequence. Examination of the accident site showed that the aircraft was in a left-wing low nose-down attitude when it hit the ground. The aircraft skidded for approximately 4 metres (m) after impact, leaving a shallow impression made by the forward edge of the bottom cockpit area and the propeller.

1.12.2 The aircraft cart-wheeled and, during the process, the left-wing outboard section had broken off before the aircraft came to rest approximately 65m from the main wreckage. The left fuel tank had ruptured, and the fuel ignited, setting alight the main wreckage and a portion of the ploughed field. The cockpit Plexi-glass windshield had shattered during the accident sequence, and the engine top cowling had separated and came to rest next to the outboard left-wing section. The engine had detached from the cradle and was found next to the wreckage. Three propeller blades slash marks were noticed on the soft ground at the first point of impact.

Figure 10: An aerial view of the accident site.

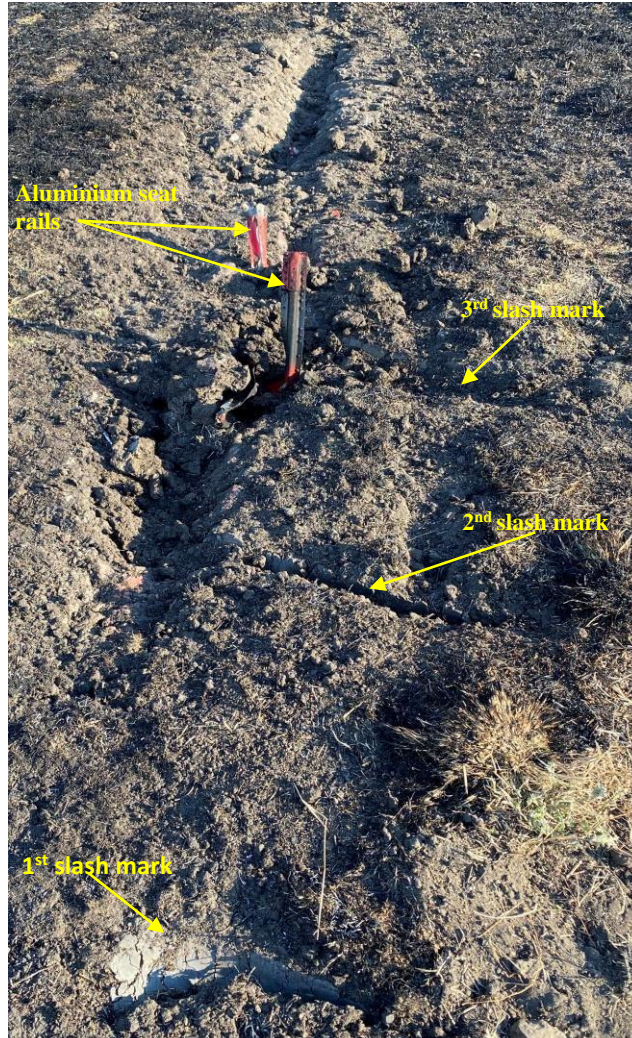
- 1.12.3 Next to the blades slash (grooves) marks were the aircraft seat rails from the left pilot seat floor. The propeller had separated from the engine crankshaft (drive shaft) flange and was found next to the main wreckage, about 12m to the left. One blade was bent aft from the shank to the tip, and the other was twisted.
- 1.12.4 Examination of the propeller/blades, the broken drive shaft and impact marks on the soft ground indicated that the engine was producing a large amount of power at the time of impact – the amount of power sheared off the drive shaft.

Figure 11: Blades slash marks and the seat rails.

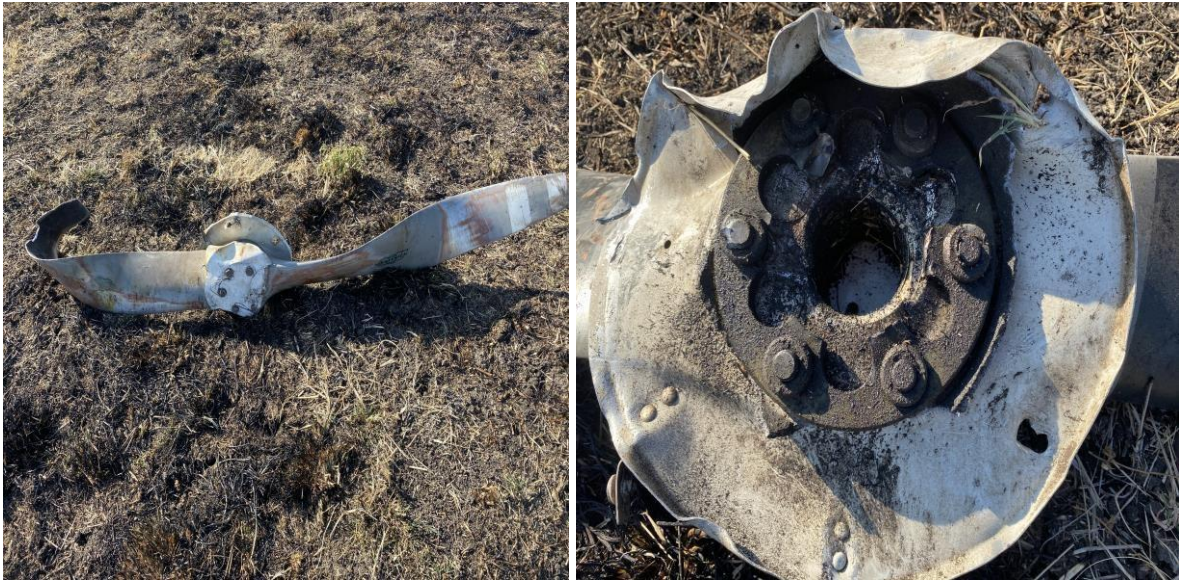
Figures 12/13: The propeller (left) and the crankshaft flange (right).

1.16.4 The fractured engine crankshaft/driveshaft that was noted at the accident site was an indication that the engine was developing a large amount of power at impact and that the internal

components were in good condition. The exact amount of engine power was undetermined due to the absence of a flight data recorder (FDR). According to the type certificate data sheet (TCDC), the maximum permissible take-off engine revolutions per minute (RPM) is 2 475 and for all other operations the maximum permissible RPM is 2 700. Experts opinion indicated that the engine was operating at approximately 2 400 RPM at the time of impact.

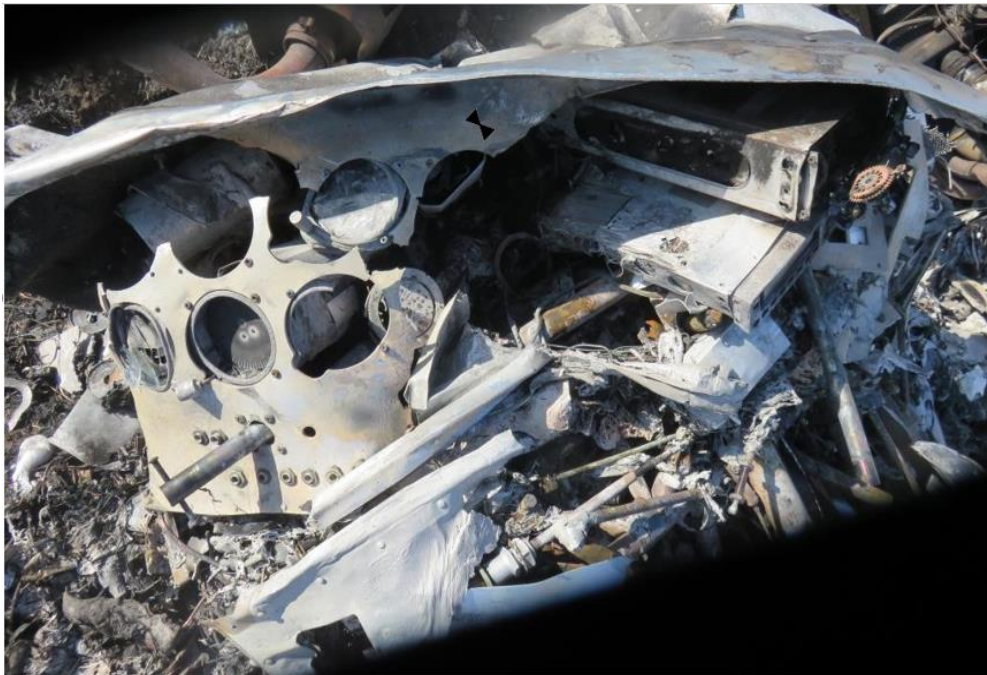
1.12.5 The fire had destroyed the cockpit/cabin interior furnishings including seat cushions, seatbelts, wall coverings and floor carpets. All six main flight instruments, the engine instruments and the radio had burnt and got detached from their respective mounting points. The flight instrument panel surface was examined for witness marks of any needle positions at the time of impact; no reliable marks were found. The position of the power lever and the mixture control lever could not be determined due to the extent of damage. The position of the fuel selector could not be confirmed due to the fire damage. The circuit breaker panel had burnt with a majority of breakers fractured. The aircraft's avionics had burnt and got detached from their mounting brackets.

Figure 14: Burnt cockpit/cabin.

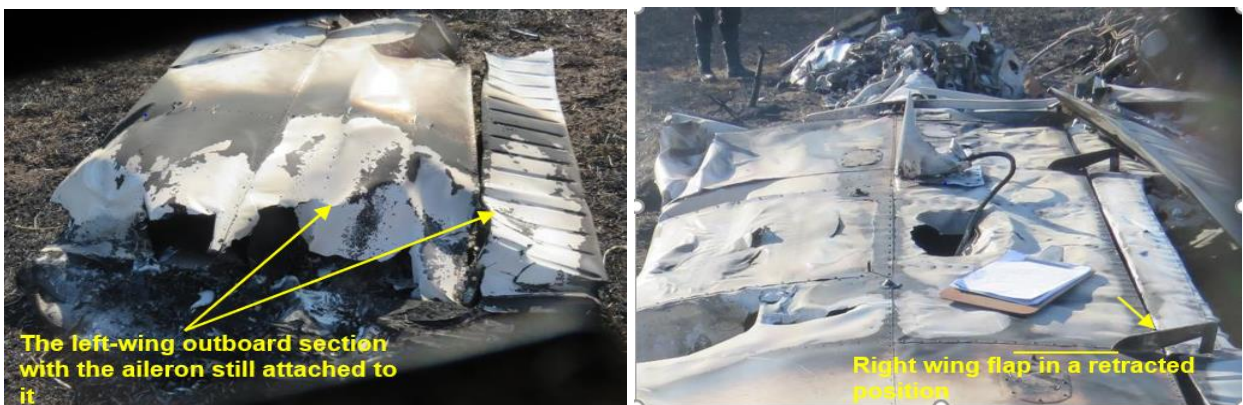
1.12.6 The flying controls surface sustained varying degrees of damage during the accident sequence. Both ailerons were still attached to the wings pivot points, however, the left aileron had separated from its control inputs rods. The right-wing aileron control rod and bellcrank were intact and moved freely through their full range when examined. The rudder control cables had dislodged from their fuselage support pulleys but were continuous and correctly attached to the damaged rudder pedal mechanisms. The left and right rudder pedal assemblies were severely disrupted during the accident, and the pedal “reach set” by the pilot could not be determined. The rudder was correctly attached and moved freely through its full range when examined. The elevators were still attached and moved freely through their respective range when examined. Despite the fuselage fracture, the elevator push rods and linkages were intact, had full continuity and operated in their full range when examined. The horizontal stabiliser was in a position corresponding to neutral trim. The flaps were found in a retracted (UP) position as supposed to a partial landing configuration (second notch “25 degrees) to decrease speed and height in a controlled manner.

Figures 15/16: The left-wing outboard section (left) and the right-wing flap still in retracted position (right).

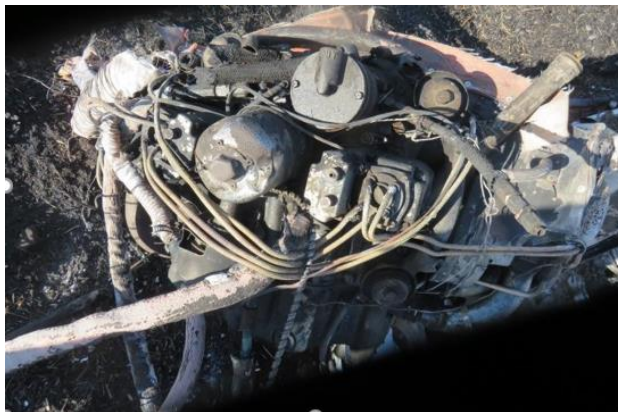
1.16.6 According to the latest Lycoming service instruction No.1009BE dated 24 April 2020, time between overhaul (TBO) periods for Lycoming O-360-A30 engine model is 2000 hours or 12 years, whichever comes first. The engine was operated within the manufacturer's recommended TBO schedule.

Figure 17: The aircraft engine.

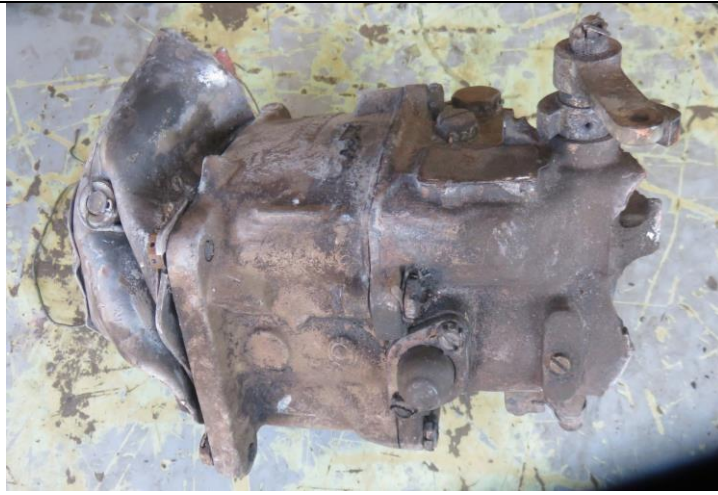
Impact damaged carburettor.

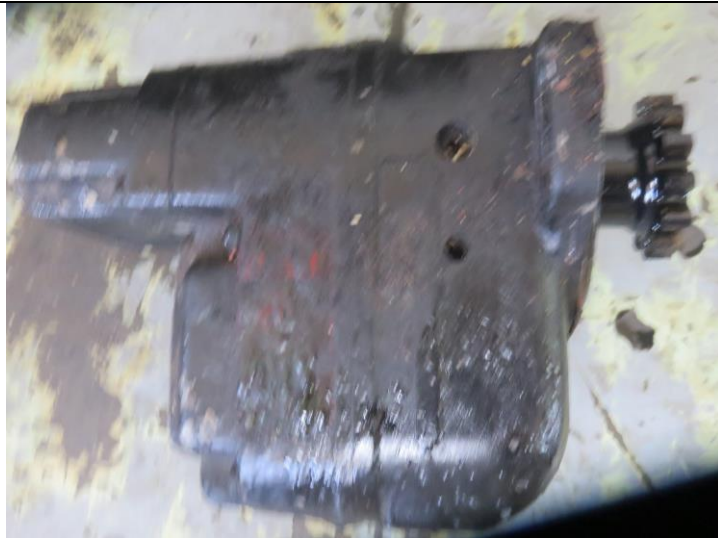
Magnetos were tested and were correctly set.

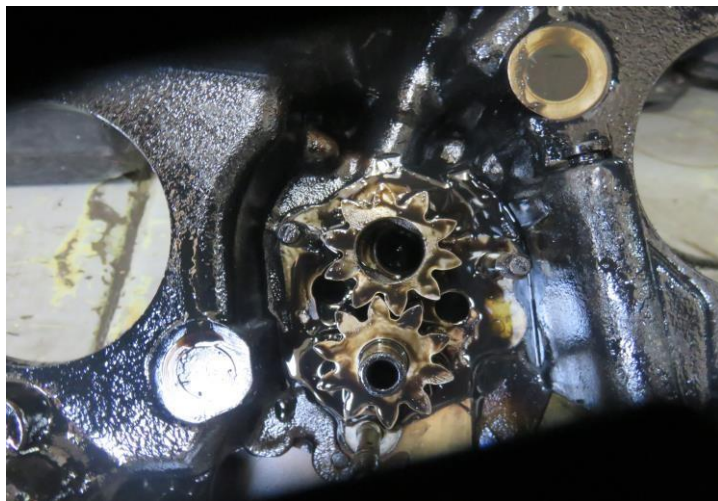
Engine-driven oil pump (gears), correctly assembled and normal.

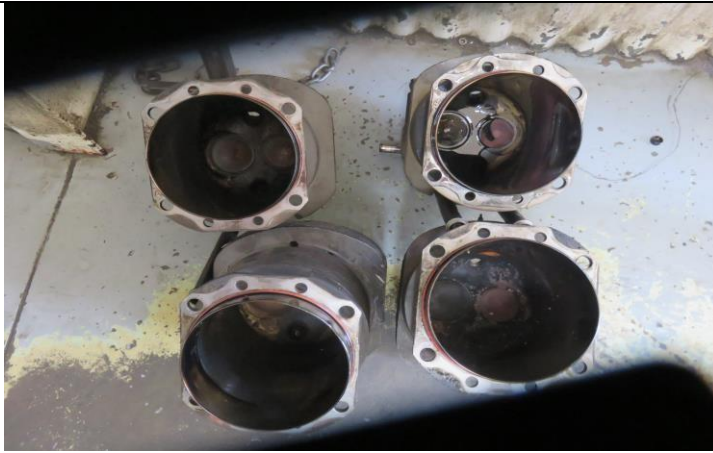
Cylinders showing normal wear with all inlet and exhaust valves in a normal operation condition.

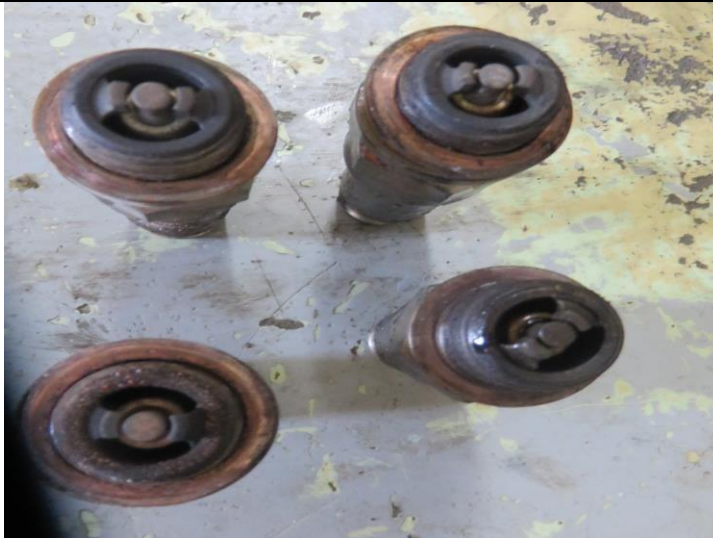
Four undamaged spark plugs were tested for continuity and the electrodes on them were normal.

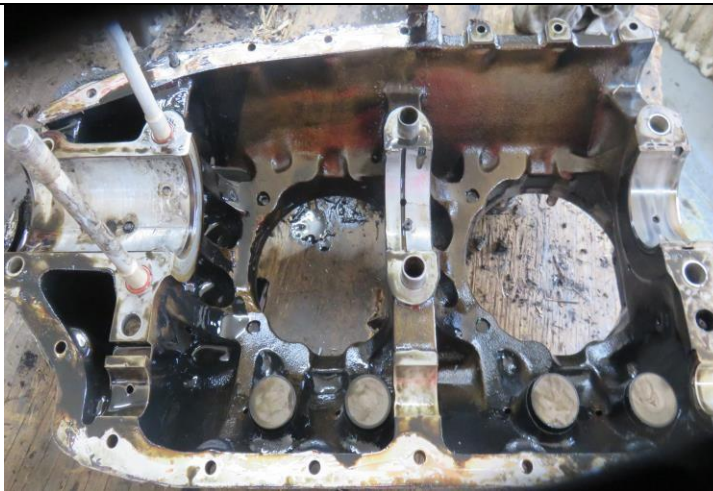
Left crankcase half showing hydraulic tappets/lifters in a good condition.

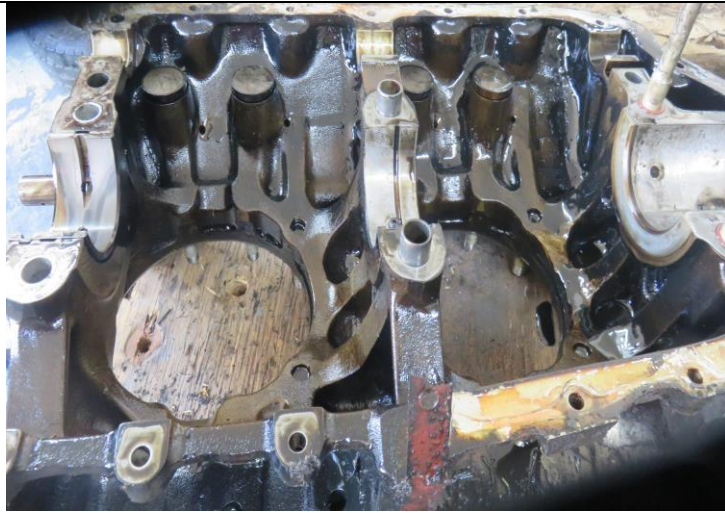
Right crankcase half showing hydraulic tappets/lifters in a good condition.

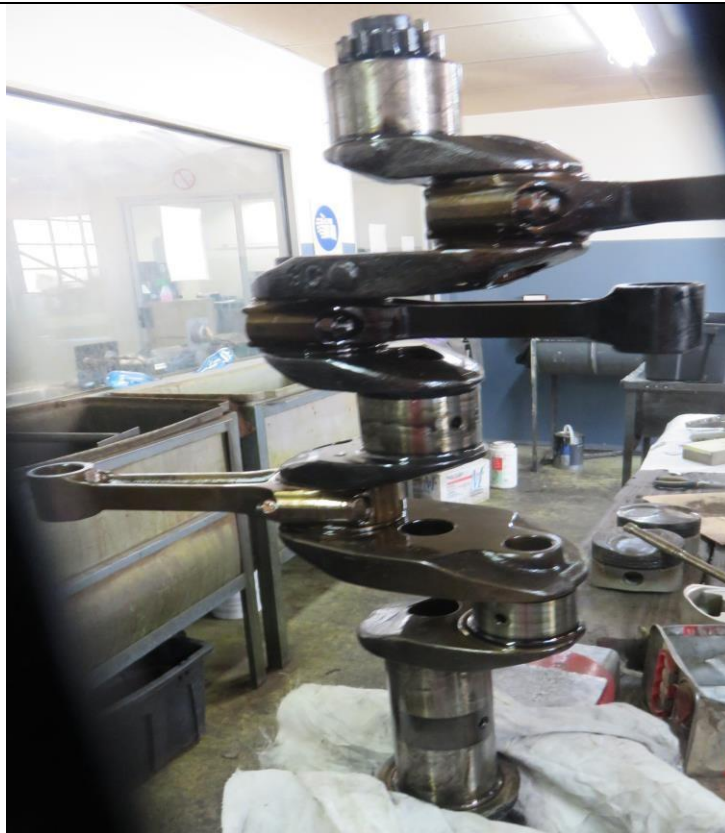
Engine crankshaft normal with oil galleries/passageways unobstructed.

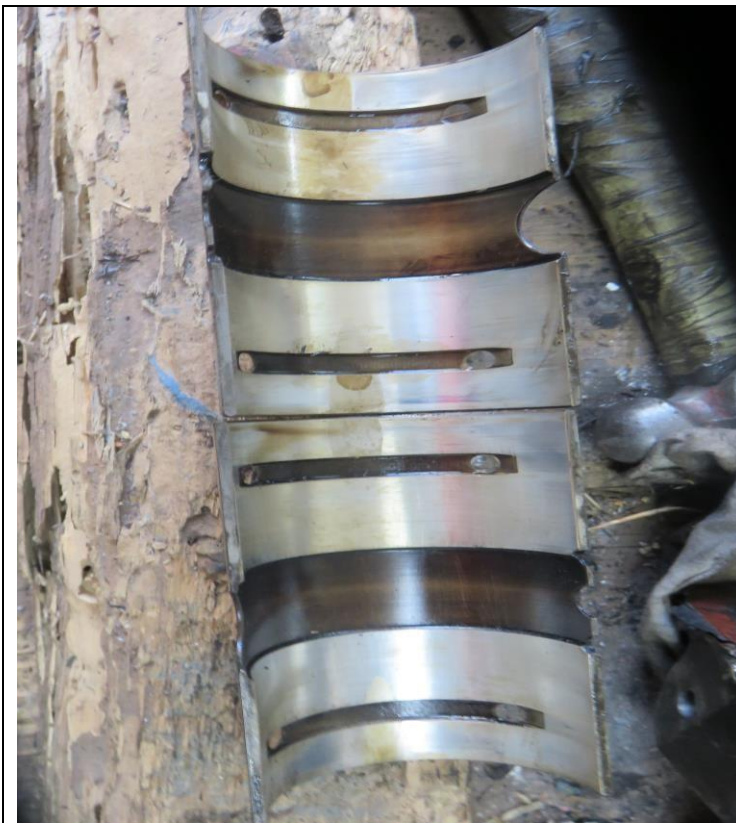
Bearings were undamaged and showed normal lubrication.

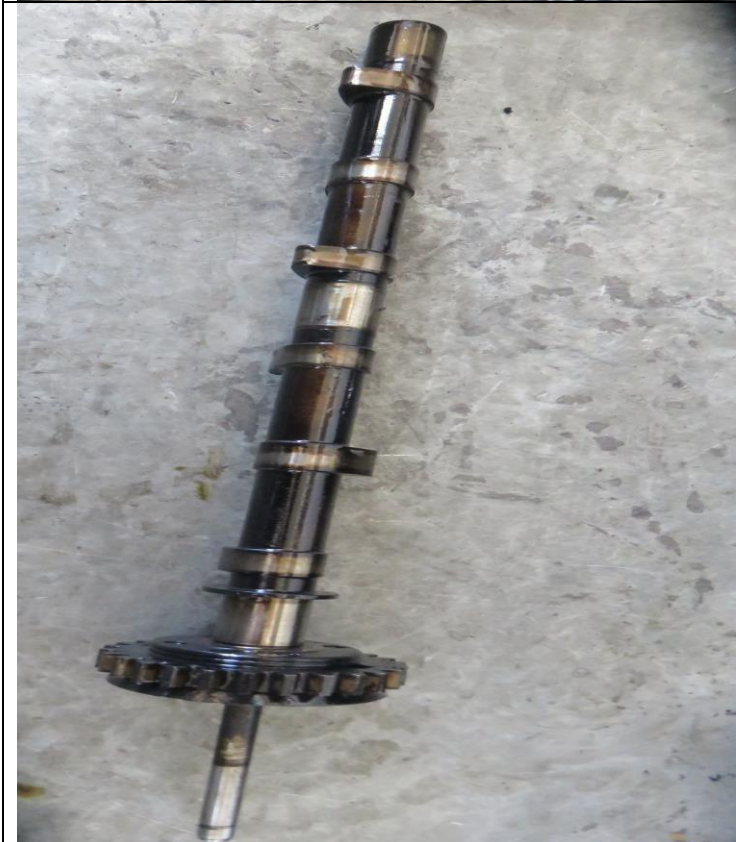
The camshaft was normal with no evidence of wear on the camshaft lobes.

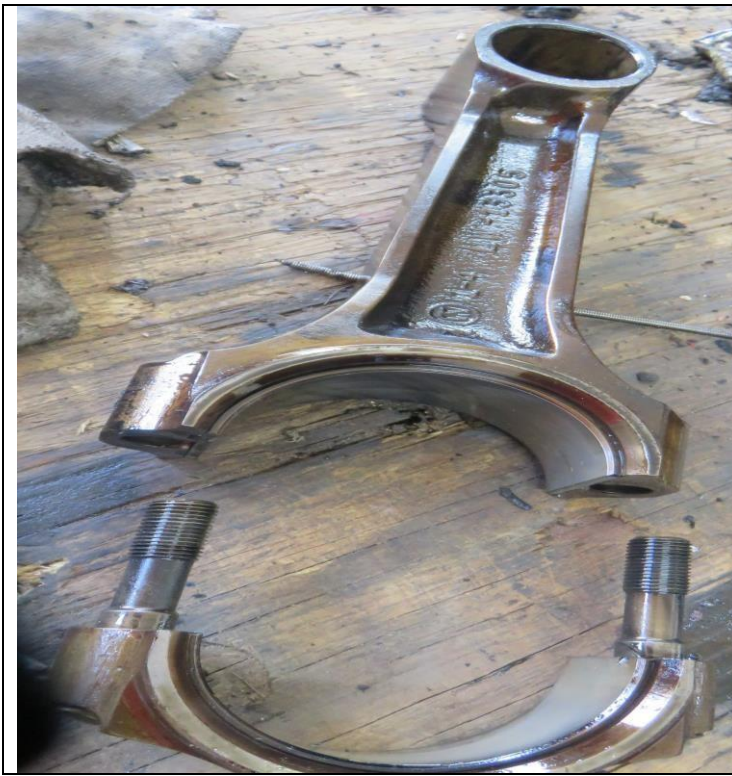
Connecting rods correctly assembled and normal.
