AIRCRAFT ACCIDENT SHORT REPORT

CA18/2/3/9895: Dynamic roll-over during a training flight at FACT.

Aircraft registration : ZS-ROP

Aircraft manufacturer and model : Airbus Helicopters, H120

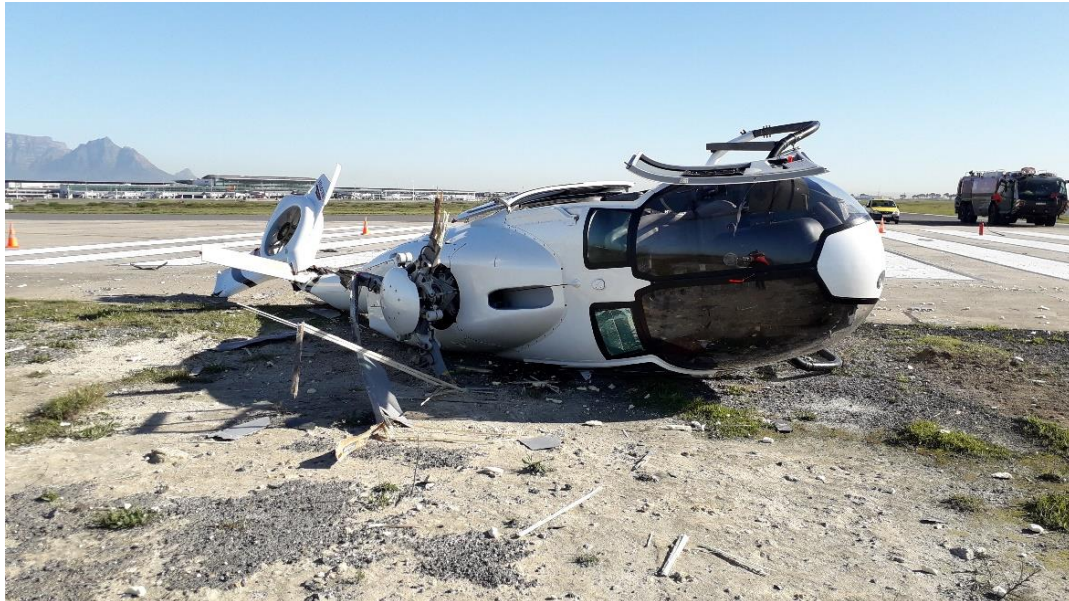
The right skid gear first made contact with the ground (grass covered area) near the threshold of Runway 34 (see Figure 2). The helicopter then came to rest on the edge of the threshold facing east. Debris (mostly consisting of carbon fibre) was spread over a large area because the three main rotor blades impacted the ground and broke into smaller pieces as the rotor system was still turning at normal operating speed on impact. The tail boom (also constructed from carbon fibre) was damaged on the front part of the fenestron tail rotor assembly (see Figure 4).

Figure 2: The helicopter as it came to rest. (Photograph courtesy of FACT ARFF)

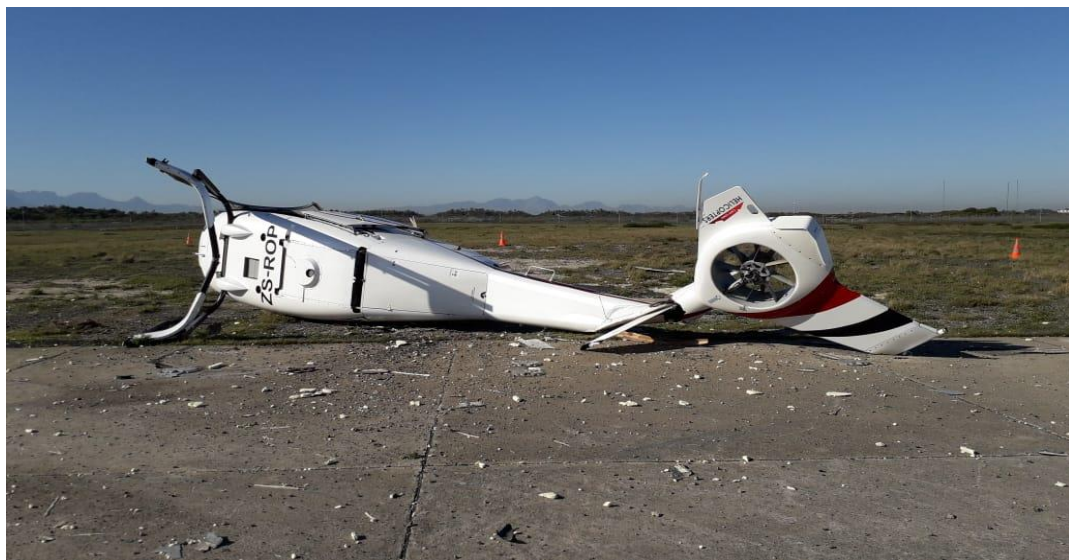
Figure 3: Debris on the runway threshold after the accident. (Photograph courtesy of FACT ARFF)

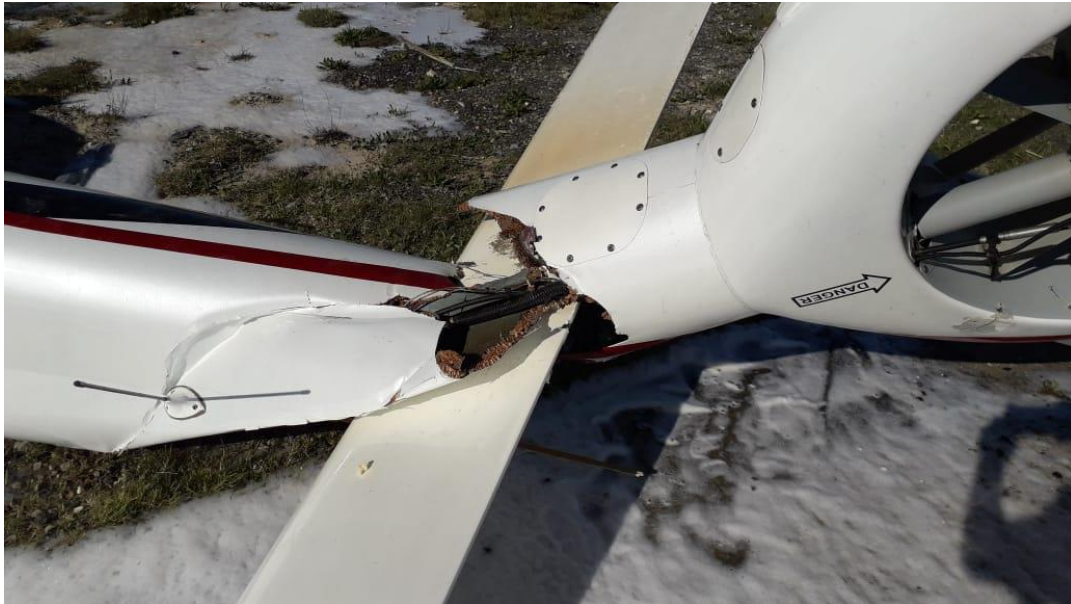
Figure 4: The broken tail boom structure on the front part of the fenestron. (Photograph courtesy of FACT ARFF)
