AIRCRAFT ACCIDENT REPORT AND EXECUTIVE SUMMARY

Reference:	CA18/2/3/9907	
Aircraft registration	ZS-OET	Date of accident	26 August 2020		Time of accident	1630Z
Type of aircraft	Cessna 172F (Aeroplane)		Type of operation		Training (Part 141)	
Pilot-in-command licence type		Commercial Pilot	Age	26	Licence valid	Yes
Pilot-in-command flying experience		Total flying hours	1 220.0		Hours on type	150.3
Last point of departure		Springs Aerodrome (FASI), Gauteng Province				
Next point of intended landing		Springs Aerodrome (FASI), Gauteng Province				
Aircraft damage		Destroyed				
Location of the accident site with reference to easily defined geographical points (GPS readings if possible)						
Springs Aerodrome (GPS position: 26°15'15.68" South 028°23'42.58" East), elevation 5 363 feet						
Meteorological information		Surface wind: 320°/3kts, temperature; 22°C, dew point; -2°C, CAVOK				
Number of people on-board		2 + 0	No. of people injured	1	No. of people killed	1

Reference number : CA18/2/3/9907
Name of owner : Mach 1 Aviation Academy (Pty) Ltd
Name of the operator : Mach 1 Aviation Academy (Part 141)
Manufacturer : Cessna Aircraft Company
Model : 172F
Nationality : South African
Reg

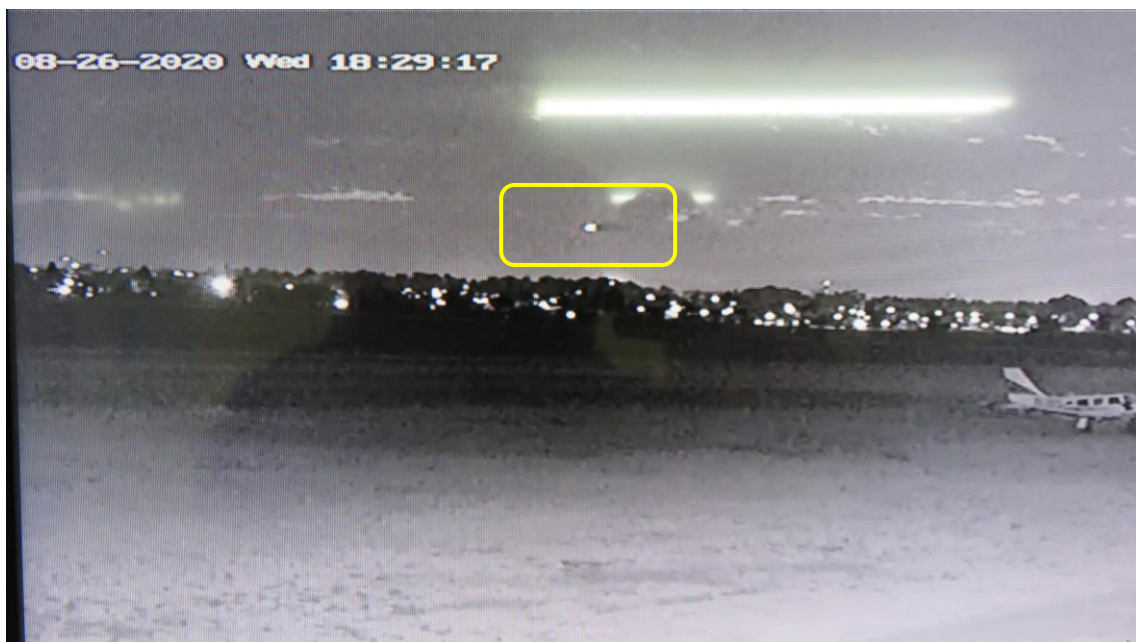
Figure 1: The aircraft on the left downwind for Runway 03. (Source: ATO video camera)

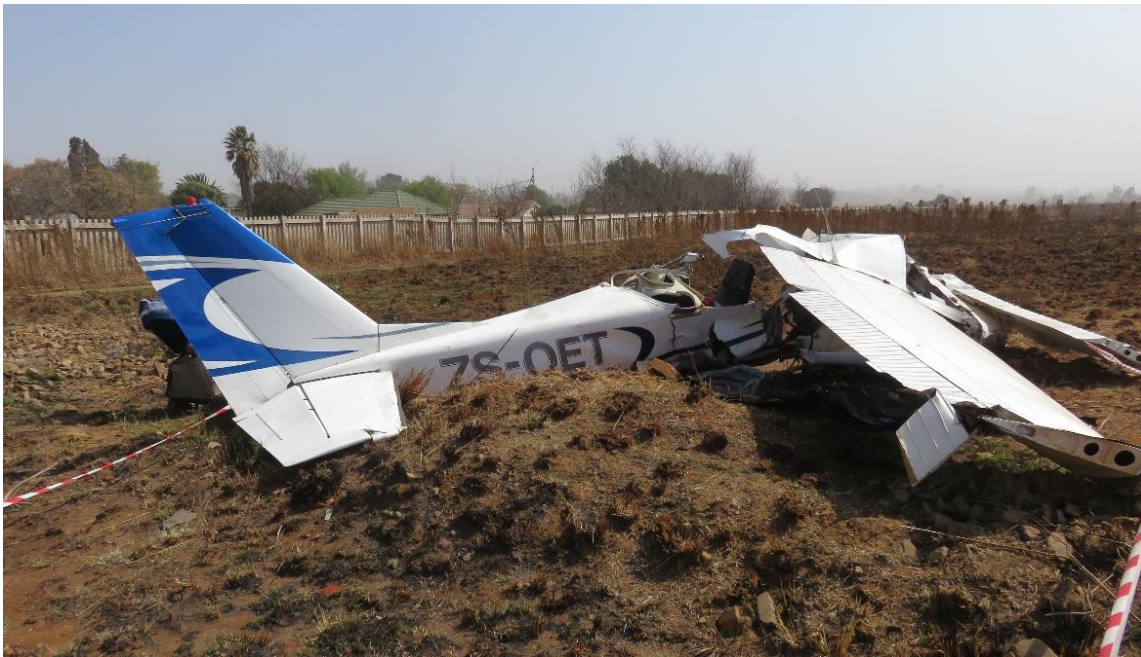
1.3.1 The aircraft was destroyed during the accident sequence.

Figure 3: The aircraft as it came to rest in an upright position on its belly.

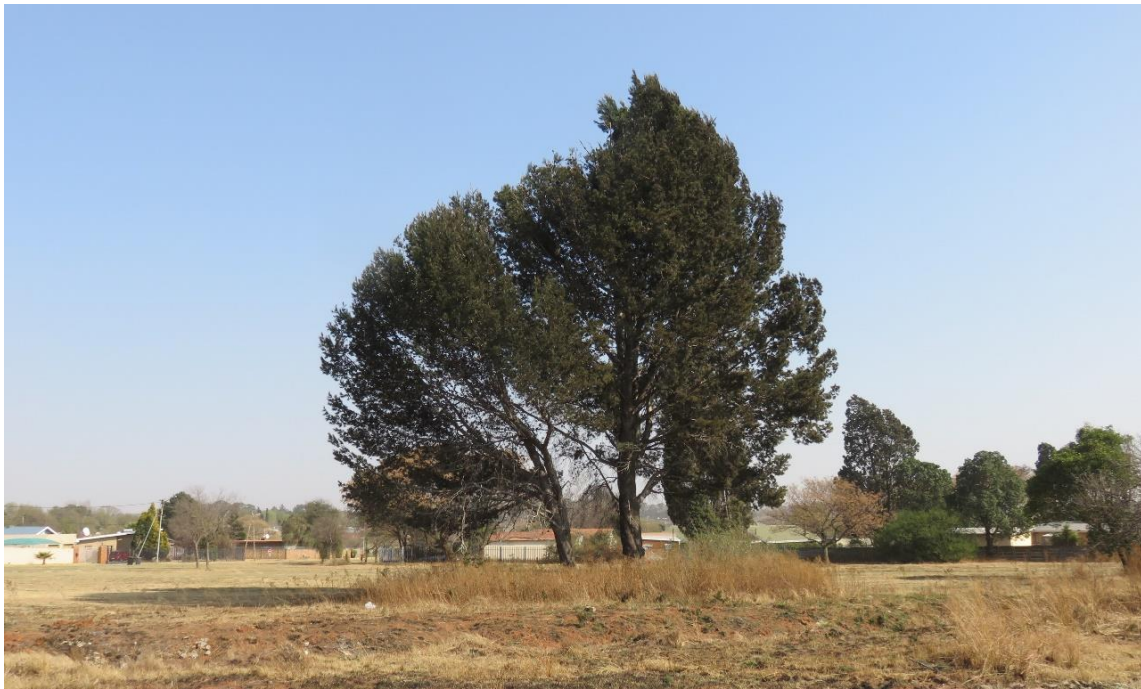
1.4.1 Apart from the tree, no other damage was caused.

Figure 4: The tree with which the aircraft's left wing collided.

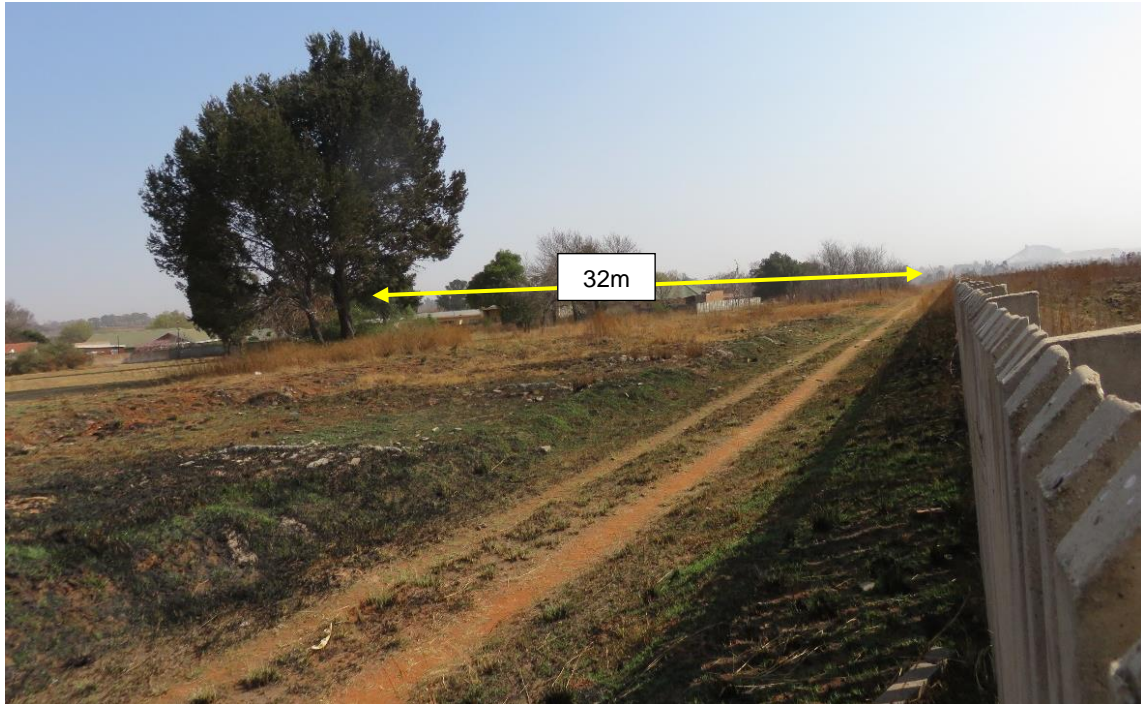
1.12.1 The left wing of the aircraft impacted a tree that was located 32 metres (m) outside FASI's perimeter fence (see Figure 5) during a glide approach for Runway 03 at night time. The aircraft appeared to be in a left bank attitude of approximately 30° when the left wing impacted the tree. The pilot lost control and the aircraft impacted terrain in a north-westerly direction and within the aerodrome's perimeter. The aircraft came to rest in an upright position, parallel to Runway 03. Although the left wing remained partially attached to the fuselage, it was severely deformed, and the leading edge displayed evidence of impact with the tree as it was flattened. Control continuity was established and all flight controls were accounted for, with minor damage visible to the empennage, including the rudder, horizontal stabilisers and elevators. No pre-existing failure could be found.

Figure 6: The tree that the aircraft collided with was 32m outside the aerodrome perimeter fence.

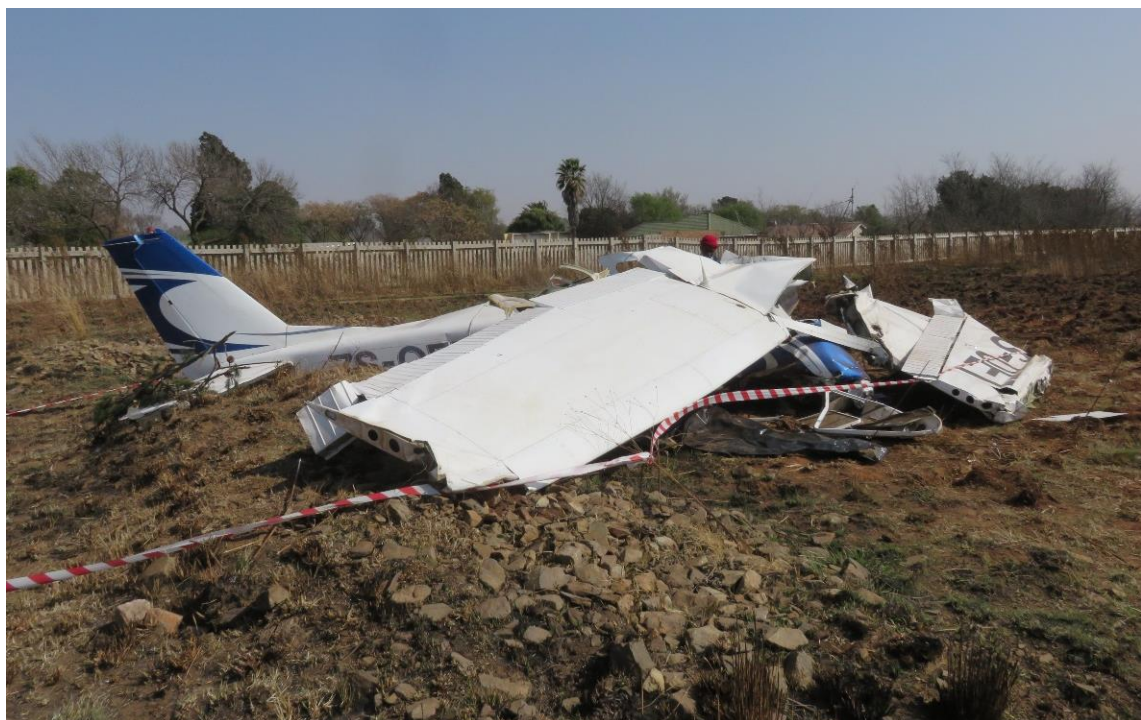
1.12.2 From the CCTV footage, the aircraft is seen impacting the tree, thereafter, the aircraft completes a barrel roll (rotates 360° to the left) before impacting terrain in a slight right-wing low attitude. The quality of the video footage was not of high resolution and no screenshots were possible as the aircraft turned left towards the aerodrome (where the cameras were installed) with the landing light on, which distorted the footage. The footage from all the cameras was in black and white.

Figure 7: The aircraft impacted terrain 14m inside the aerodrome perimeter.

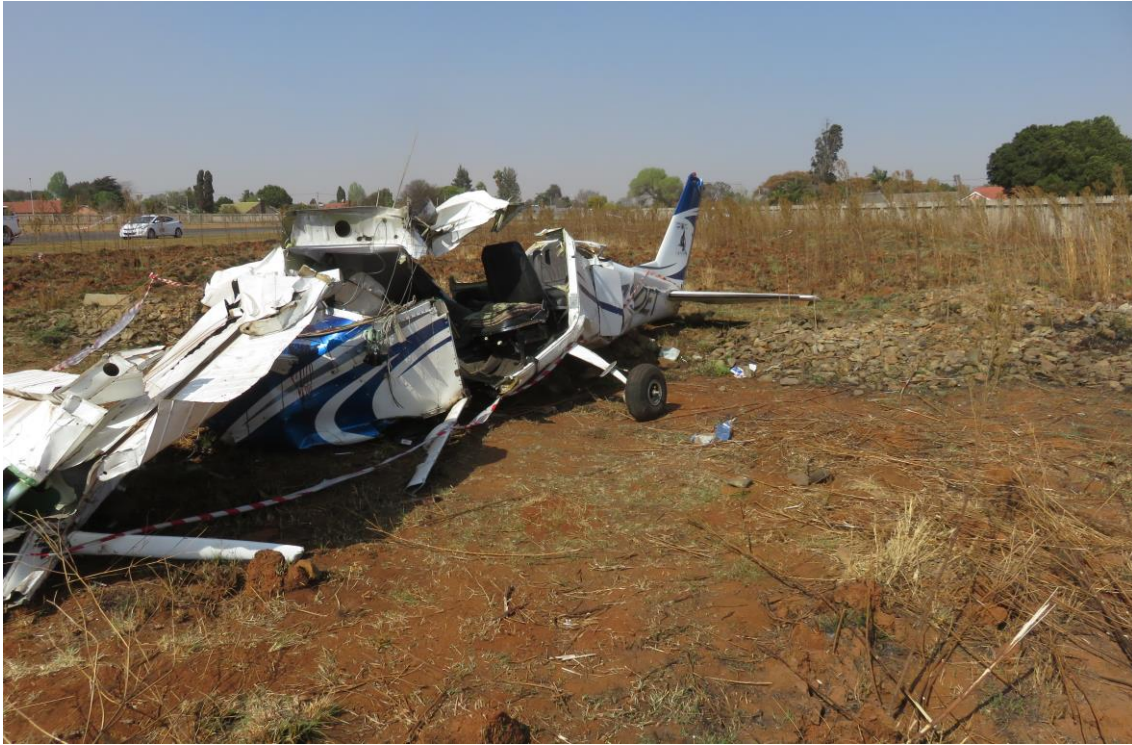
Figure 8: A view of the left-side of the wreckage.

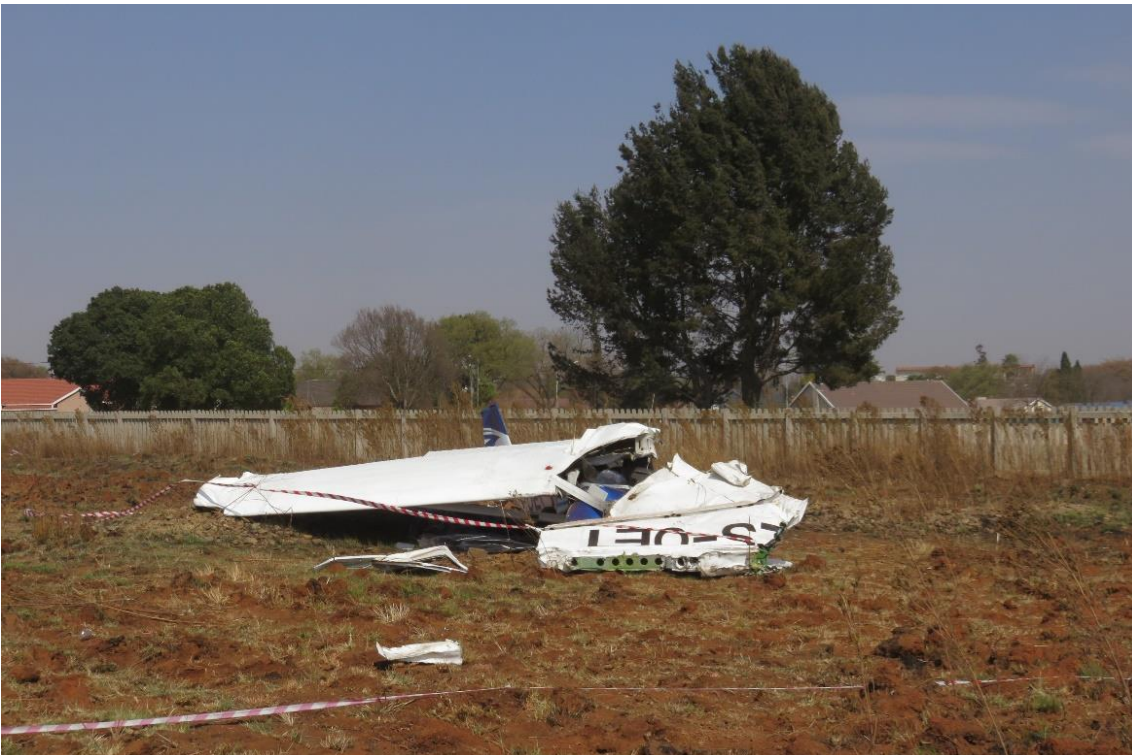
Figure 9: The wreckage location in relation to the tree the aircraft impacted.

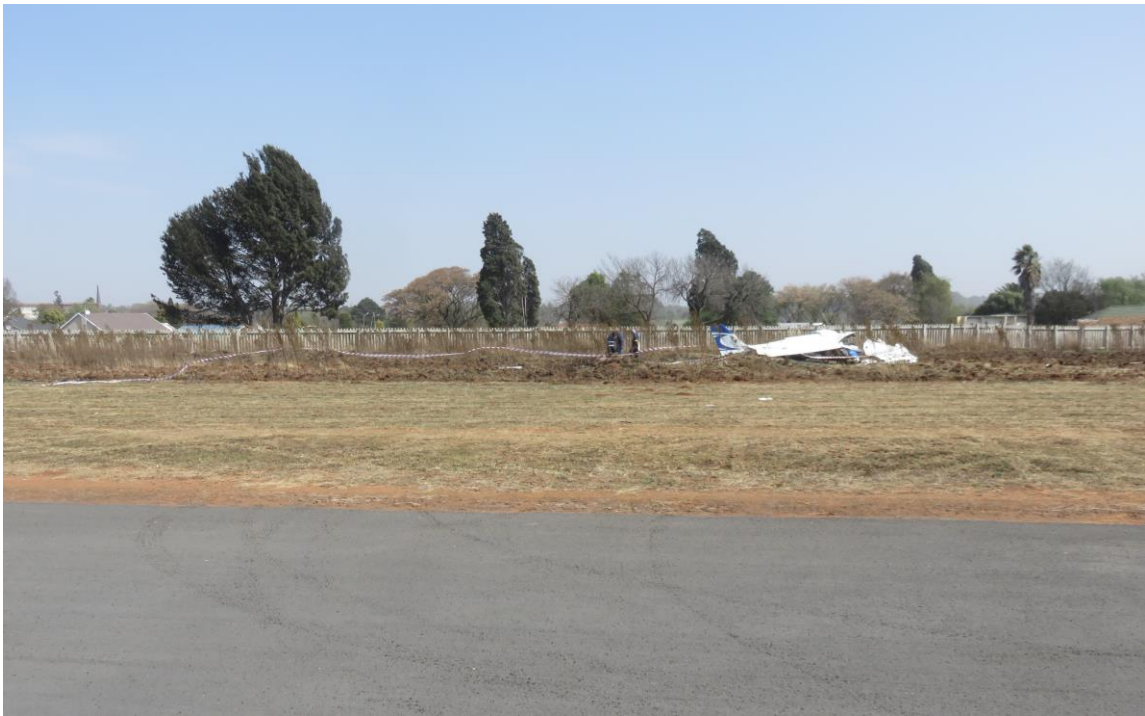
Figure 10: A view of the wreckage and the tree (on the left) the aircraft collided with (taken from the runway side).

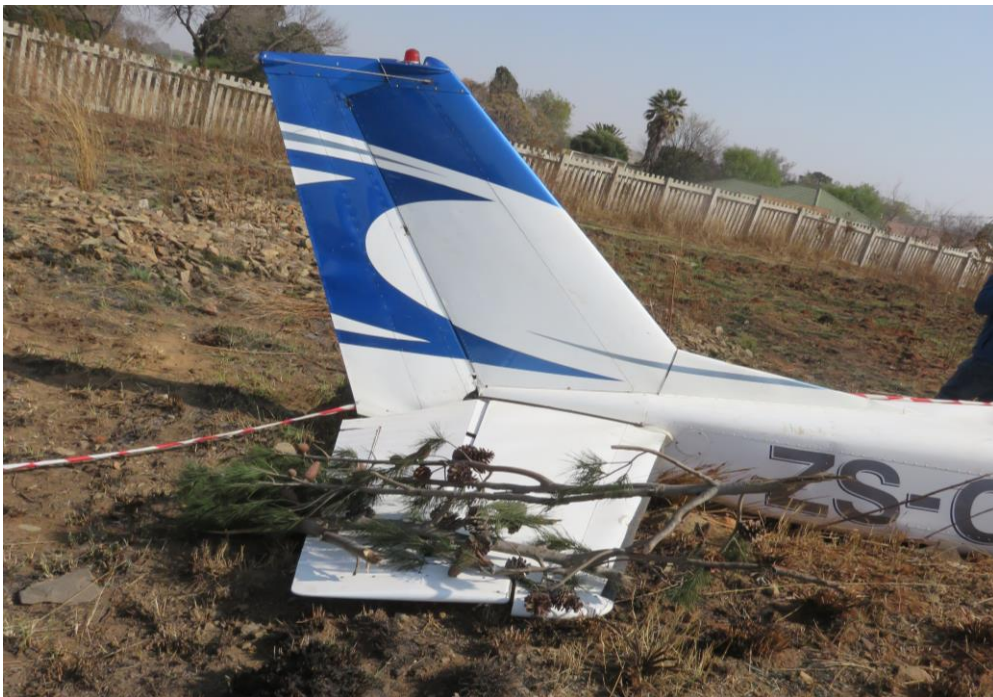
Figure 11: Tree branches on the horizontal stabiliser from the tree with which the aircraft collided.
