AIRCRAFT ACCIDENT REPORT AND EXECUTIVE SUMMARY

Reference:		CA18/2/3/9920	
Aircraft Registration	ZU-EPK	Date of Accident	24 October 2020		Time of Accident	1030Z	
Type of Aircraft	Bushbaby		Type of Operation		Private (Part 94)		
Pilot-in-command Licence Type	National Pilot Licence (NPL)		Age	58	Licence Valid	Yes	
Pilot-in-command Flying Experience	Total Flying Hours		63.1		Hours on Type	59.7	
Last Point of Departure		Eva's Field, KwaZulu-Natal Province					
Next Point of Intended Landing		Light Flight Airstrip, KwaZulu-Natal Province					
Damage to Aircraft		Destroyed					
Location of the accident site with reference to easily defined geographical points (GPS readings if possible)							
The accident occurred on the embankment next to the Eva's Field runway at Global Positioning System (GPS) co-ordinates: 29° 29' 23.1" S 30° 16' 11.6" E at an elevation 3356 feet (ft)							
Meteorological Information	Wind direction: 035°; Wind speed: 13kts, Temperature: 36°C; Dew Point: 8°C; Cloud cover: Nil; Cloud base Nil; QNH: 1014hPA

Reference Number : CA18/2/3/9920
Name of Owner/Operator : Mr Stephen O'Hara
Manufacturer : Kitplanes for Africa
Model : Bushbaby
Nationality : South African
Regist

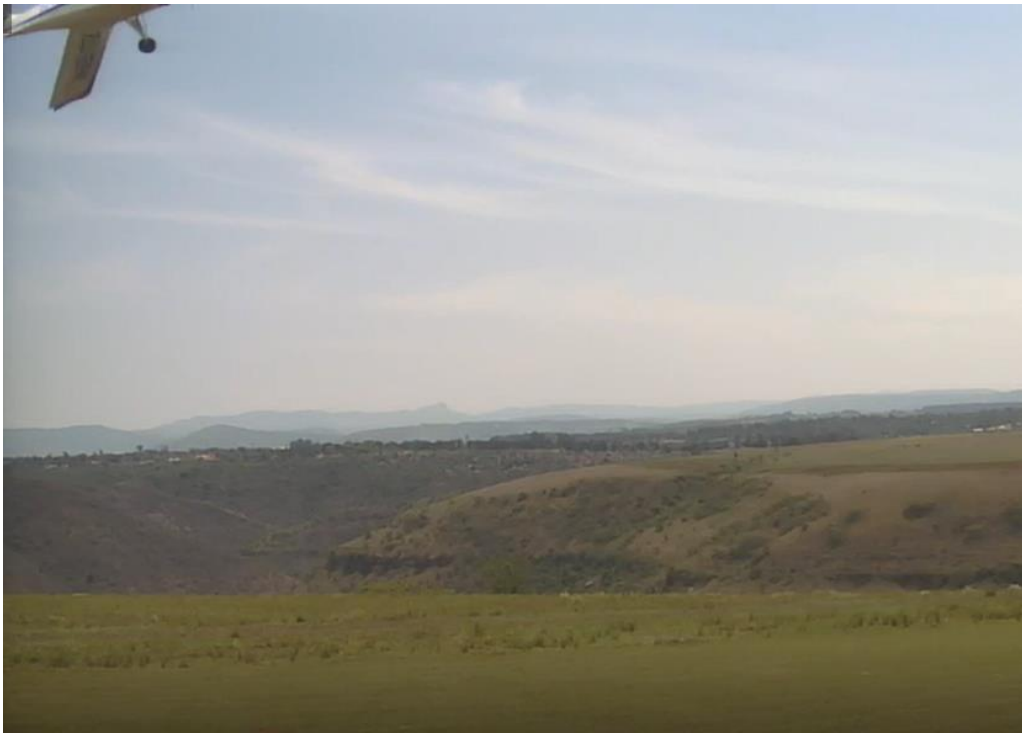
- 1.1.4 During this sequence, the eyewitness stated that he heard the engine misfire and, moments later, the left wing dropped. Figures 1, 2, 3 and 4 are the snapshots of the security footage given to the investigation team by the airfield owner. The snapshots show the aircraft moments before it impacts the ground. *Moments after getting airborne, the aircraft makes a steep left turn (Figure 1); thereafter, the left wing drops further and the pilot seems to be unable to correct (recover) the aircraft; the aircraft continues in the left roll whilst losing height in what seems like a teardrop turn to return to Eva's Field (Figure 2).*

Figure 1: Steep bank after take-off. (Source: Security video)

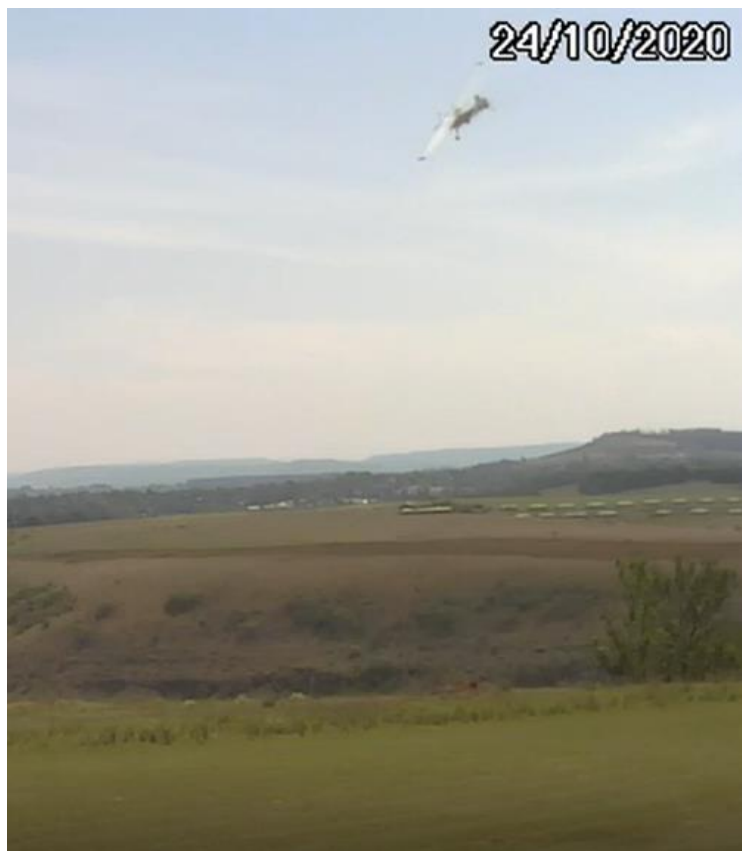
Figure 2: The aircraft making a turn. (Source: Security video)

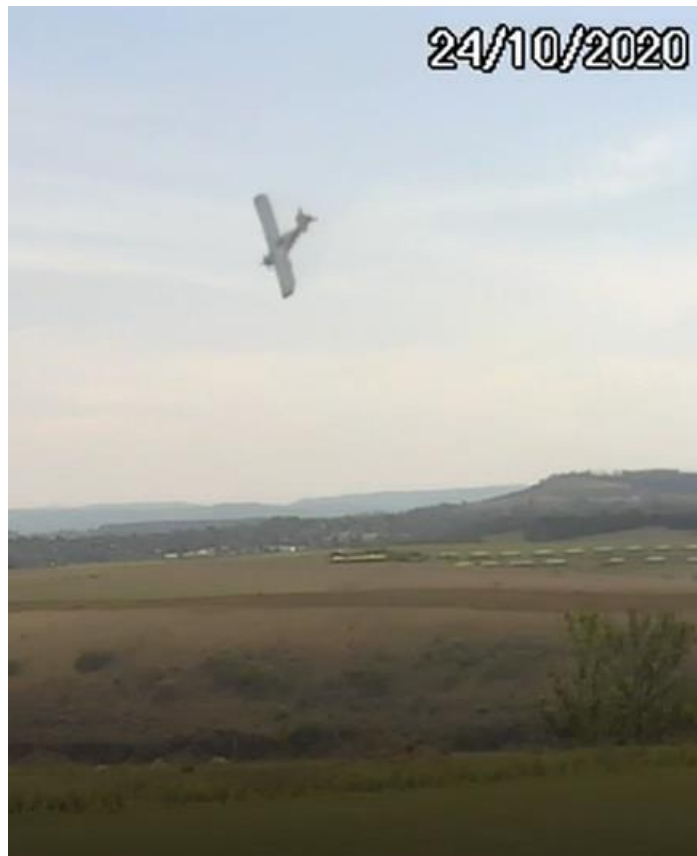
Figure 3: The aircraft almost inverted in a dive position. (Source: Security video)

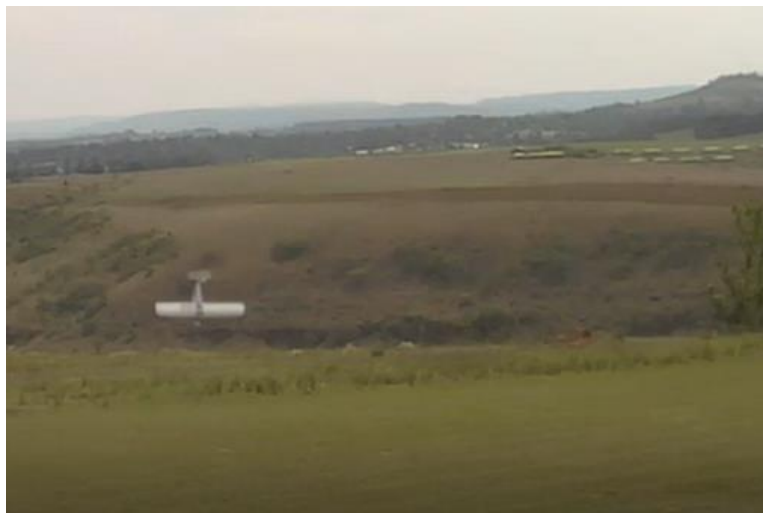
The aircraft continues to lose height and finally disappears at the end of the runway/beginning of the valley. The pilot was unable to recover the aircraft and he crashed down the embankment facing a northerly direction at 1030Z (Figures 3 and 4). The pilot and the passenger were fatally injured in the accident and the aircraft was destroyed.

Figure 4: The aircraft just before it disappears in the valley. (Source: Security video)

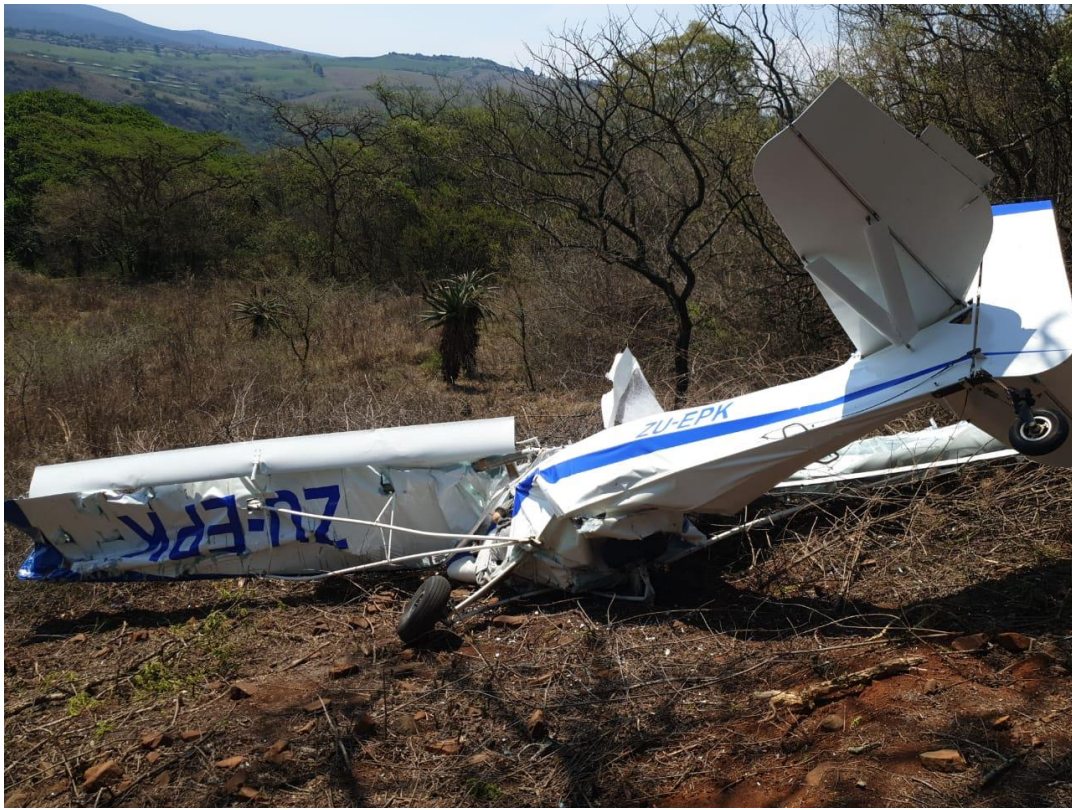
Figure 5: The aircraft post-accident.

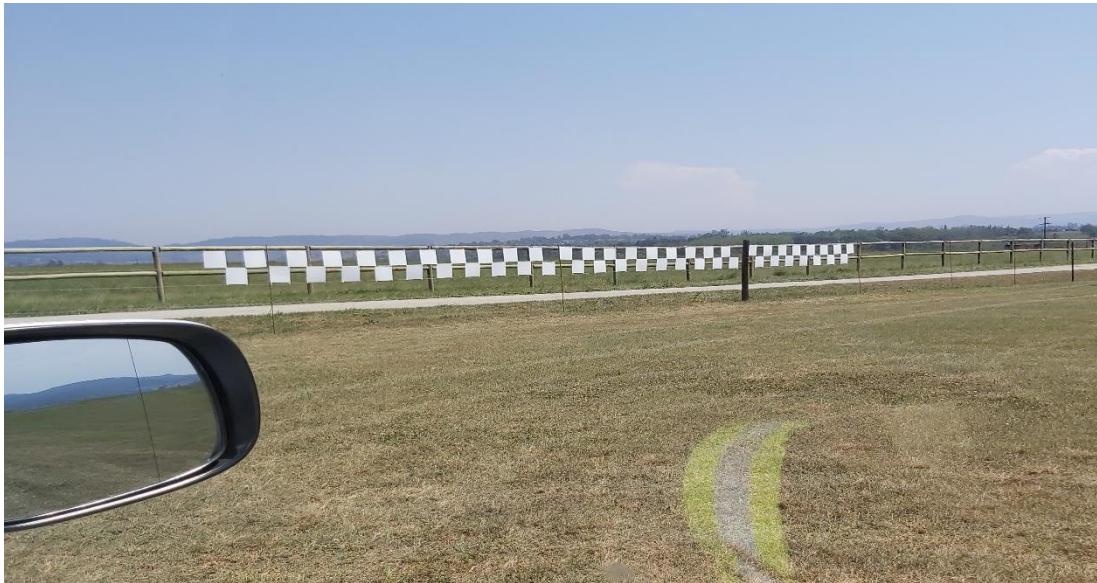
Figure 6: The fence at the end of the Runway 18 with plates installed.

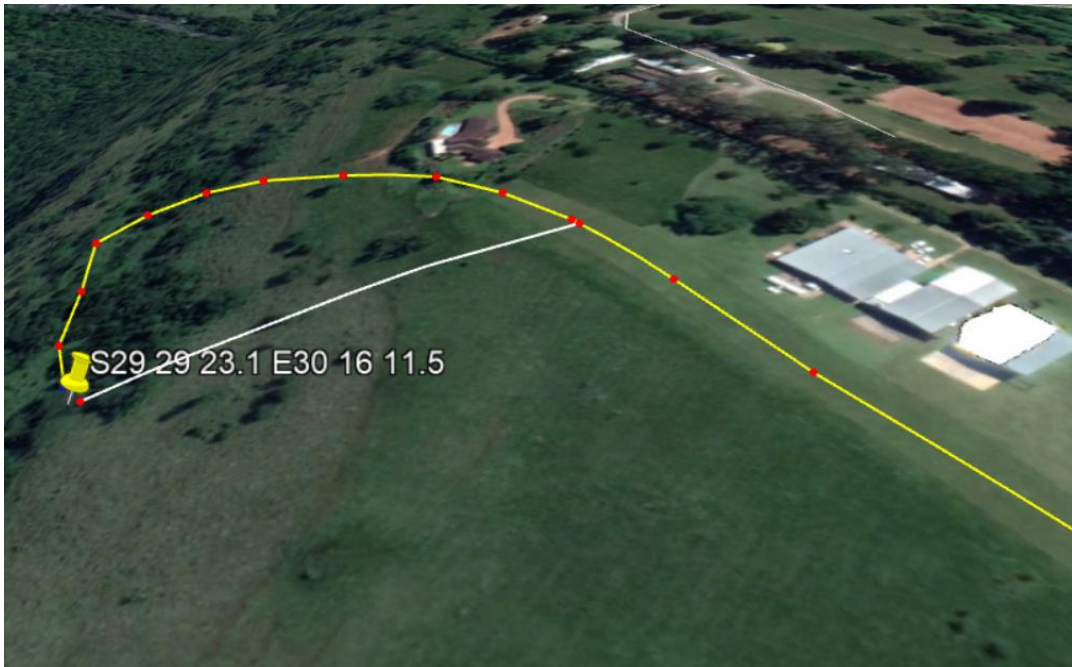
1.1.5 The accident occurred in day light in the valley, at the end of RWY 18 at Eva's Field in Hilton, KwaZulu-Natal, at Global Positioning System (GPS) co-ordinates determined to be 29° 29' 23.1" S 30° 16' 11.6" E at an elevation of 3356 feet (ft).

Figure 7: The airstrip elevation is 3453ft and the accident site elevation is 3356ft. The white line shows a distance of 130.83m from the crash site to the runway threshold.

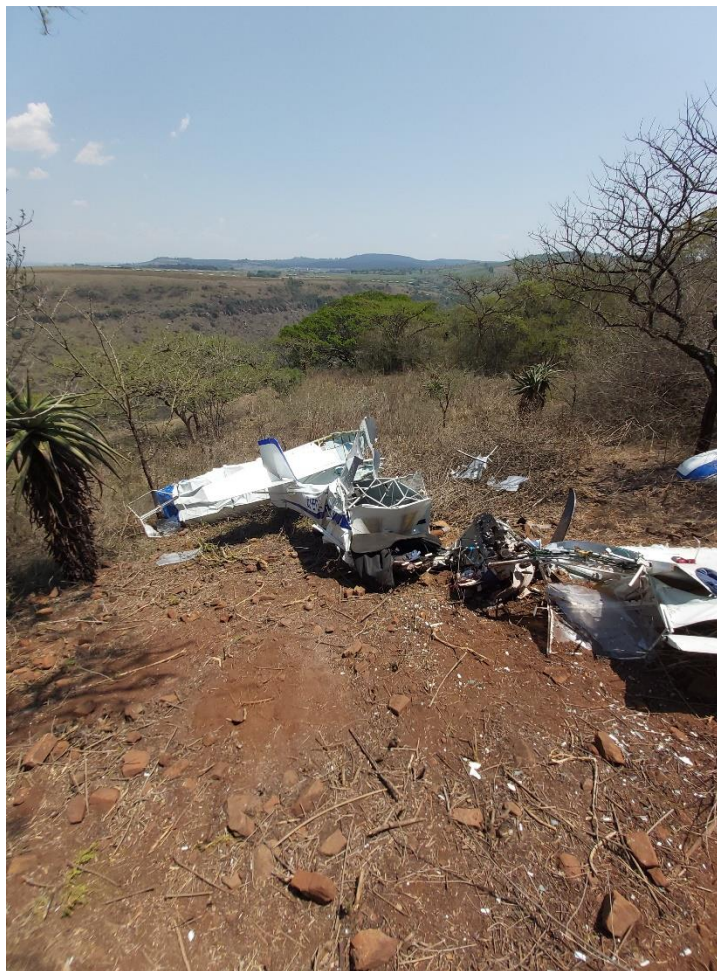
- 1.3.1 The aircraft was destroyed during the accident sequence. The aircraft was cut open to gain access to the occupants so as to remove them.

Figure 8: The aircraft at the accident site.

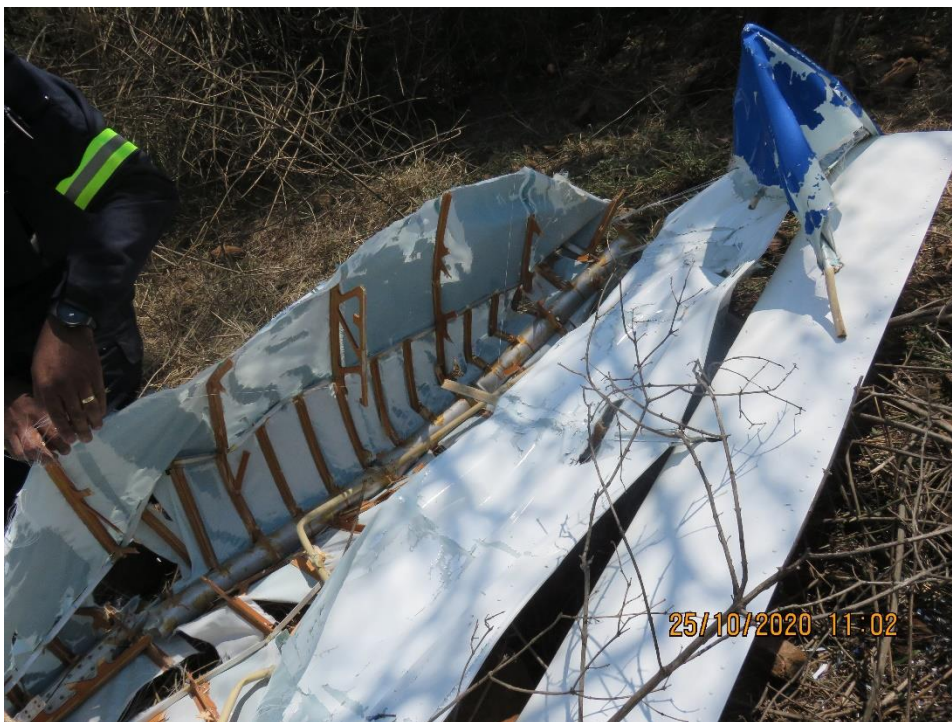
1.12.1 The aircraft crashed in the valley just below Eva's Field in a northerly direction. The wreckage distribution was limited to one area. The wings main spar was intact but the front spar of both wings was broken at four points (Figure 8). The damage on the wings indicated the high impact force.

Figure 9: The damaged main left-wing spar.

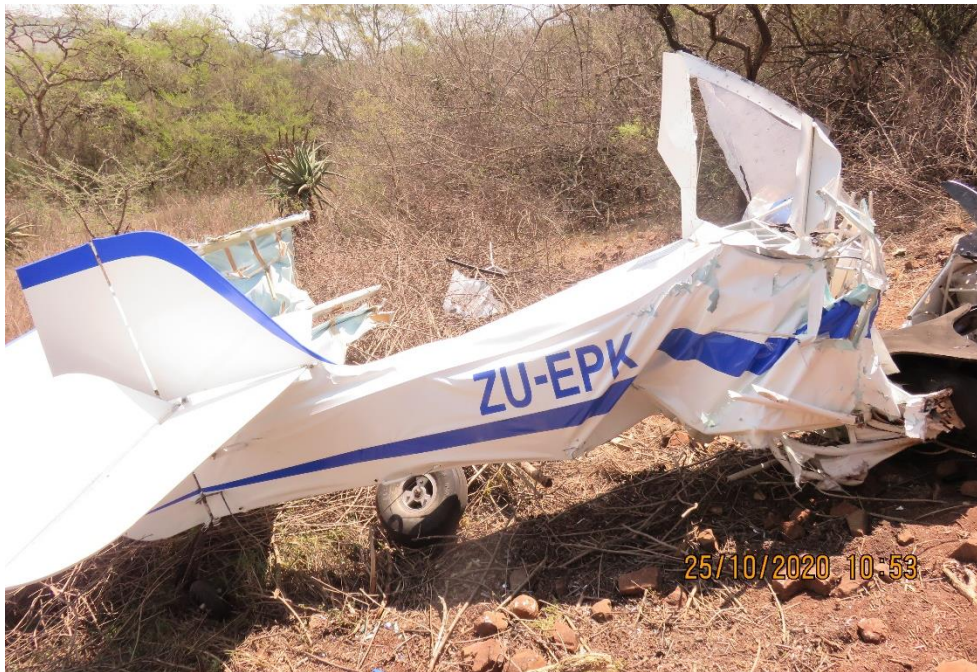
Figure 10: Wrinkles on the fuselage due to impact forces.

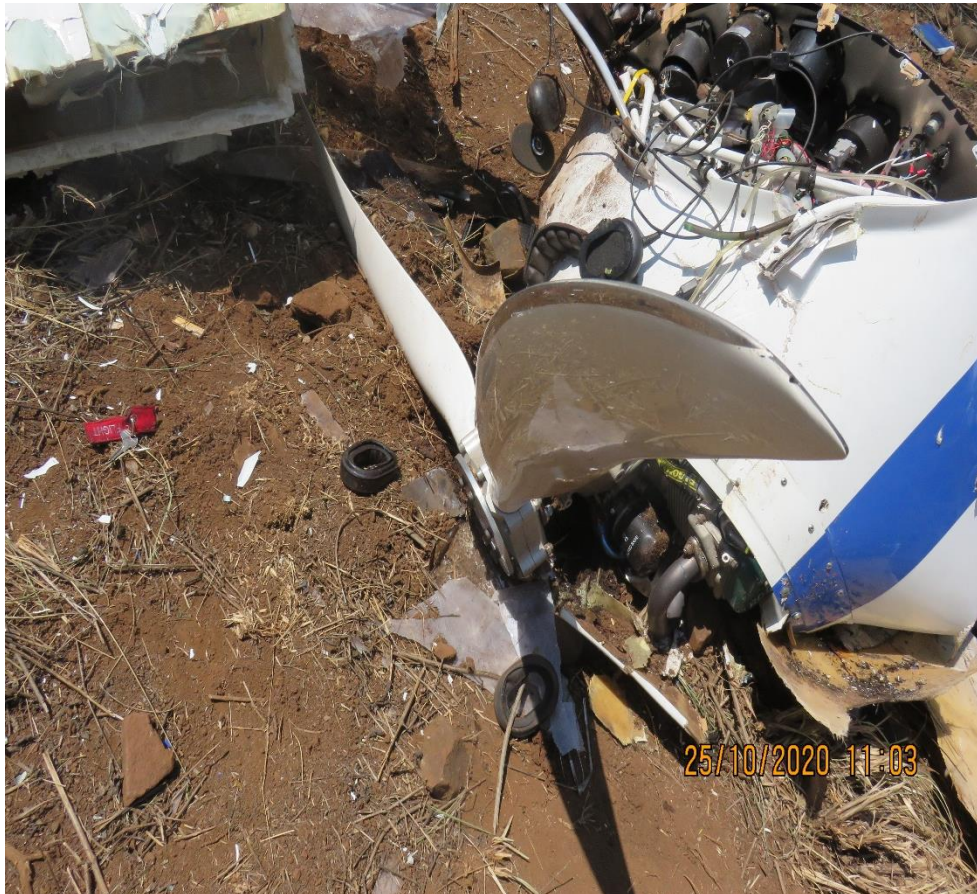
Figure 11: Two of the three propeller blades were still intact.

- 2.2.7 Two of the propellers on the aircraft were found intact except for the third propeller that made contact with the ground at the time of the accident. On the airframe, the fuel filter was dry, showing that there was no fuel in the system.

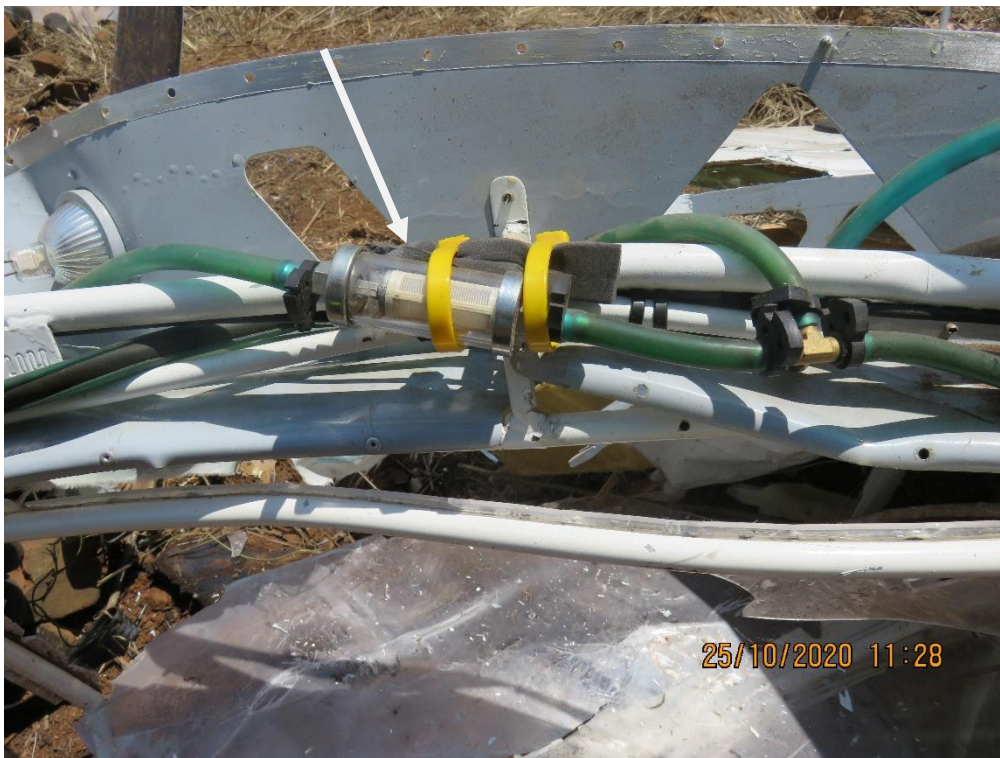
1.12.2 The fuel tanks on both wings ruptured on impact and the remaining fuel leaked out. A light fuel smell was still hanging in the air when the investigators arrived at the scene. The cockpit was compressed due to the engine pushing towards the fuselage during impact. The wrinkles on the fuselage showed excessive force involved as it had compressed (Figure 10). The jaws of life were used to cut open the aircraft to remove the occupants trapped inside the cockpit. The left main landing gear had broken off and the right landing gear had bent under the aircraft during the accident. Two of the three propeller blades were not damaged, except for the one that impacted the ground and broke off completely (Figure 11). Evidence of the propeller blades indicated that the engine was not operational at the time of impact (Figure 11). The airframe fuel filter was found empty with no sign of fuel in the system (Figure 12).

Figure 12: Arrow showing an empty or dry airframe fuel filter.

3.3.1 It is probable that the engine stopped due to fuel exhaustion after the initial climb and the pilot lost control of the aircraft after making a sharp left turn; he failed to recover the aircraft and, subsequently, impacted the ground in the valley.
