<b>AIRCRAFT ACCIDENT REPORT AND EXECUTIVE SUMMARY</b>
---

<b>Reference:</b>		<b>CA18/2/3/9942</b>	
<b>Aircraft Registration</b>	<b>ZS-JJJ</b>	<b>Date of Accident</b>	13 January 2021		<b>Time of Accident</b>	0515Z	
<b>Type of Aircraft</b>	Piper PA-46-350P Jetprop DLX		<b>Type of Operation</b>		Private (Part 91)		
<b>Pilot-in-command Licence Type</b>	Private Pilot Licence (PPL)		<b>Age</b>	69	<b>Licence Valid</b>	Yes	
<b>Pilot-in-command Flying Experience</b>	<b>Total Flying Hours</b>		6 654.0		<b>Hours on Type</b>	772.2	
<b>Last Point of Departure</b>		Koedoesberg Game Farm private airstrip, KwaZulu-Natal Province					
<b>Next Point of Intended Landing</b>		Pongola Aerodrome (FAPL), KwaZulu-Natal Province					
<b>Damage to Aircraft</b>		Substantial					
<b>Location of the accident site with reference to easily defined geographical points (GPS readings if possible)</b>							
On a gravel road 500m from the take-off runway; Global Positioning System co-ordinates: 27°26'34.69" South 031°41'2.91" East) at an elevation 913 feet (ft)

<b>Probable Cause</b>							
Engine power loss in-flight, resulting in an unsuccessful forced landing.							
<b>Contributing Factor/s:</b>							
Disregar

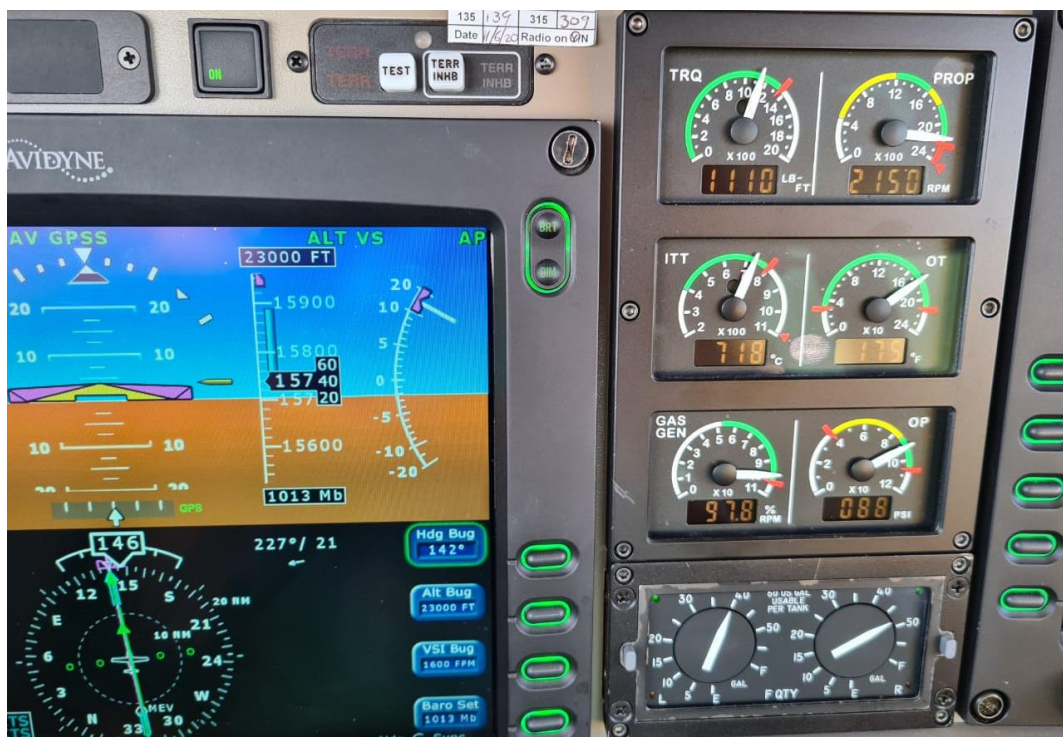
**Figure 1:** The engine instruments indicating normal operation during the climb.

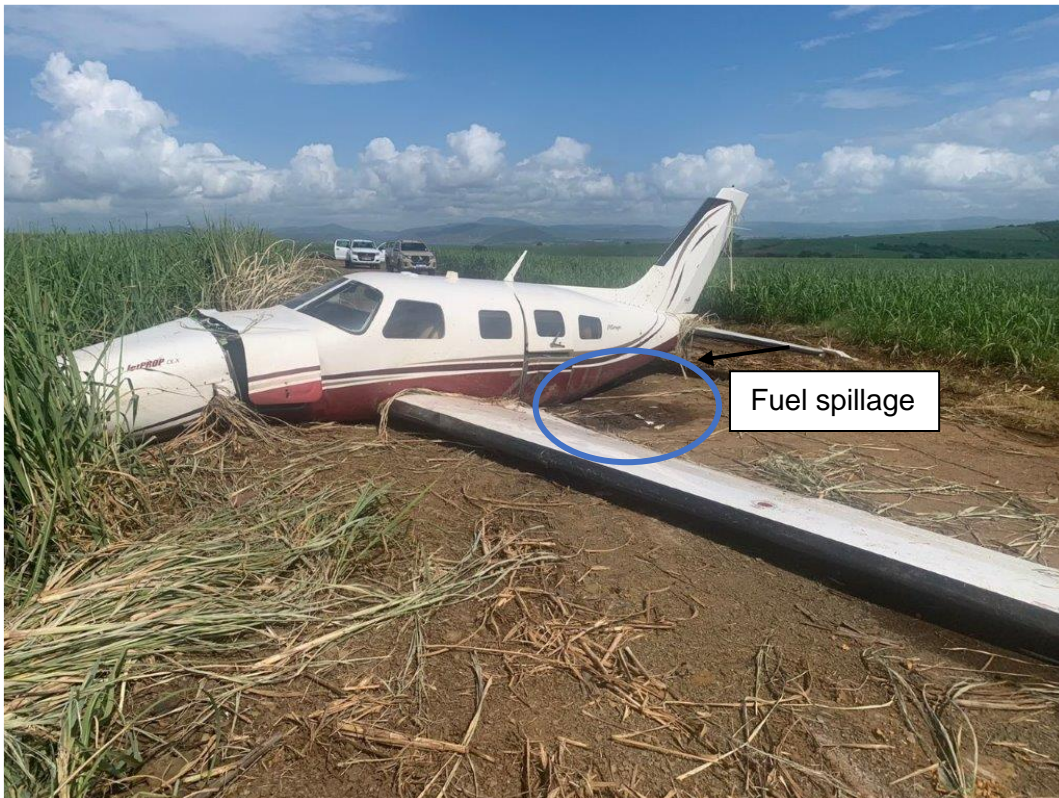
1.3.1 The aircraft sustained substantial damage during the accident sequence.

**Figure 3:** The damaged aircraft post-accident. (Source: Owner)

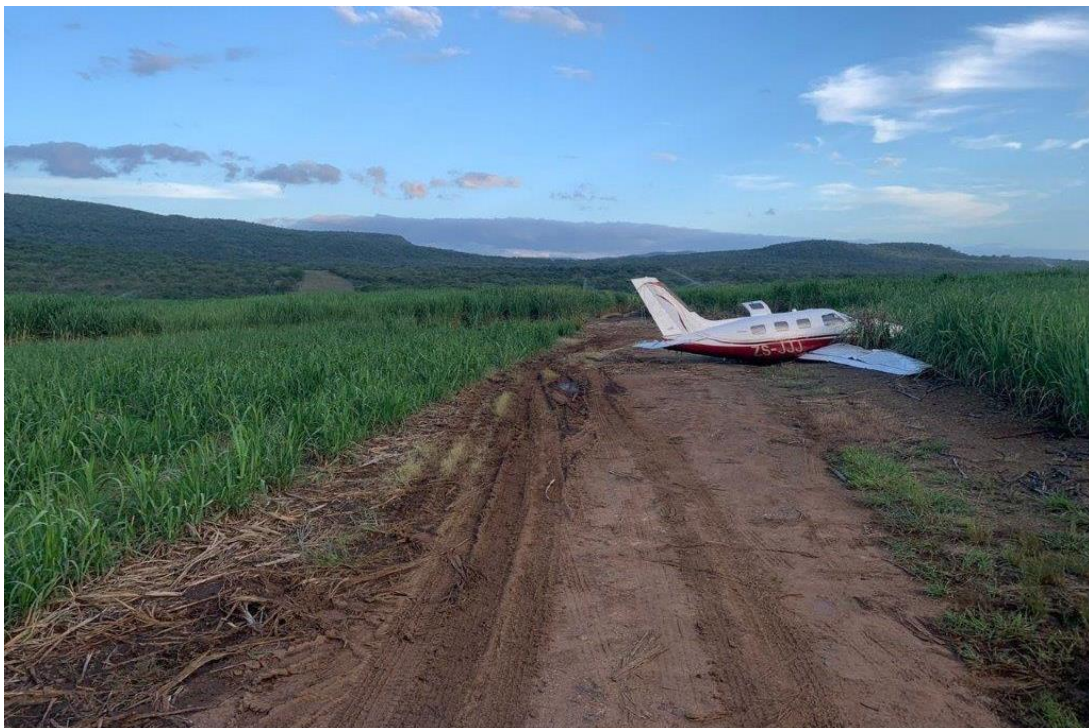
1.12.1 The accident occurred shortly after take-off from Runway 29 at Koedoesberg private airstrip on a gravel road approximately 500m from the threshold of Runway 11 following an engine power loss. The gravel road serves as a fire break between the sugar cane fields and is 5m wide. The aircraft veered off to the right and came to rest on the verge of the road. The undercarriage collapsed, and all four propeller blades were severed at their respective roots. The fuel tanks ruptured and there was an indication of fuel spillage on the ground during recovery. It could not be determined how much fuel leaked and how much fuel was in the aircraft at the time of accident.

**Figure 4:** The aircraft as it came to rest. (Source: Owner)

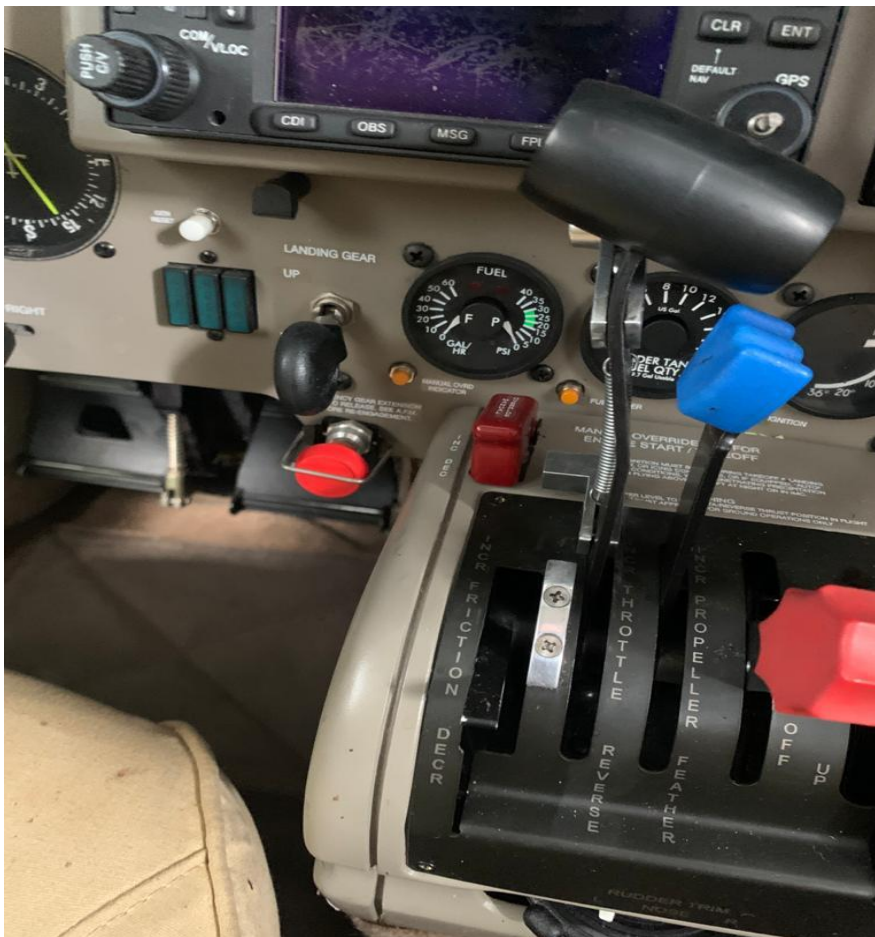
**Figure 5:** Engine controls of the aircraft post-accident.

1.12.2 The throttle lever was found in full forward position. The pitch lever was in full fine position.

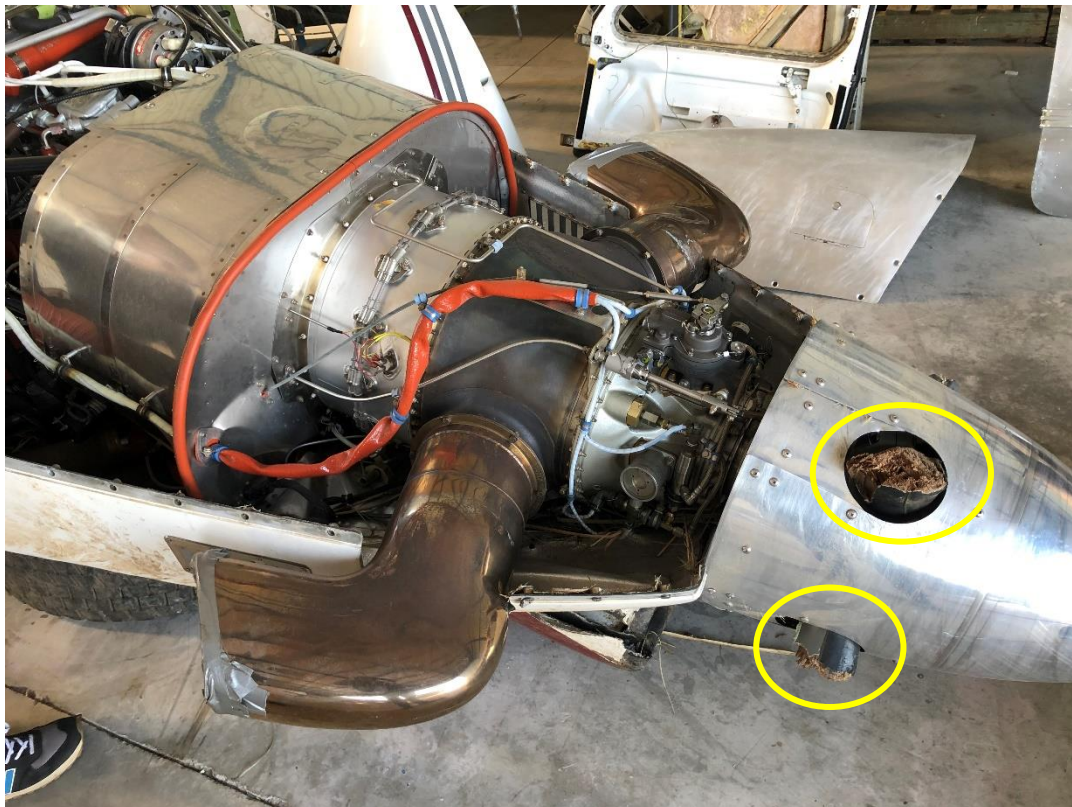
**Figure 6:** Three of the four propeller blades visible in this picture, which were severed at the roots.

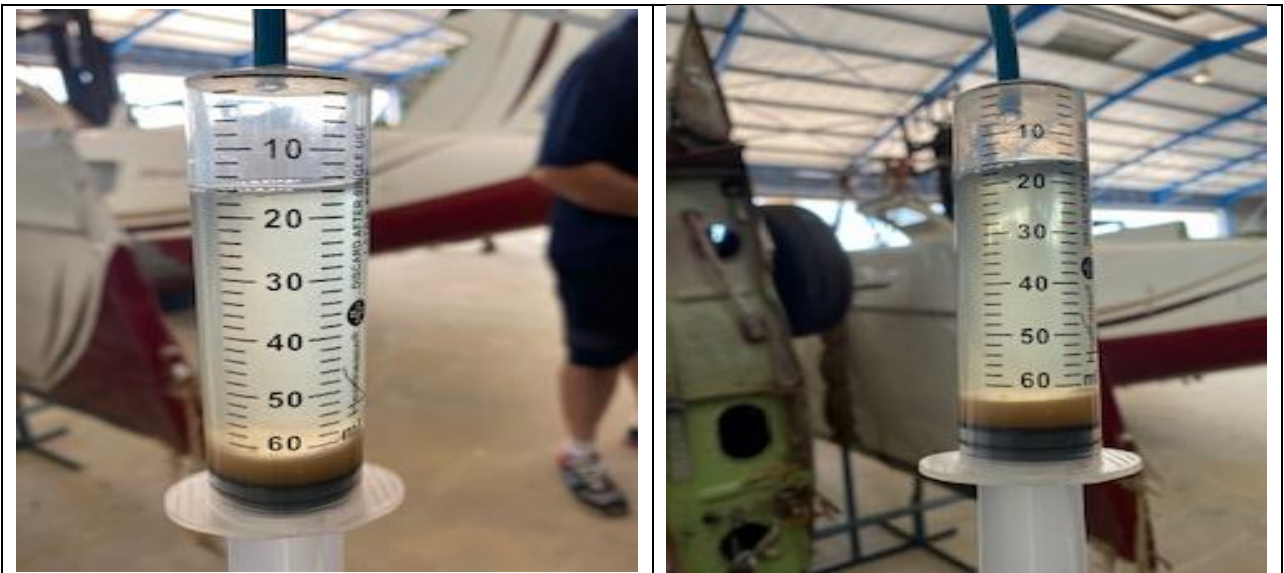
1.16.2 Approximately 60 millilitres (ml) of fuel was drained from the right-wing collector tank by the AMO and it was found to have evidence of contamination (see Figure 7).

1.16.3 The chemical analysis of the fuel sample drained from the fuel pump filter was carried out by the engine manufacturer during the investigation at their facilities. This is the summary: *“the chemical foot print of the fuel sample is similar to Kerosene. There was not enough fuel to do a full test to compare with the specification and to make an assessment of its characteristics. However, based on the observation of the fuel sample and engine disassembly, it is not probable that the fuel itself contributed to the engine power loss.”* (SIC)

**Figure 7:** Contaminated fuel drained from the right-wing collector tank.

- 3.2.13 A small amount of fuel that was drained from the right-wing collector tank displayed some contamination. The fuel tanks were ruptured, and fuel spillage was reported at the crash site following the accident. There was not enough fuel to conduct fuel testing. The fuel filter was found to be dirty.

- 3.2.16 Based on the observation of the fuel sample and engine disassembly, it is believed that the fuel condition could have contributed to the engine power loss.

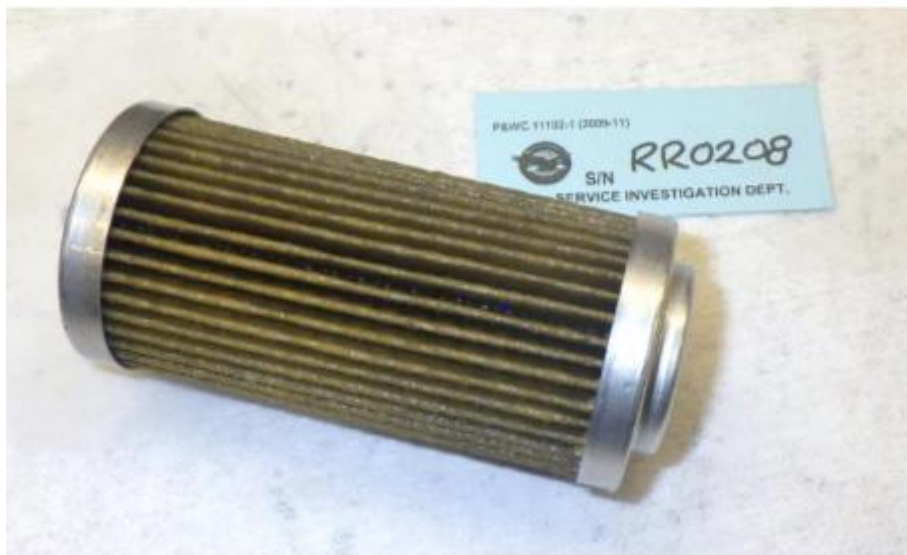
**Figure 8:** Fuel filter.

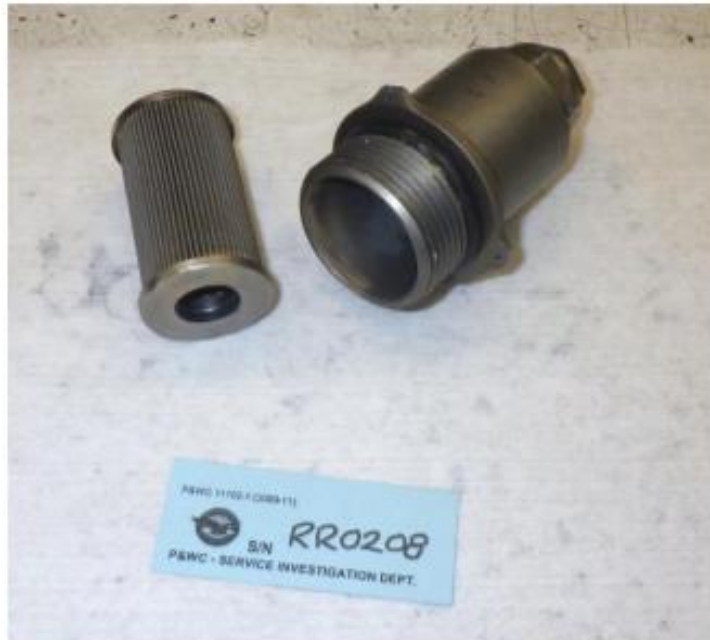
**Figure 9:** The fuel filter after it was removed from the filter housing.

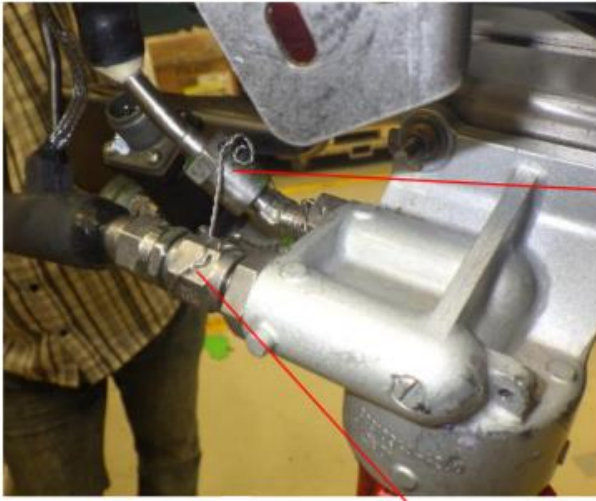
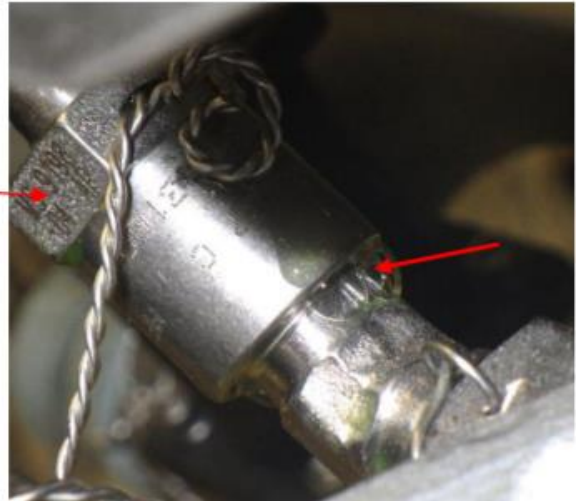
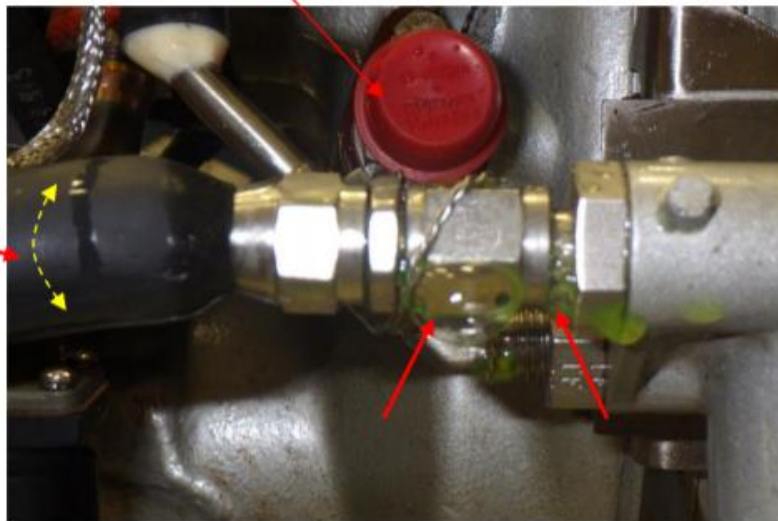
*Compressor Discharge Air (P3) and P3 Filter: Compressed air was applied to the P3 air filter housing and leak-check fluid was applied on all the connections. Both P3 lines at the P3 air filter housing were leaking as shown with red arrows. Manipulation of the flexible portion of P3 line (between the FCU and P3 air filter housing) during the leak check made the leak at the B-nut worse. There were no other leaks along the P3 line. The lock wire was in the correct orientation. The P3 air filter showed environmental dust on the external surfaces.*

Manipulation of the flexible portion of the P3 line influenced the leak rate at the B-NUT

**Figure 10:** The leak location where the B-nuts attach to the P3 air-filter.

- 2.2.8 During the examination of the engine, two loose B-nuts were found at the P3 filter housing. A leak test was performed, and it was found that air was leaking at both these locations. Both these B-nuts were still in the wire locked position during examination. It could not be established when these B-nuts were last disturbed (loosen) as the aircraft was fitted with a compressor wash kit, which did not require the removal of the B-nuts at the P3 filter housing to perform the task. The FCU and fuel pump were removed from the engine and inspected. According to available information, nothing untoward was found with either of these units.

- 3.4.1 Disregard for standard safe operating procedures by the pilot/owner of the aircraft.
- 3.4.2 The engine investigation revealed that there was an air leak at the B-nuts that attach to the P3 air-filter housing which supplies air to the fuel control unit. The air leak contributed to the reduction in engine power during this flight.

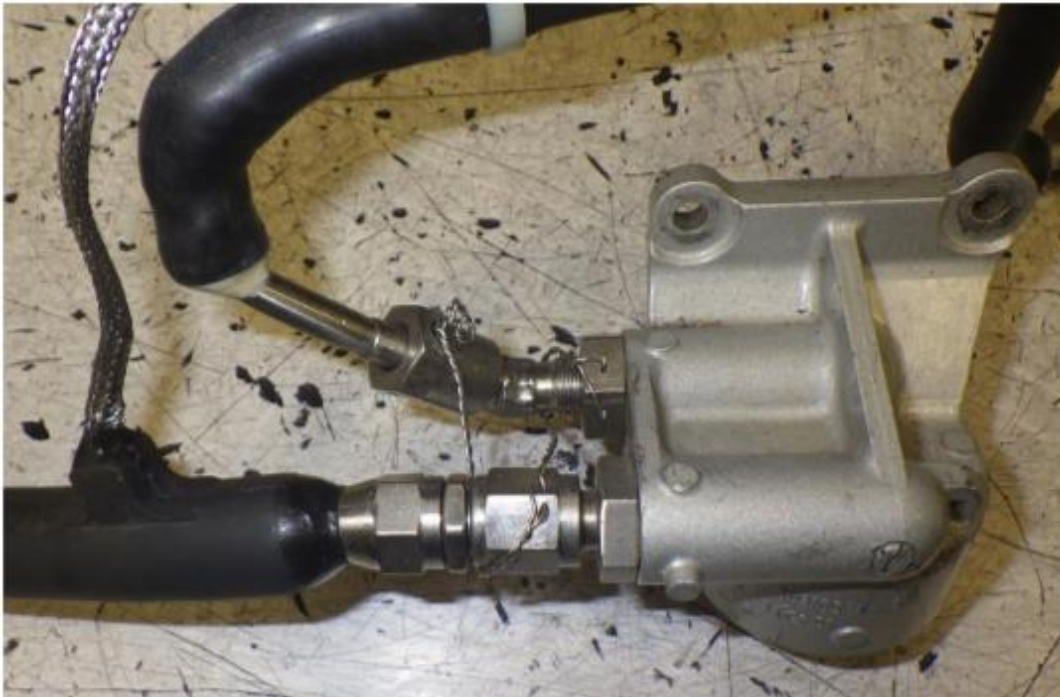
1.16.5 *Removal of the lock wire showed that both B-nuts at the P3 filter housing were loose, they unscrewed with no resistance. The condition of the threaded portion of both B-nuts and respective fittings did not show any visual damage that would have prevented tightening to the required torque. According to the maintenance manual, the required torque is 90-100 in.lb (inch pounds).*

**Figure 11:** Loose B-nuts that were removed from the engine.  
(Source: Technical report from the engine manufacturer)

- 3.2.10 Examination of the filter housing revealed that the engine displayed two loose B-nuts at the P3 filter housing. A leak test revealed that there was a leak at the location where the B-nuts attach to the P3 lines. The B-nuts were not torqued to the correct torque value that is stipulated in the AMM. The torque value for the B-nuts is 90-100 lbs.

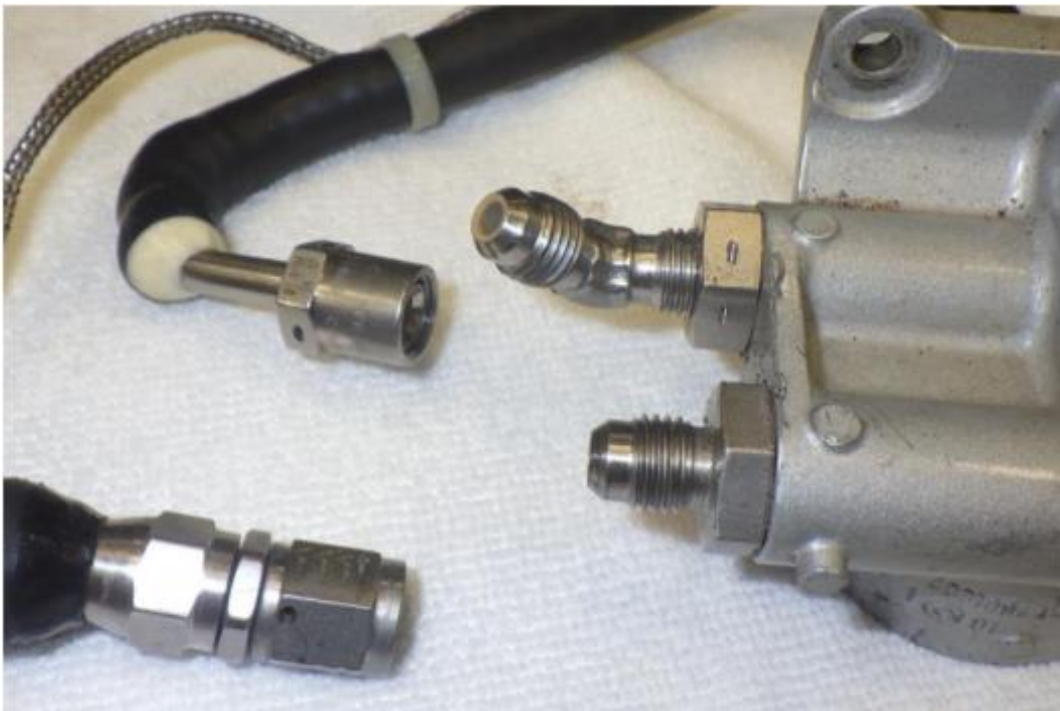
**Figure 12:** Loosened B-nuts from the P3 filter housing.  
(Source: Technical report from the engine manufacturer)

- 3.2.17 During the investigation of the engine and after the removal of the wire locking from the B-nuts on the P3 line and filter, it was established that the B-nuts were not tightened. This resulted in an air leak on the P3 line and filter, which in turn caused insufficient P3 air supply to the FCU.
