Accident and Incident Investigations Division

<b>AIRCRAFT ACCIDENT REPORT AND EXECUTIVE SUMMARY</b>
---

<b>Reference:</b>		CA18/2/3/9945	
<b>Aircraft Registration</b>	ZS-TCJ	<b>Date of Accident</b>	21 January 2021		<b>Time of Accident</b>	1545Z	
<b>Type of Aircraft</b>	Air Tractor AT-402B		<b>Type of Operation</b>		Aerial Work Operations (Part 137)		
<b>Pilot-in-command Licence Type</b>	Airline Transport Pilot Licence		<b>Age</b>	52	<b>Licence Valid</b>	Yes	
<b>Pilot-in-command Flying Experience</b>	<b>Total Flying Hours</b>		18 290.7		<b>Hours on Type</b>	114.4	
<b>Last Point of Departure</b>	Farm Sardinia in the Bultfontein District, Free State Province						
<b>Next Point of Intended Landing</b>	Hoopstad Airfield, Free State Province						
<b>Damage to Aircraft (Substantial/Destroyed)</b>	Destroyed						
<b>Location of the accident site with reference to easily defined geographical points (GPS readings if possible)</b>							
Farm Sardinia, Bultfontein, Free State Province; GPS co-ordinates: 28° 04' 56" S, 026° 05' 37" E at an elevation of 4 214ft

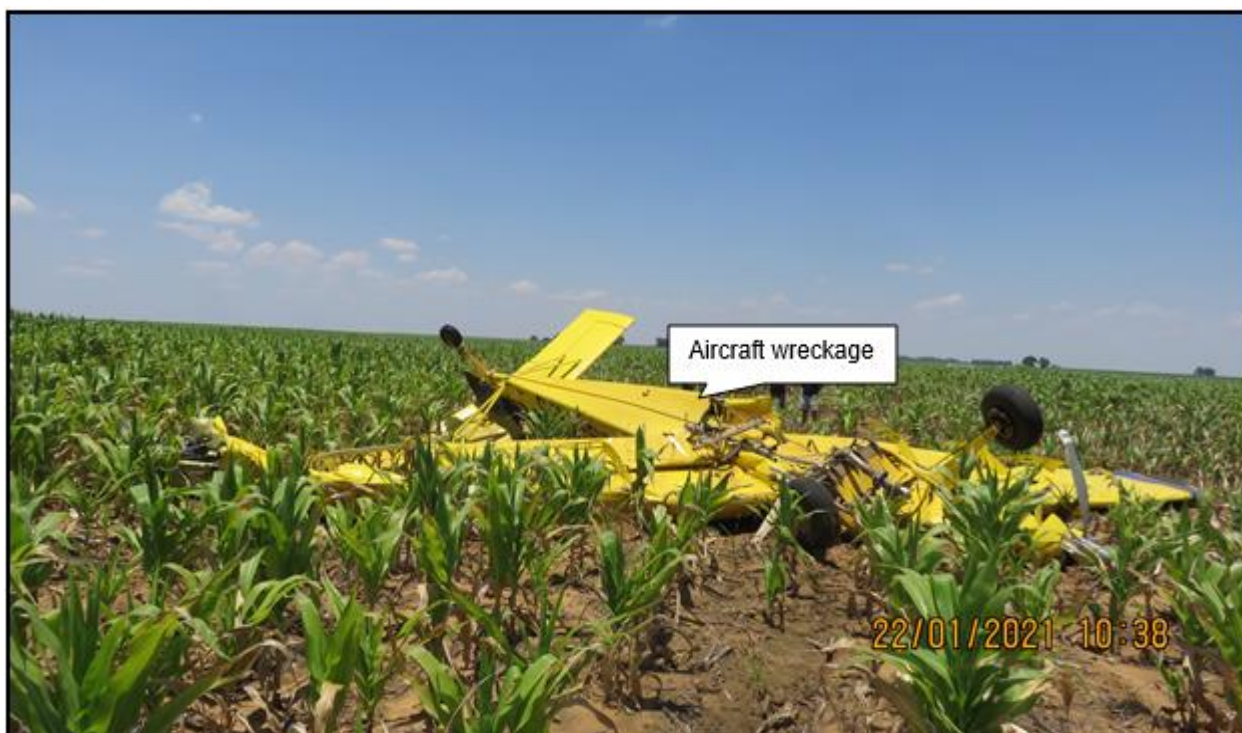
- 1.3.1 The aircraft was destroyed during the impact sequence.

**Figure 2:** The wreckage post-accident.

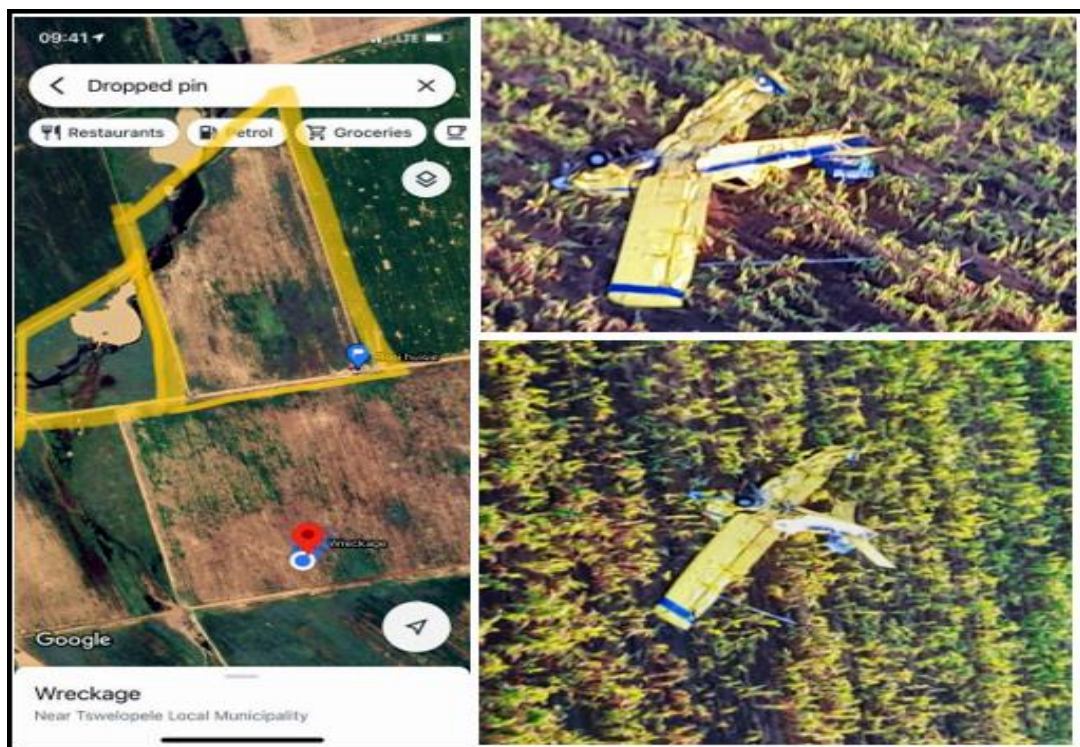
**Figure 3:** The area where the aircraft was operating (left); the wreckage as it was found at the accident site (right).

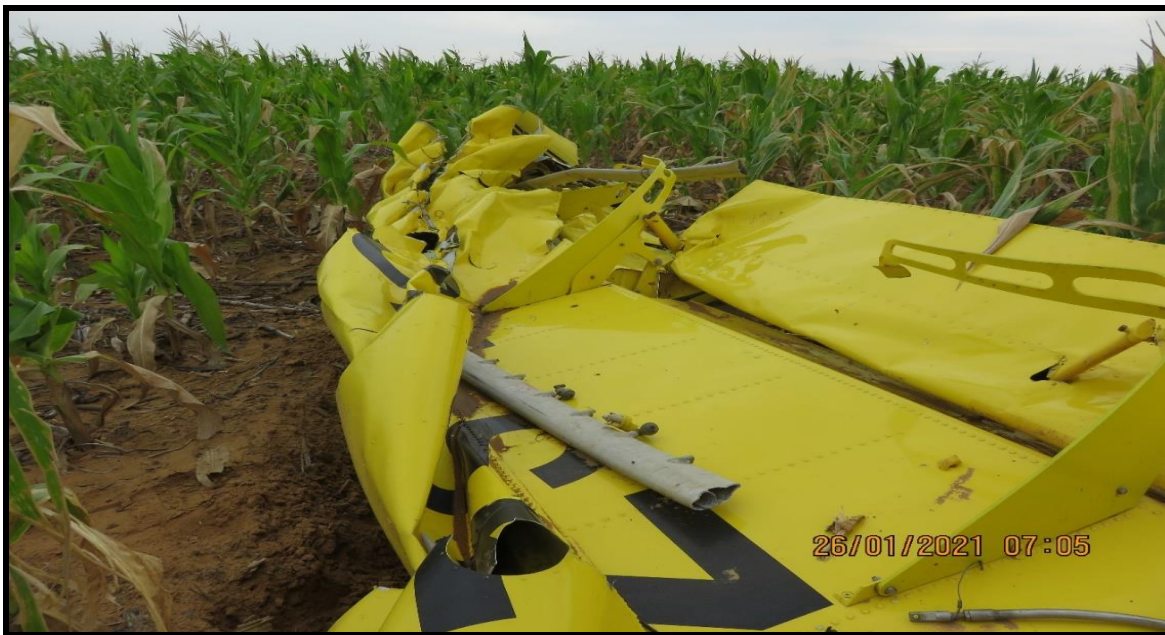
**Figure 4:** The damaged left wing due to impact.

- Damage on the left-wing indicated a downward folding of the leading-edge with more damage on the wing tip. Impact with the ground was from the top front part of the wing; the flap control surface on the left wing was at 10° position.

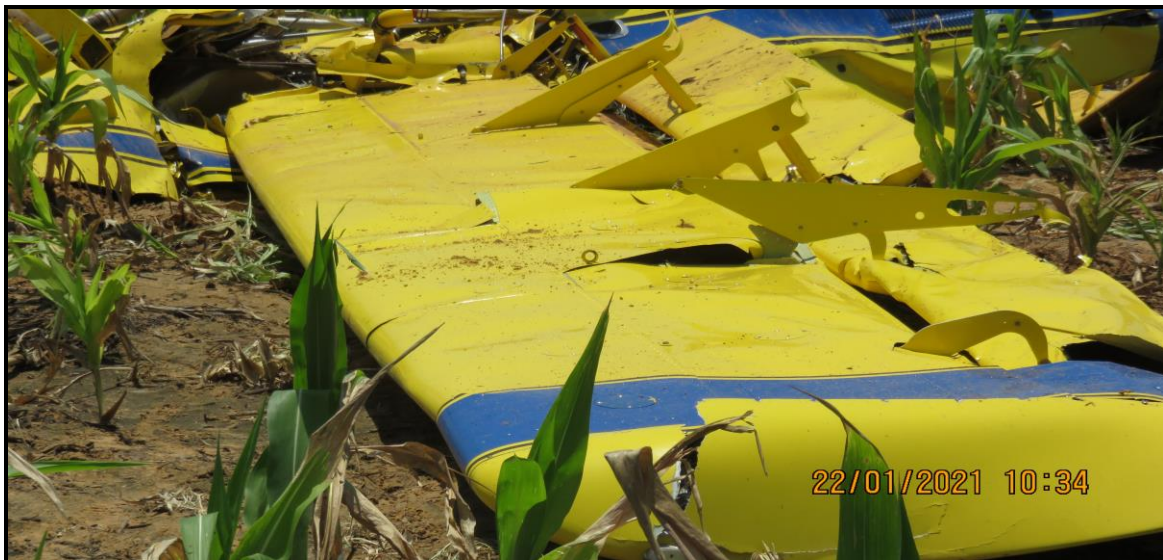
**Figure 5:** Damage on the right-side wing.

- The right-side wing was also found lying upside down (inverted position). The wing sustained damages to the attachment points and on the flight controls due to impact forces. Wrinkle damage was observed over the bottom and upper wing surface. The aileron control surface was bent due to impact. The wing was fairly intact with fuel tank containing sufficient fuel on-board. Damage was also observed on the wing tip, spray nozzle mounting bars which were bent, and the root attachment. The flaps were positioned between 5 and 8 degrees, which is the recommended position during turns.

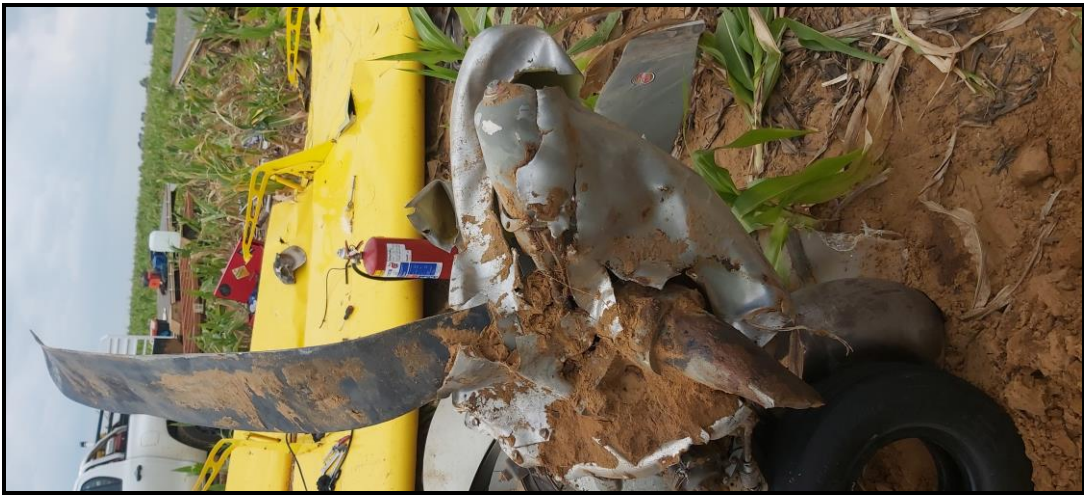
- The nose section was destroyed with damages extending to the engine. The engine was destroyed; it had separated into two parts. The nose section had extensive damage, which caused the compressor section to separate.
- The propeller hub was destroyed due to impact with the ground. One of the three propeller blades had broken off. The propeller hub and the blade that broke off were found lodged into the soil. The damage on the propeller indicated that the engine was not turning with power at the time of impact. The propeller blades were found in a feathered position. This is indicative of an engine that experienced a sudden power interruption during the impact sequence.

**Figure 5:** The damaged propeller.

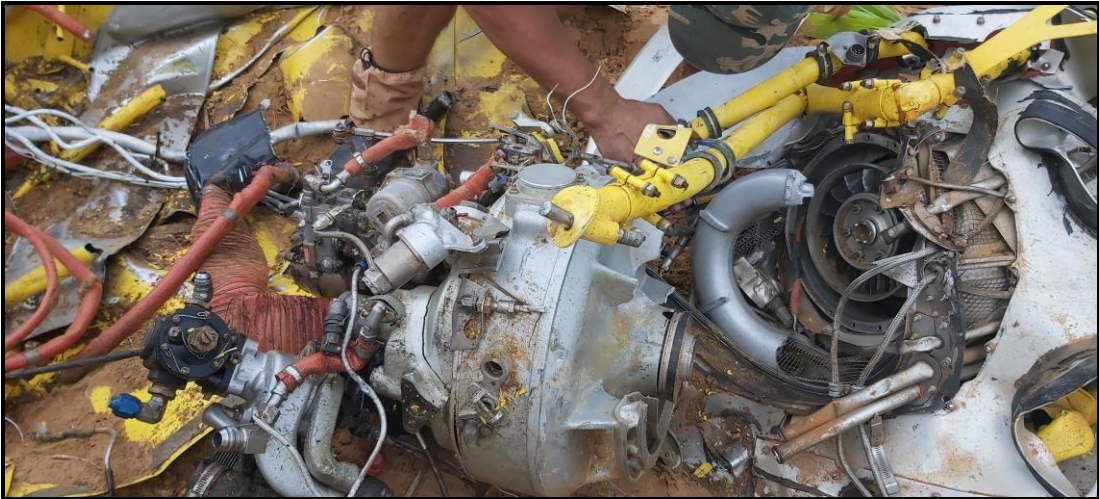
- All engine controls were still connected, and continuity was established. The throttle control was found in a full forward position. The propeller pitch control lever was found in a rear position and the propeller mechanism was found engaged in a flight mode position of the propeller settings.

**Figure 6:** The engine damage post-accident.

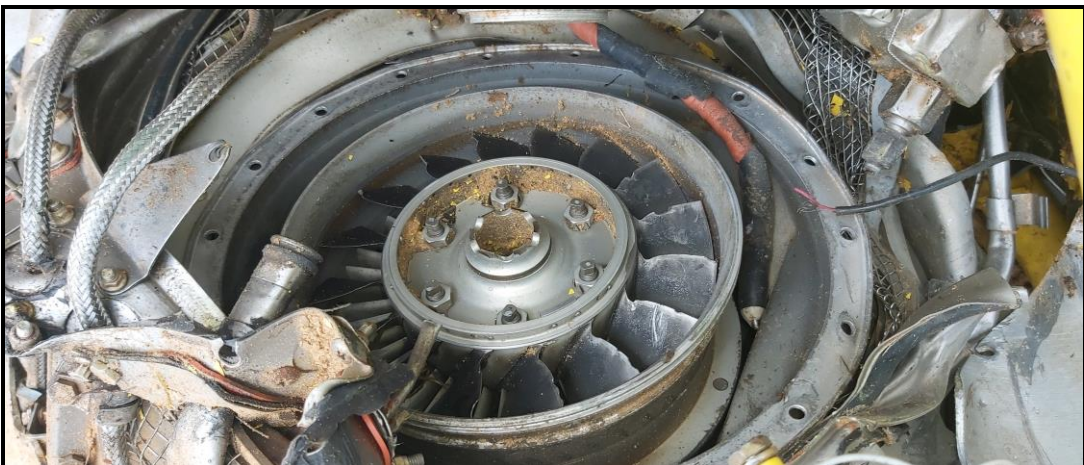
- Turbine blades were found protruding from the exhaust pipes. Also, there was damage observed on the compressor blades in the compressor section which had separated from the engine due to impact.

**Figure 7:** Damage on the engine turbine blades section.

- Damage on both the compressor and the turbine blades was consistent with damage caused while the engine was turning with no power during impact. Soil debris which was sucked in during the impact sequence was also observed.

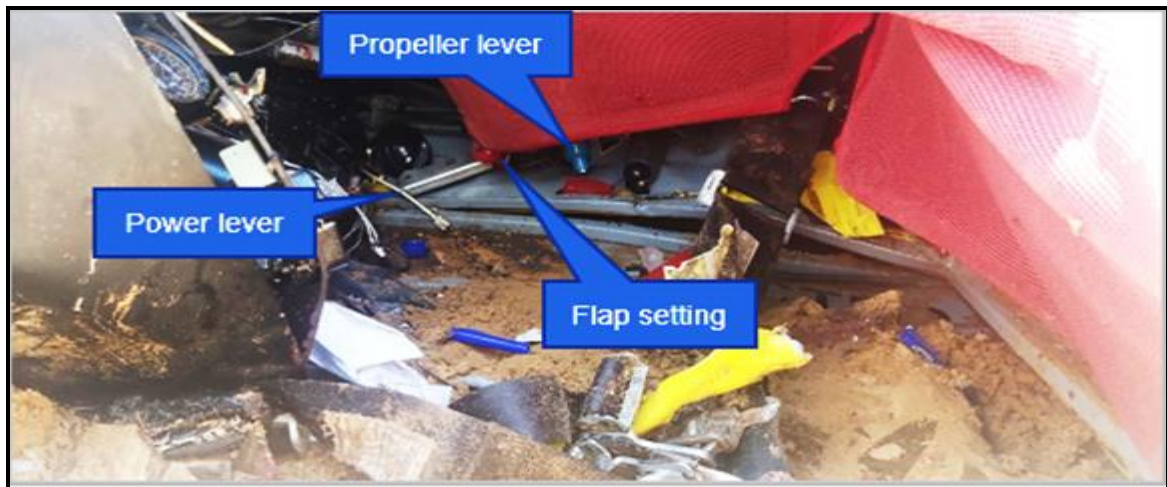
**Figure 7:** The aircraft's engine, propeller and flaps control.

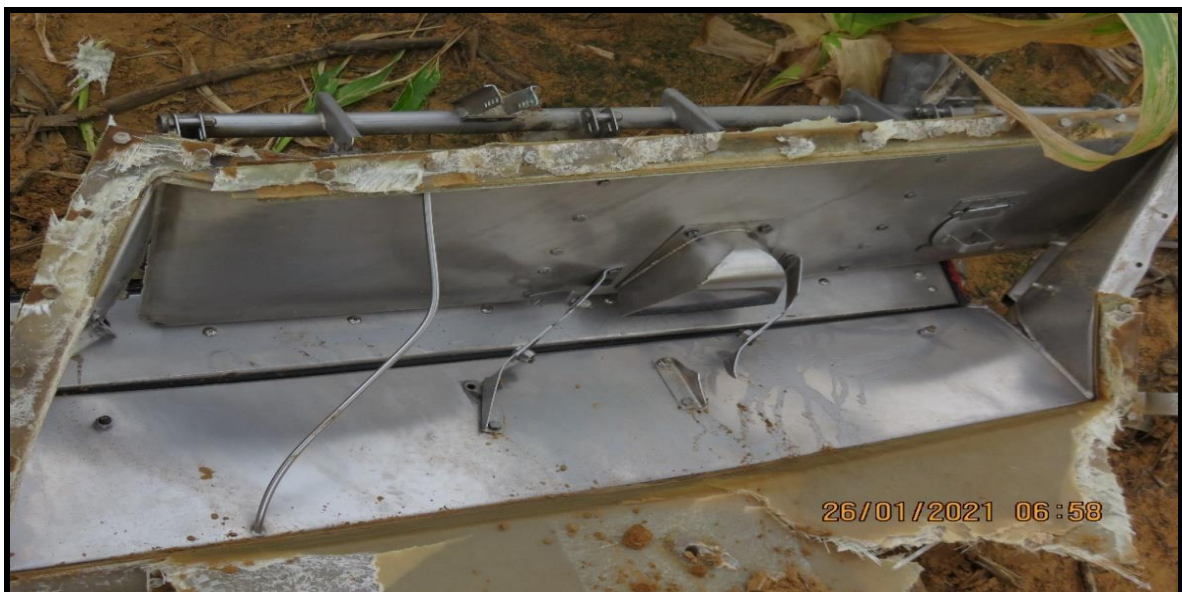
- 1.12.4 The hopper tank emergency dumb gate (door) was found in a “closed” and “locked” position. This door is used in emergency situations/drills in case of an engine failure to help reduce the aircraft's weight by dumping the crop-spraying solution.

**Figure 8:** The hopper gate of the aircraft.

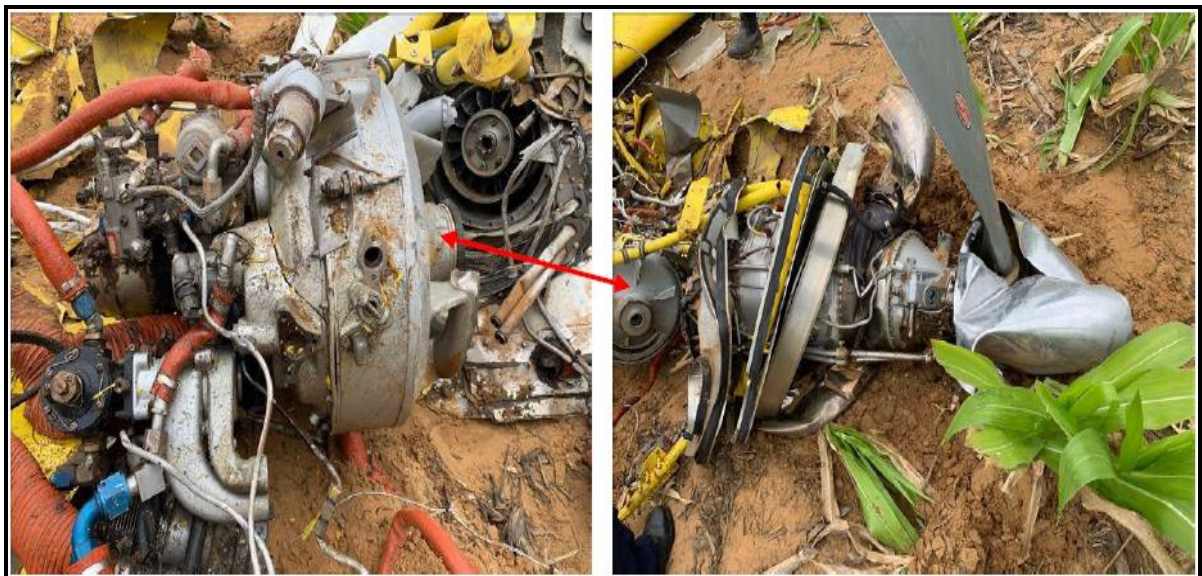
*The engine had fractured and separated into two sections. The inlet case stuts had fractured, liberating the accessory gearbox (figure 9 & 10). The gas generator and the power section were still attached at 6'Oclock position and held by approximately 13 bolts.*

**Figure s9 and 10:** Engine inlet stuts, liberating the accessory gearbox.

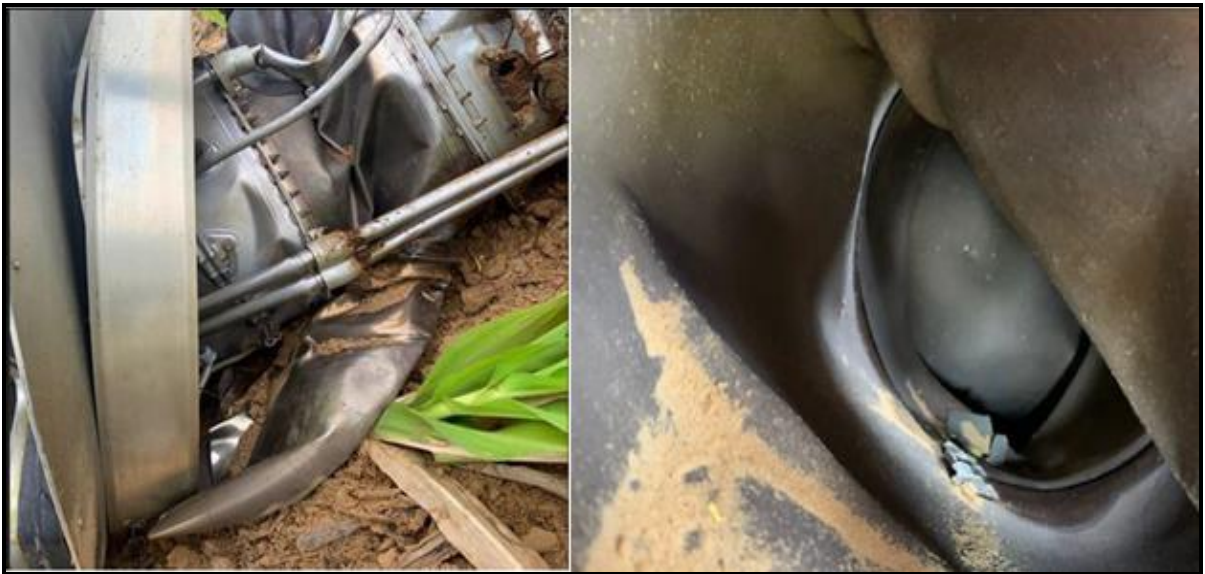
*The exhaust case was bent, and the airframe exhaust stacks were crushed/deformed on the underside. Examination of the exhaust duct revealed TP blade fragments in the exhaust case (Figures 11 and 12). The blade fragments showed rubbing wear on the shrouded tip. Environmental debris was observed in the exhaust case's inner surface.*

**Figures (11 and 12):** Damage of the exhaust case (left); PT blades fragment in the exhaust case (right)

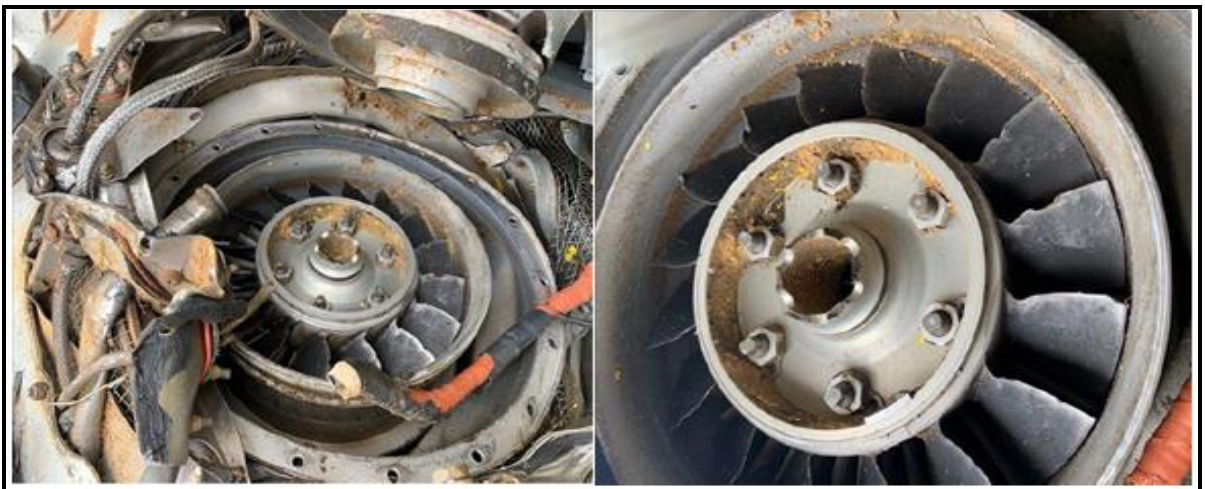
1.16.2 *The first stage compressor rotor aerofoils showed environmental debris. Foreign object damage was observed on the leading edges, rubbing wear and blade tip curl (Figure 13). The compressor rotor shaft was fractured, and the compressor rotor did not rotate.*

**Figure (13&14):** Shows the damages on the compressor rotor blades
