<b>LIMITED ACCIDENT INVESTIGATION REPORT</b>
--

<b>Reference Number</b>		CA18/2/3/9952						
<b>Classification</b>	Accident	<b>Date</b>	4 September 2021	<b>Time</b>	1106Z			
<b>Type of Operation</b>		Private (Part 94)						
<b>Location</b>								
Place of Departure		Numbi Airstrip near Hazyview, Mpumalanga Province		Place of Intended Landing		Da Gama Dam near White River, Mpumalanga Province		
Place of Accident		5nm south of Numbi Airstrip						
GPS Co-ordinates		Latitude	25°05'50.68"S	Longitude	031°04'26.0" East	Elevation	2621ft	
<b>Aircraft Information</b>								
Registration		ZU-DVG						
Model/Make		Bantam B22J (Serial Number: 05268)						
Damage to Aircraft		Substantial		Total Aircraft Hours		3659.7		
<b>Pilot-in-command</b>								
Licence Valid		Yes	Gender		Male	Age	76	
Licence Type		National Pilot Licence (NPL)						
Total Hours on Type		±6890		Total Flying Hours		+7005.2		
People On-board		1+1	Injuries	1	Fatalities	0	Other (on ground)	0
<b>What Happened</b>

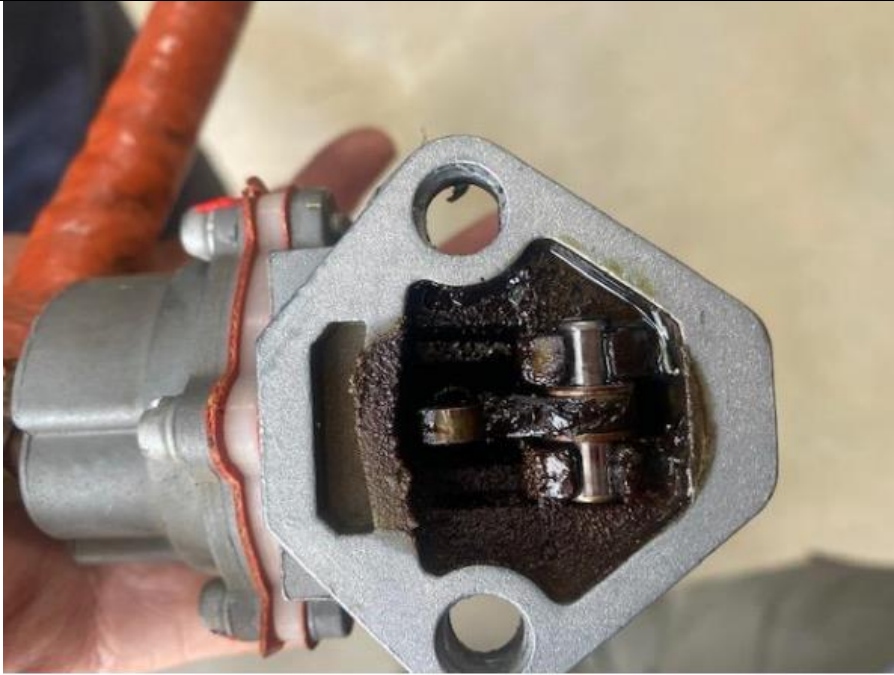
The approved person reported that after strip down, cleaning and inspection of the engine, it was found that the possible cause of engine failure was due to the mechanical fuel pump inefficiency. As the pilot had shut down the electrical fuel pump, he was dependent on the primary mechanical pump. There was evidence of sludge inside the mechanical fuel pump, which is likely to reduce pumping ability (see Figure 5-7). Cylinder number 2 failed a Cold Blow By test by 50/80; the minimum is 60/80. The fuel filter was in good condition and there were no particles in the fuel found in the carburettor bowl.

**Figure 2:** Visible sludge inside the mechanical fuel pump.

The findings of the failed engine at the maintenance facility revealed that the possible cause of engine failure was the sludge in the mechanical fuel pump which blocked fuel flow, thus, starving the engine (of fuel). The cause of the sludge could not be determined. The aircraft fuel flow was dependent on the primary mechanical fuel pump. There was sludge in the mechanical fuel pump which likely reduced pumping (flow) ability (see Figure 3 and 4). According to the airframe logbook, the mechanical fuel pump was inspected during the 75-hour inspection on 21 March 2021. The mechanical fuel pump is an on-condition component. The electric fuel pump was found in good condition.

Unsuccessful forced landing as a result of engine stoppage in-flight due to fuel starvation caused by sludge in the mechanical fuel pump.

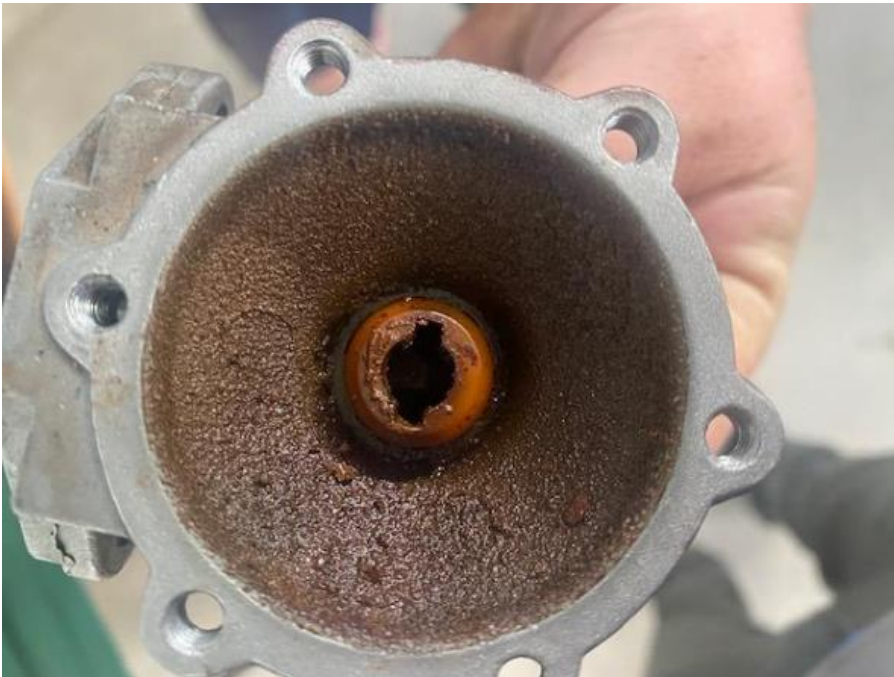
**Figure 3:** Mechanical fuel pump with sludge.

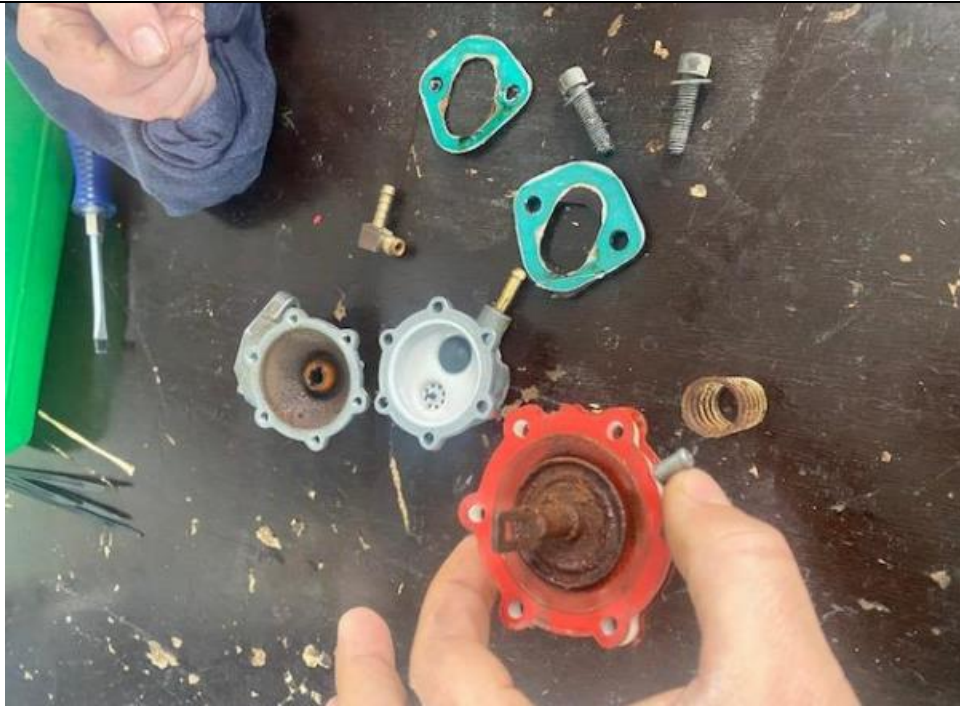
**Figure 4:** Sludge in the mechanical fuel pump.
