HELICOPTER ACCIDENT REPORT AND EXECUTIVE SUMMARY

Reference:		CA18/2/3/9955	
Aircraft Registration	ZS-HWZ	Date of Accident	17 February 2021		Time of Accident	0500Z	
Type of Aircraft	Bell 206B		Type of Operation		Private (Part 91)		
Pilot-in-command Licence Type	Private Pilot Licence		Age	54	Licence Valid	Yes	
Pilot-in-command Flying Experience	Total Flying Hours		1 223.1		Hours on Type	1 048.6	
Last Point of Departure	Ubhejane Game, Portion 21, Rhenosterhoekspuit 466 KQ, Bela-Bela						
Next Point of Intended Landing	Wonderboom Aerodrome (FAWB), Gauteng						
Damage to Helicopter	Substantial						
Location of the accident site with reference to easily defined geographical points (GPS readings if possible)							
In Wonderboom General Flying Area (GPS position: 25°28'43.20" South 028°09'58.00" East)							
Meteorological Information	Surface wind: Light and variable; Temperature: 20°C: Visibility: CAVOK						
Number of People On-board	1 + 0	Number of People Injured	0	Number of People Killed	0	Other (On Ground)	0

Probable cause							
The pneumatic Scroll-to-Pc Filter Tube Assembly had fractured due to fatigue at the forward Pc filter connection. This resulted in engine in-flight shu

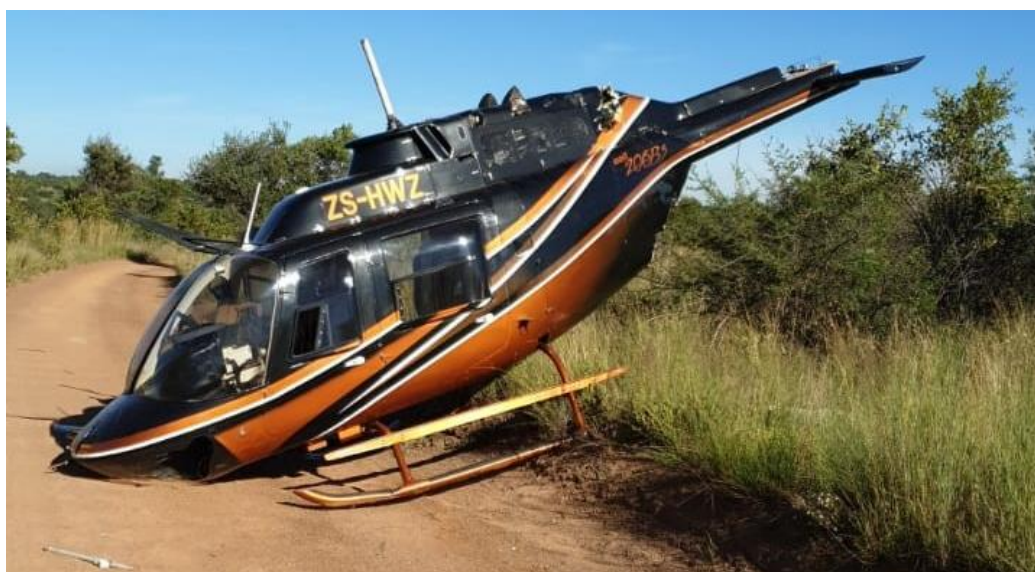
1.3.1 The helicopter sustained substantial damage during the accident sequence.

Figure 1: The helicopter as it came to rest.

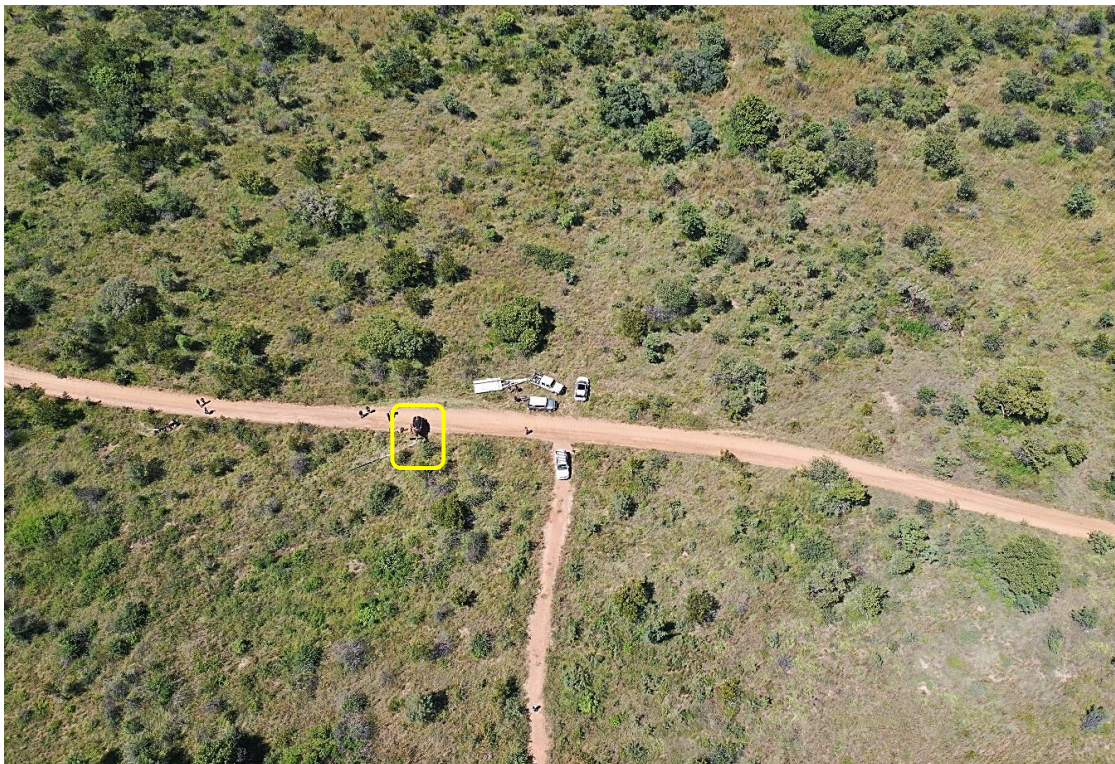
Figure 2: An aerial view of the terrain and the helicopter. (Source: Aviation Assessing Services)

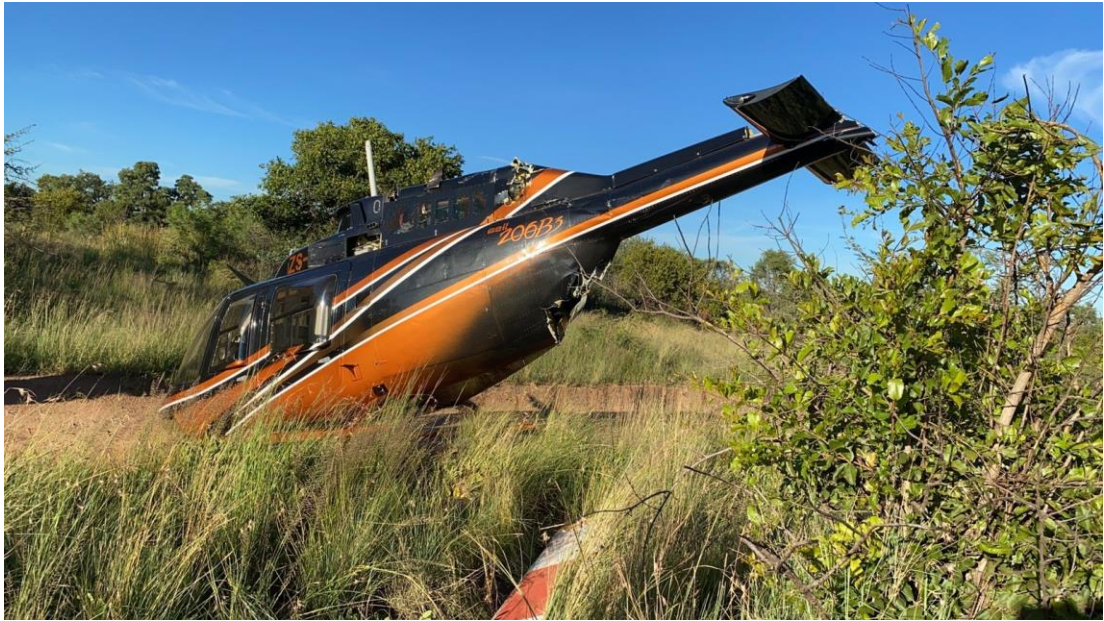
1.12.1 During an attempted forced landing on a dirt road, the main rotor blades struck a tree on the side of the road, which caused the helicopter to yaw and pitch nose up. During touch down on a dense bushy terrain, the main rotor blades severed the tail boom, the main rotor assembly broke off from the main rotor drive shaft and came to rest on the left of the main wreckage.

Figure 3: The helicopter as it came to rest.

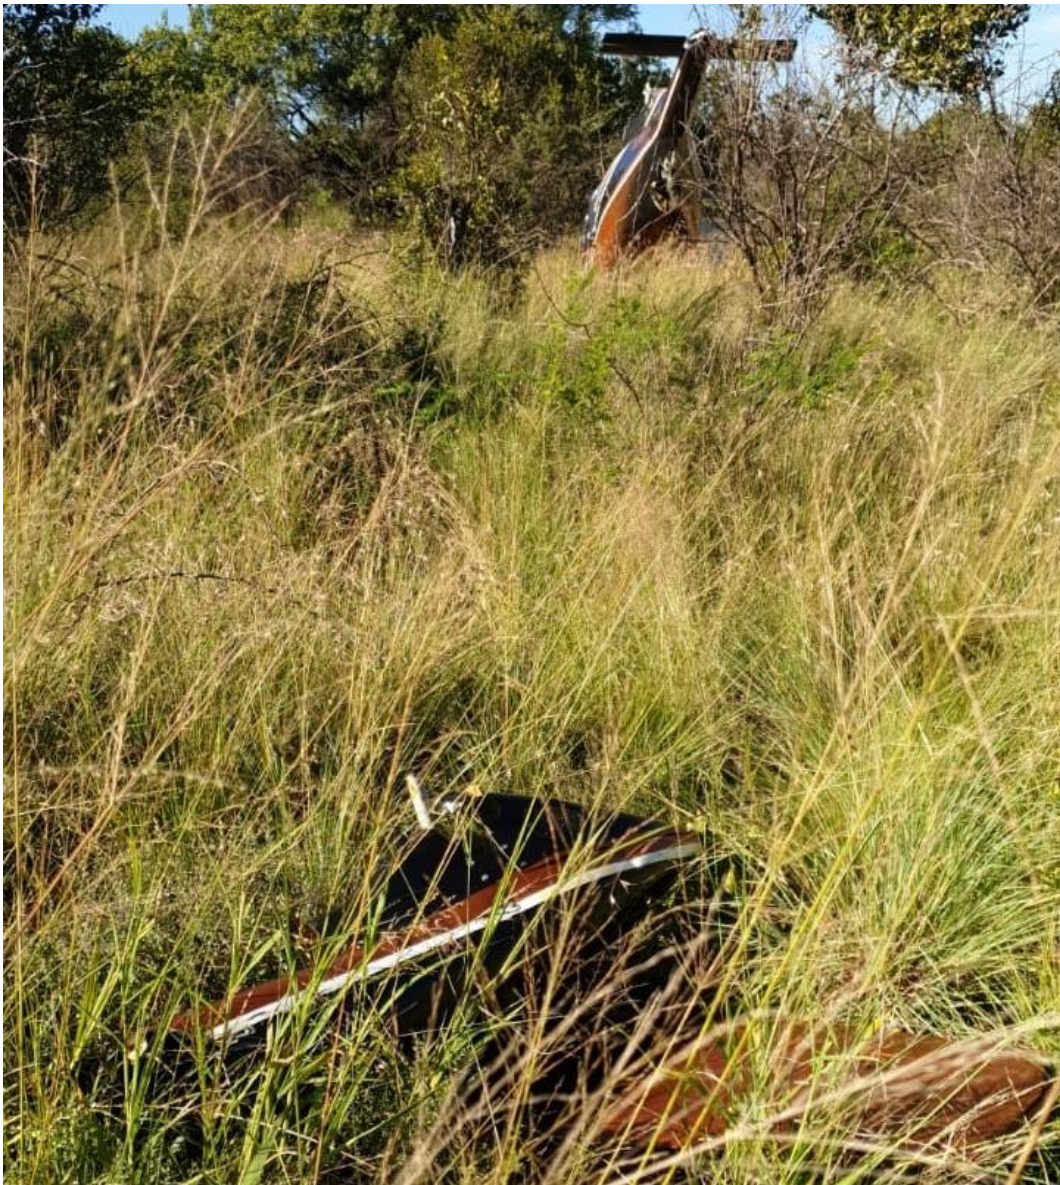
Figure 4: An aft view of the helicopter as it came to rest with the aft tail boom in the foreground.

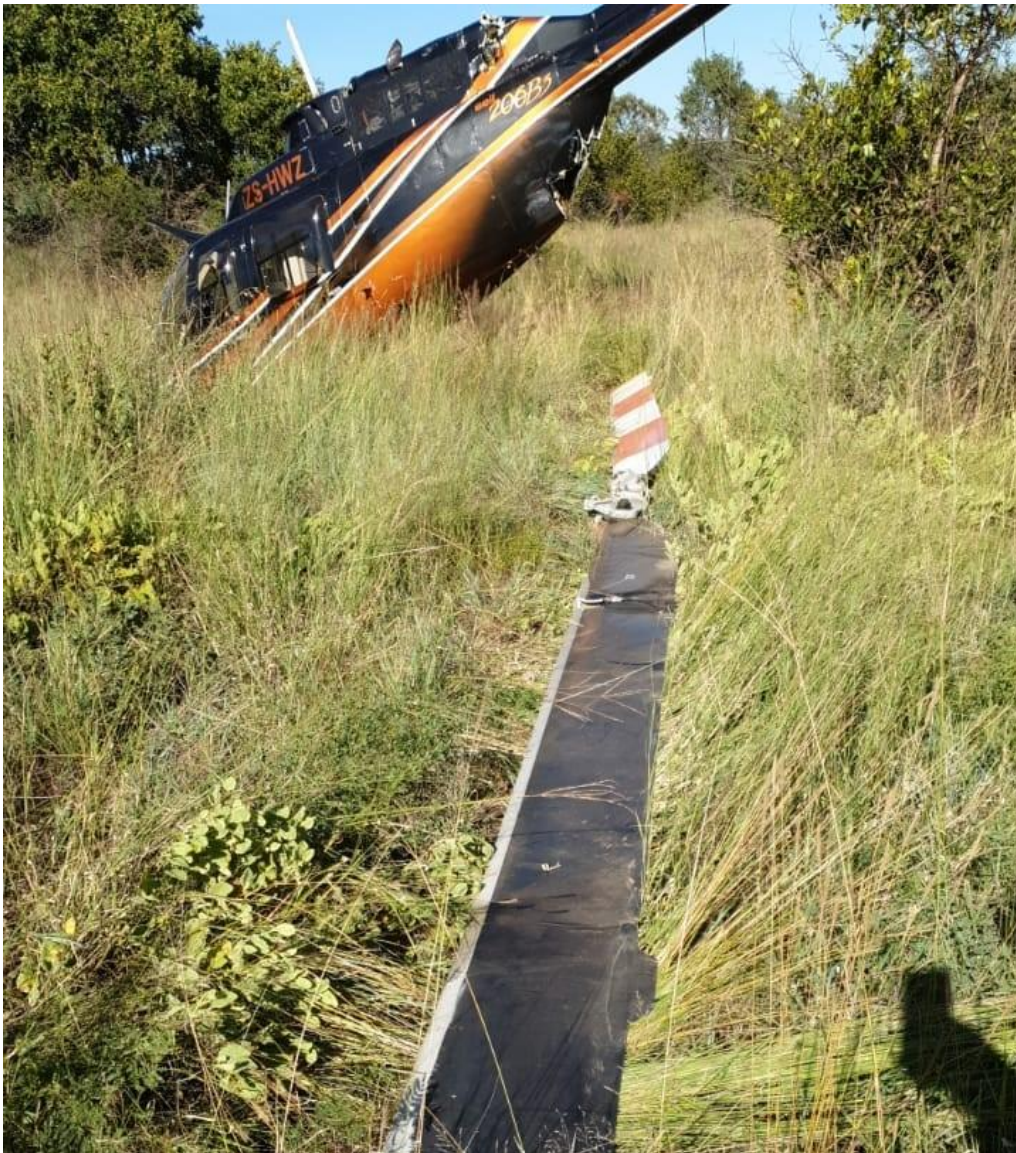
Figure 5: The entire main rotor assembly had separated from the main rotor drive shaft.

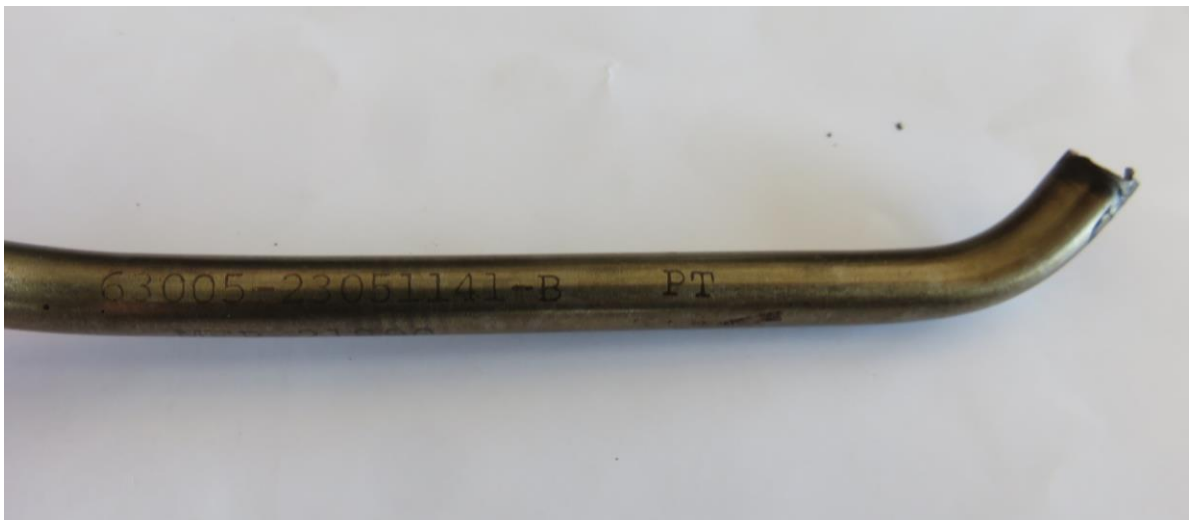
The Pc tube that was fitted to the engine had part number 63005-23051141-B (see Figure 6). This tube was fitted between the Scroll-to-Pc Filter and was found to have failed at the forward end where it attaches to the Pc filter (see Figure 7). The Pc tube was the correct part as per the requirements issued by the engine's original equipment manufacturer (OEM) in the Commercial Engine Bulletin Alert (CEB-A-1294), which was first issued on 20 July 1990, followed by Revision 2, issued on 31 October 1996.

Figure 6: The fractured Pc tube with part number 63005-23051141-B printed on it.

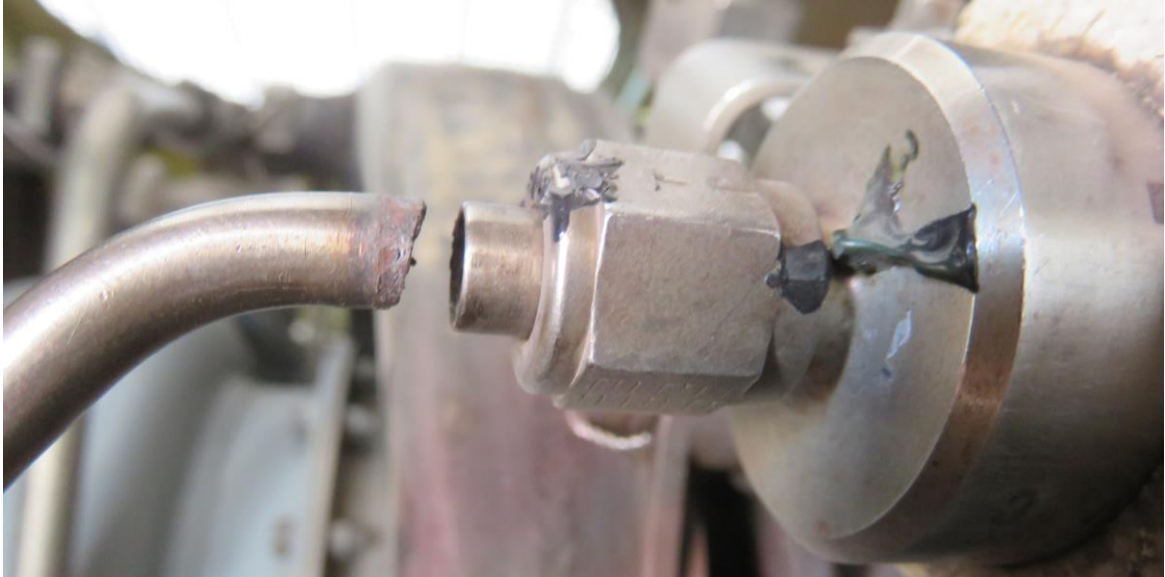
Figure 7: The fractured Pc tube (forward connection of the Pc filter) as it was found on the engine.

It was evident that the Pc tube was installed incorrectly (the wrong way around) and, as a result, the Pc tube was under undue tension during operation. The fractured surface on the filter side also displayed evidence of heat exposure. The failed Pc tube was handed over to the Laboratory for Microscopy and Microanalysis at the University of Pretoria for a metallurgical analysis of the possible failure mode. The report is attached as Annexure F.

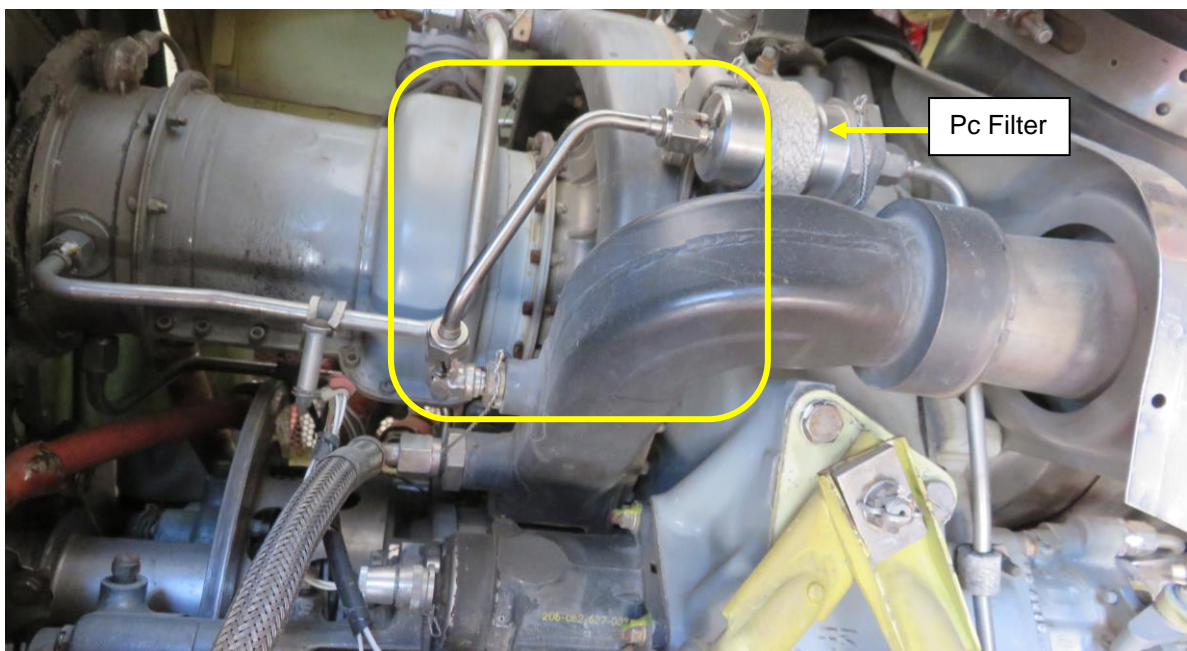
A new Pc tube (see Figure 9a) was made available by the AMO that recovered the helicopter. A second Bell 206B helicopter with registration ZS-BAC that was involved in an accident on 23 January 2021 near Reitz, which was recovered to the same AMO, was inspected to make a comparison between the two installations of the Pc tubes as the engine of the ZS-BAC was not damaged during the accident sequence. Figure 8 shows the Pc tube installation on the engine of ZS-BAC.

Figure 8: The Pc tube as it was installed on the engine of the ZS-BAC helicopter.

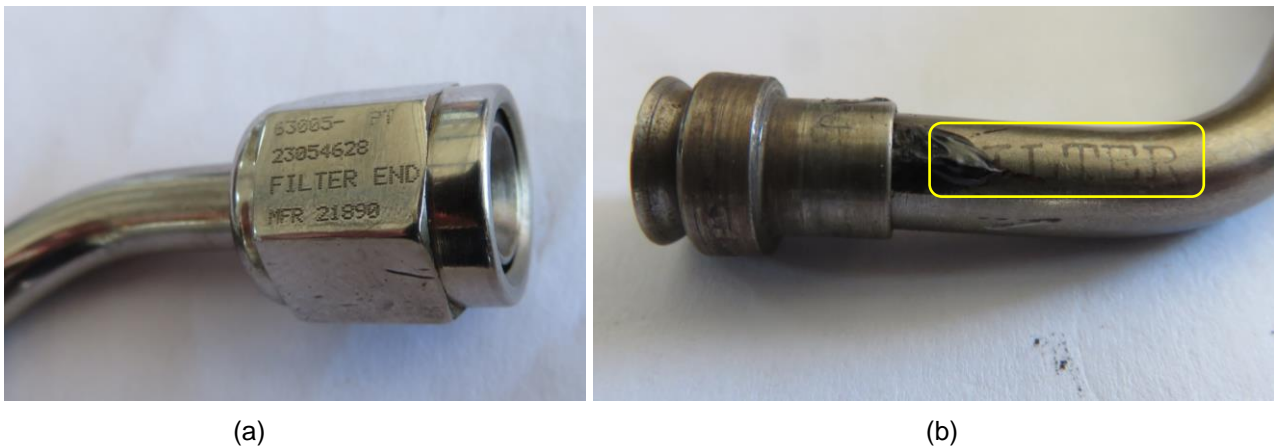
The new Pc tube with serial number 63005-23054628 was made available to the investigator by the AMO that recovered the helicopter. On the securing B-nut on the Pc filter side, the words FILTER END (see Figure 9a) are machine engraved. The Pc tube that was removed from the accident helicopter had, on the opposite end (not the side that failed), the word FILTER printed on the tube (see Figure 9b).

Figure 9: (a) The new Pc tube: (b) The Pc tube removed from the accident helicopter engine.

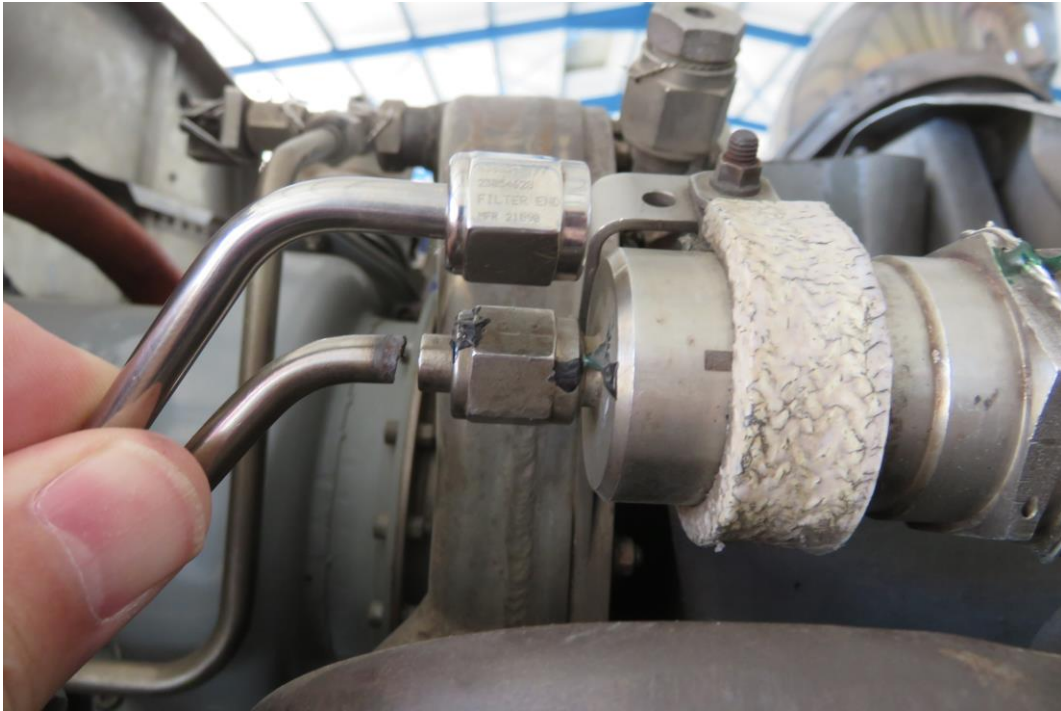
Figure 10 provides a comparison between the long end of the new Pc tube that was made available during the investigation process and the short end of the Pc tube that was connected to the forward Pc filter connection that failed in-flight.

Figure 10: Comparison between the long end (new tube, top) and the short end (failed tube).

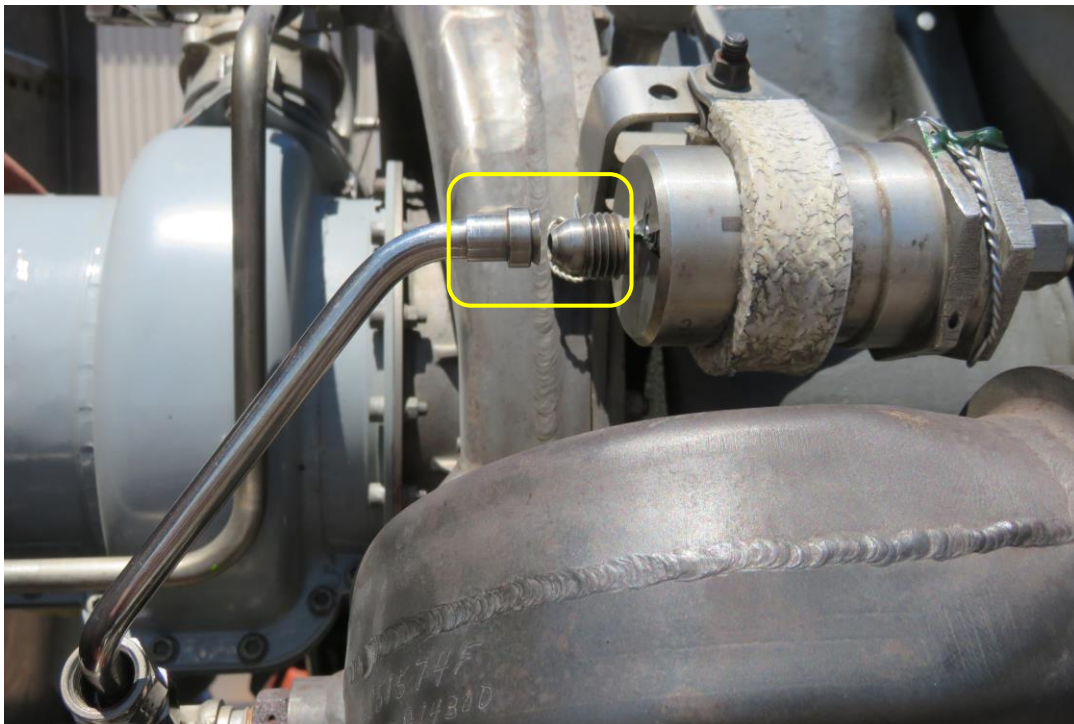
In Figure 11, the long end of the new Pc tube was connected to the compressor scroll end. This shows how the Pc tube was installed when it failed. On the picture, it is noted that the flared tube end does not meet the face of the Pc filter front connection.

Figure 11: The new Pc tube connected to the long end of the compressor scroll.

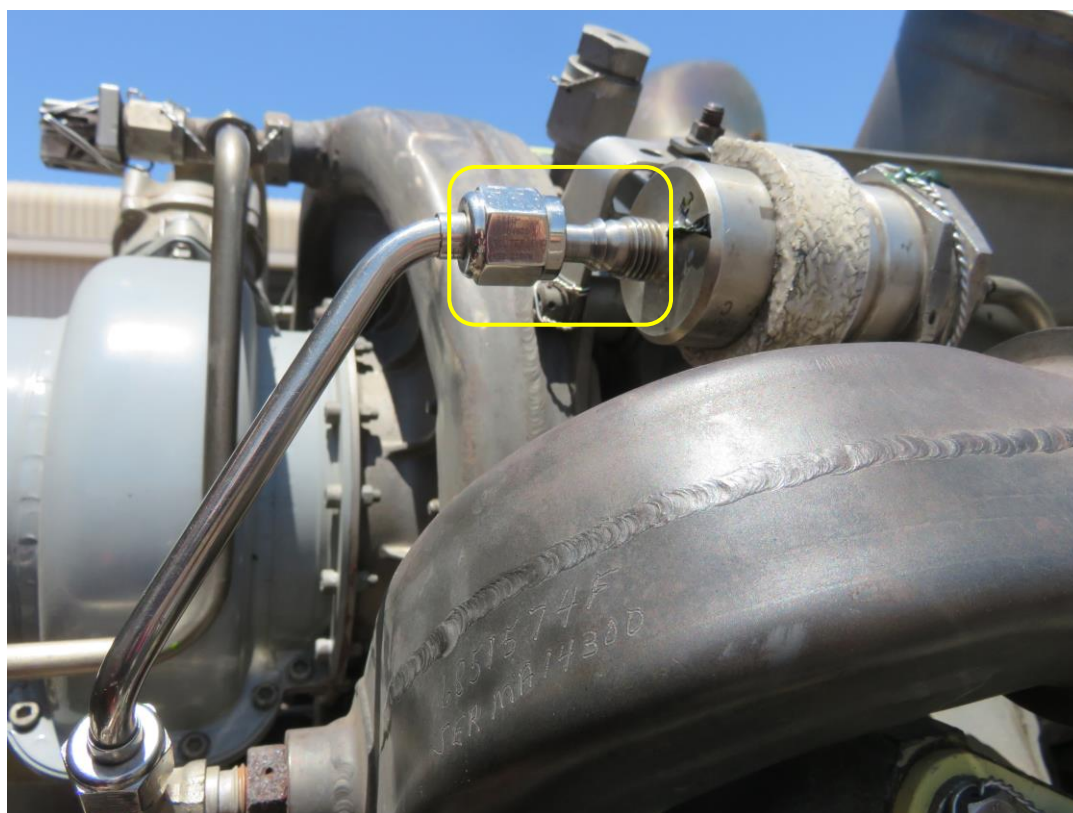
In Figure 12, the short end of the new Pc tube was connected to the compressor scroll end. The investigator noted that the flared tube end met uniformly (in a free state) to the cone of the Pc filter front connection. The Pc tube fitted without any distortions of the tube assembly. It was also possible to turn the B-nut tightly by applying light finger pressure before the necessary torque requirements were applied.

Figure 12: The new Pc tube connected with the short end to the compressor scroll.

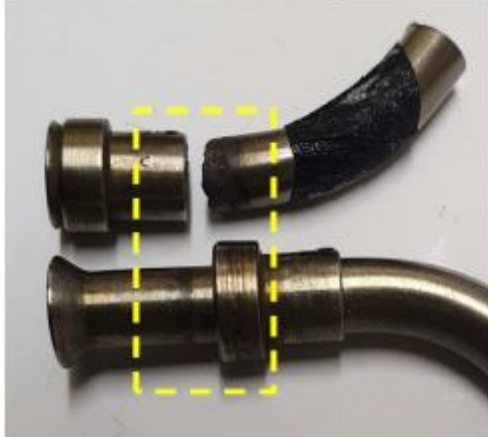
Inspection of the Tube outer surface at the location of the Tube/Floating Ferrule interface confirms the presence of corrosion products (EDS Result 2) with high Oxygen percentages as well as extensive pitting (Fractograph 7) when compared to the as manufactured outer Tube surface (Fractograph 6).

Photo 5: Tube opposing ends showing corrosion damages (Digital)

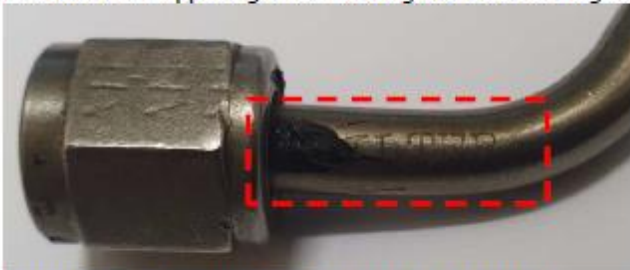
Photo 6: Fractured Tube: "Filter" inscription (Digital)

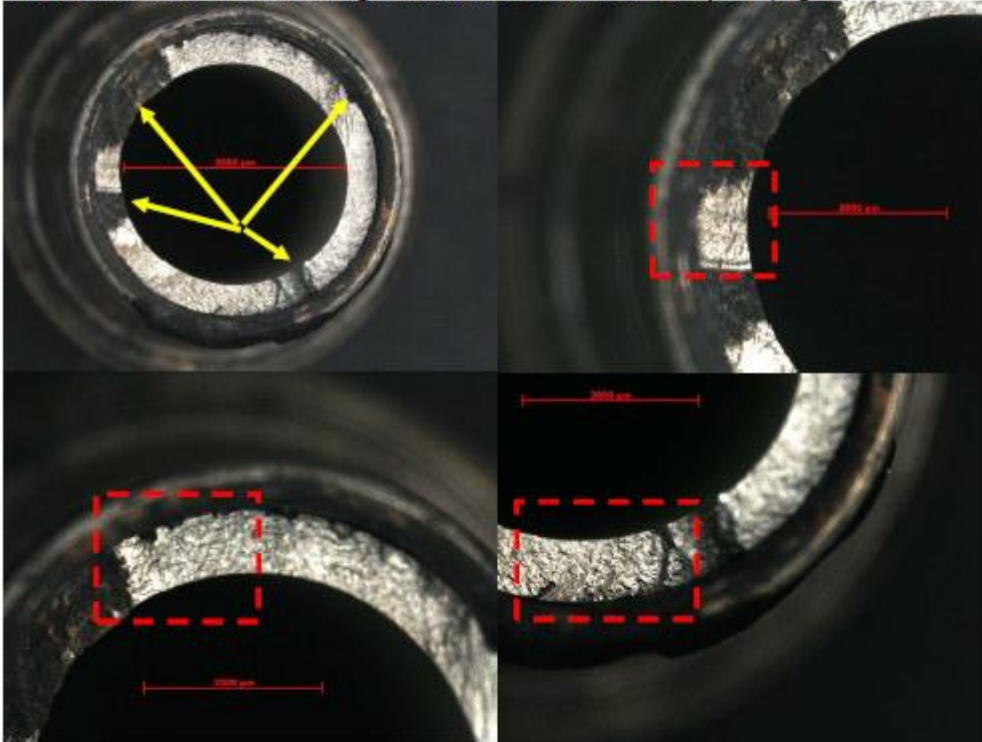
Stereograph 1: Fracture surface geometry and features (+10-25X, Zeiss Discovery V20)

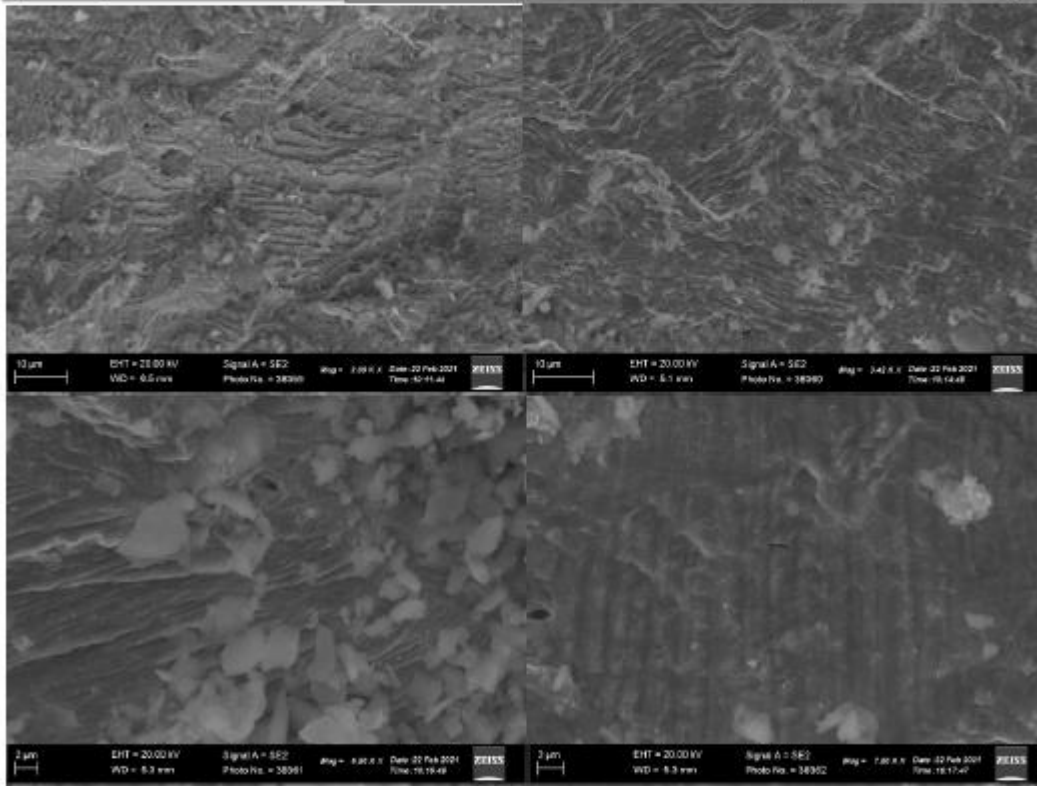
From these corrosions pits multiple fatigue fractures initiated while progressing within various planes (Fractograph 4). Corrosion- and foreign deposits on the fracture surface suggest progression over an undetermined period of operational time until final fracture (Fractograph 5).

Fractograph 4: Fracture surface morphology (2500-7300X, SE, 20kV, FEGSEM)

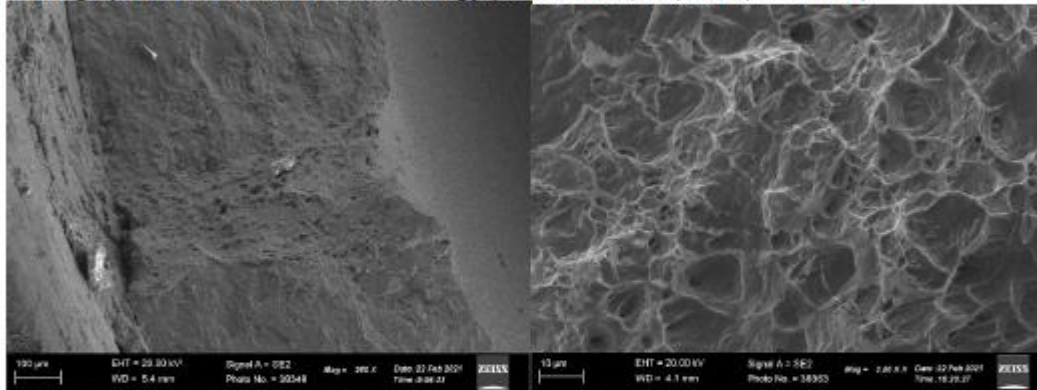
Fractograph 5: Fracture surface morphology (260-2500X, SE, 20kV, FEGSEM)

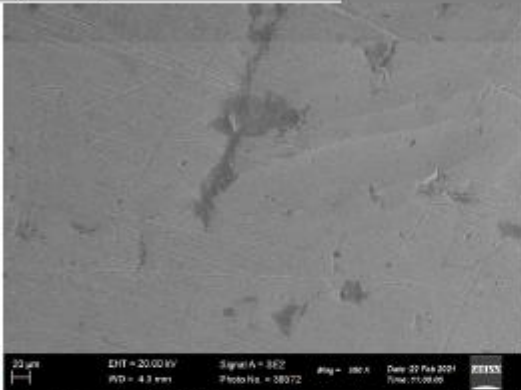
Fractograph 6: P3 Line outer surface condition (500X, SE, 20kV, FEGSEM)

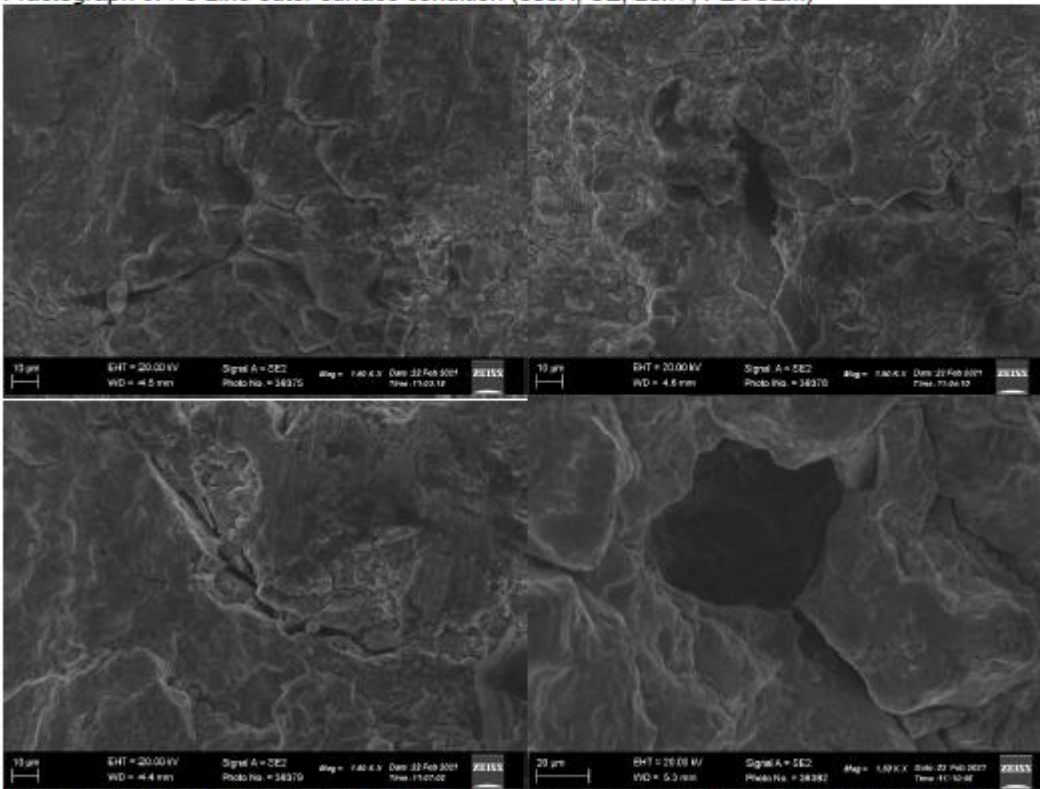
Fractograph 7: Outer surface; Floating ferrule/P3 Line interface (1500X, SE, 20kV, FEGSEM)

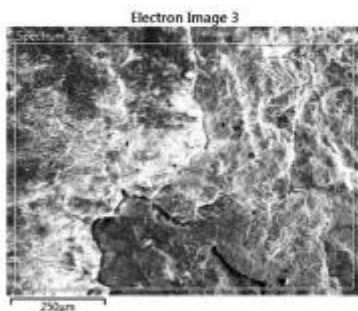
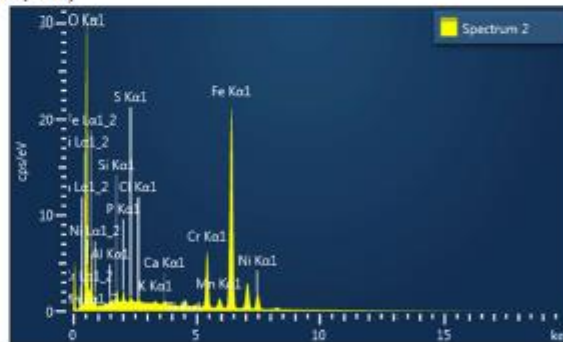
EDS result 2: Corrosion - Base Material (Oxford, 15kV, SE)
