LIMITED ACCIDENT INVESTIGATION

Reference Number		CA18/2/3/9958					
Classification	Accident	Date	12 February 2021		Time	1020Z	
Type of Operation		Part 105, Parachute Dropping					
Location							
Place of Departure		Carletonville (FACR)		Place of Intended Landing		(FACR)	
Place of Accident		771m from the threshold of the south-side runway in Carletonville Aerodrome (FACR)					
GPS Co-ordinates	Latitude	S26°22'49.8"	Longitude	E027°21'38.6'	Elevation	5029 ft	
Aircraft Information							
Registration		ZS-WWO					
Model/Make		AL-60C-M4 Kudu					
Damage to Aircraft		Substantial		Total Aircraft Hours		4920	
Pilot-in-command							
Licence Type		Private Pilot Licence		Gender		Male Age 56	
Licence Valid		Yes					
Total Hours on Type		869		Total Flying Hours		3058.7	
People On-board		2 + 6		Injuries		2 + 6	
		Fatalities		0		Other (On Ground)	
						0	
What Happened

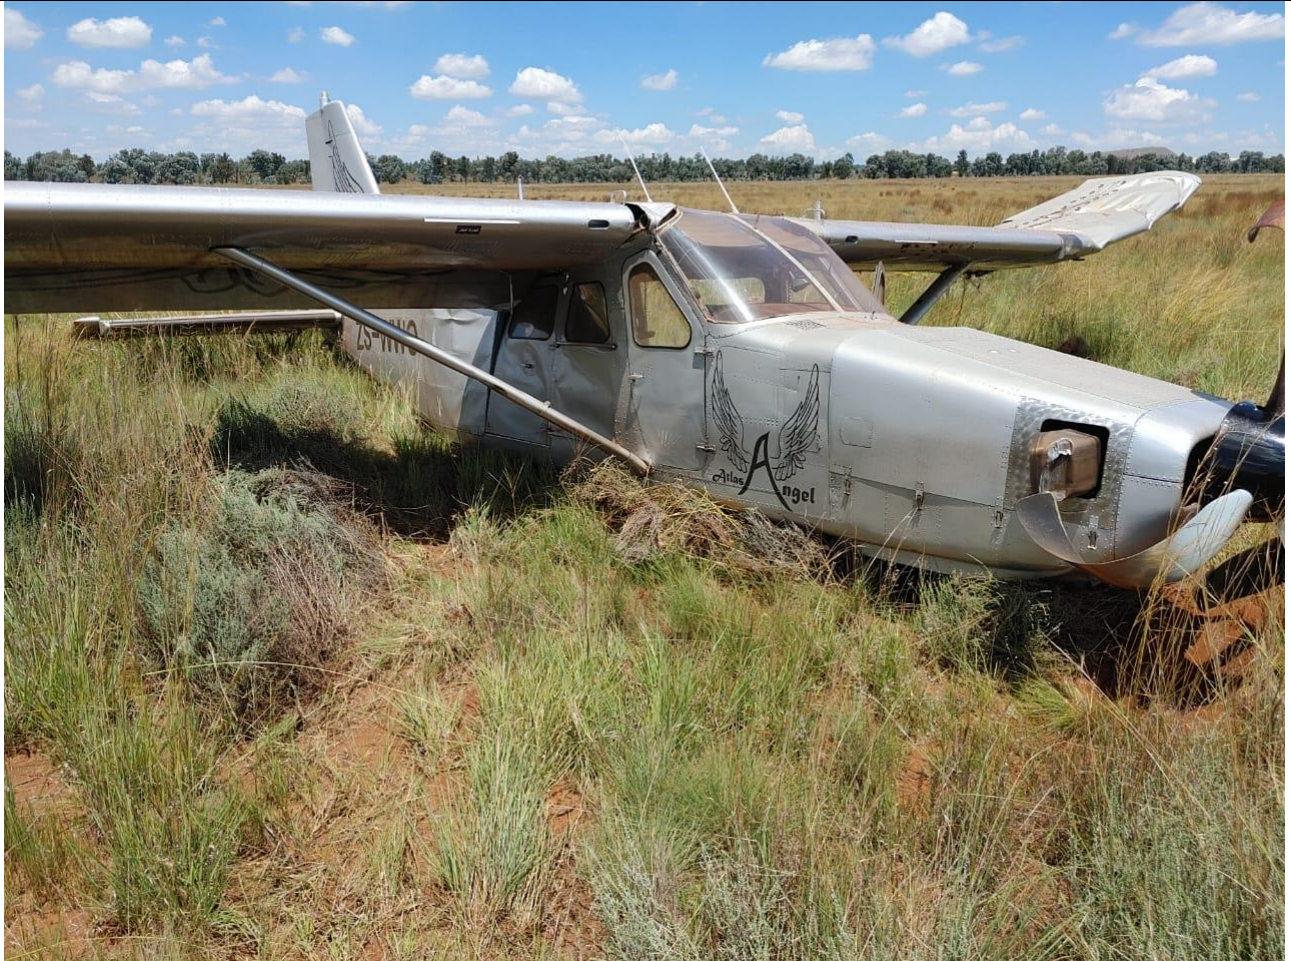
On 12 February 2021, an AL-60C-M4 Kudu with registration mark ZS-WWO took off from Carletonville Aerodrome (FACR) with the pilot-in-command (PIC) and the safety pilot, as well as six skydivers on-board. The intention of the flight was to drop off the six skydivers in the Carletonville area and return to FACR. The PIC stated that he uplifted 400 litres of Jet A-1 fuel prior to the flight, which is the maximum fuel capacity of this aircraft. The PIC further stated that immediately after take-off during the climb phase at approximately 250 feet (ft) above ground level (AGL), the aircraft lost thrust and could not climb any further. Thereafter, it started to sink. The safety pilot switched on the isolator (ISO) button to isolate the power lever "throttle" and pushed the fuel condition lever forward to try and feed fuel to the engine to restore power. During the process of restoring power, the aircraft lost height and it impacted the ground with its right-side main landing gear first, then the left-side main landing gear, followed by the left wing. The aircraft spun around clockwise and came to rest facing the direction of its approach. The aircraft sustained substantial damage during the accident sequence.

The PIC had, during the climb phase at about 250ft AGL, prematurely retracted the flaps and the aircraft entered a sink mode due to loss of lift. The safety pilot panicked and confused the sink mode (feeling) with the loss of thrust and, in response, pulled back the throttle lever, which exacerbated the situation. To recover the engine power, the safety pilot hastily opened the throttle, and this resulted in the compressor stalling the engine.

Figure 1: The aircraft as it came to rest.

It is recommended to the Director of Civil Aviation that the SACAA should consider evaluating the effectiveness of its Part 105 operation oversight programme, as well as to ensure that Part 105 operations are conducted at the same level of safety as Part 121 and 135 operations.
