<b>AIRCRAFT ACCIDENT REPORT AND EXECUTIVE SUMMARY</b>
---

<b>Reference:</b>		<b>CA18/2/3/9962</b>	
<b>Aircraft Registration</b>	ZS-JSR	<b>Date of Accident</b>	3 March 2021		<b>Time of Accident</b>	1426Z	
<b>Type of Aircraft</b>	Rallye 235E		<b>Type of Operation</b>		Private (Part 91)		
<b>Pilot-in-command Licence Type</b>	Private Pilot Licence		<b>Age</b>	26		<b>Licence Valid</b>	Yes
<b>Pilot-in-command Flying Experience</b>	<b>Total Flying Hours</b>		714.5		<b>Hours on Type</b>	221	
<b>Last Point of Departure</b>	Orient Airfield (FAOI) , Gauteng Province						
<b>Next Point of Intended Landing</b>	Wonderboom Airport (FAWB), Gauteng Province						
<b>Damage to Aircraft</b>	Substantial						
<b>Location of the accident site with reference to easily defined geographical points (GPS readings if possible)</b>							
Maize farm near FAOI, Gauteng Province, at GPS co-ordinates reading: S 26° 02' 54.36", E 027° 36' 20.32" at an field elevation of 5138ft

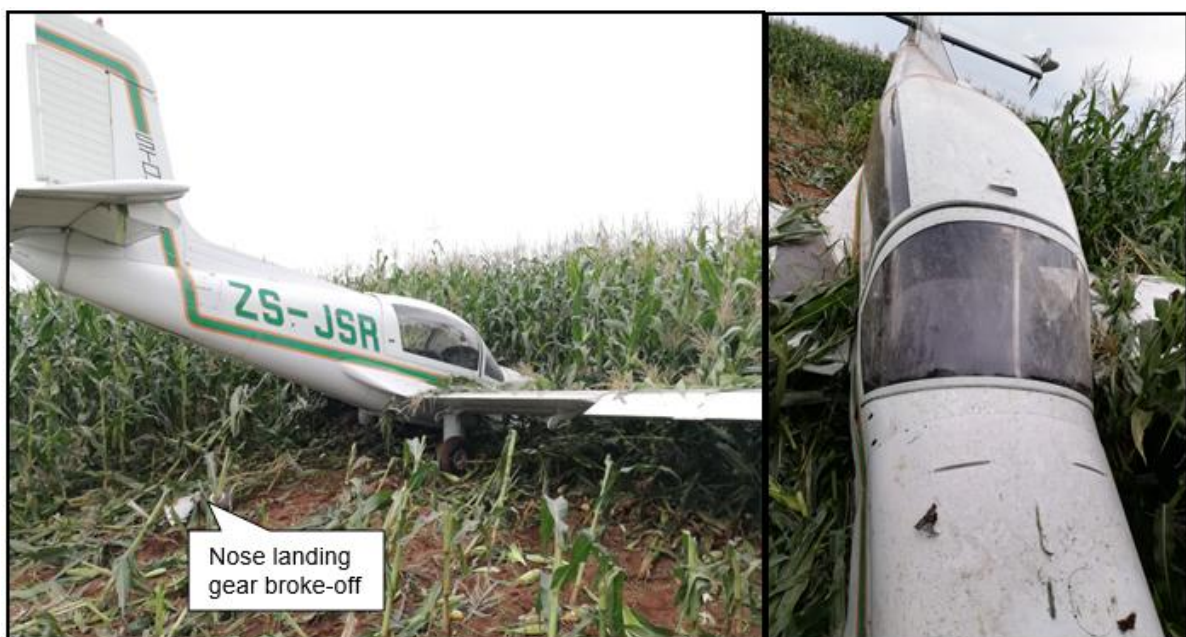
1.3.1 The aircraft sustained substantial damage to the nose landing gear, the propeller and the right-side wing leading edge.

Figure 2: The damaged aircraft as it was found at the accident site. (Source: Picture courtesy of the pilot)

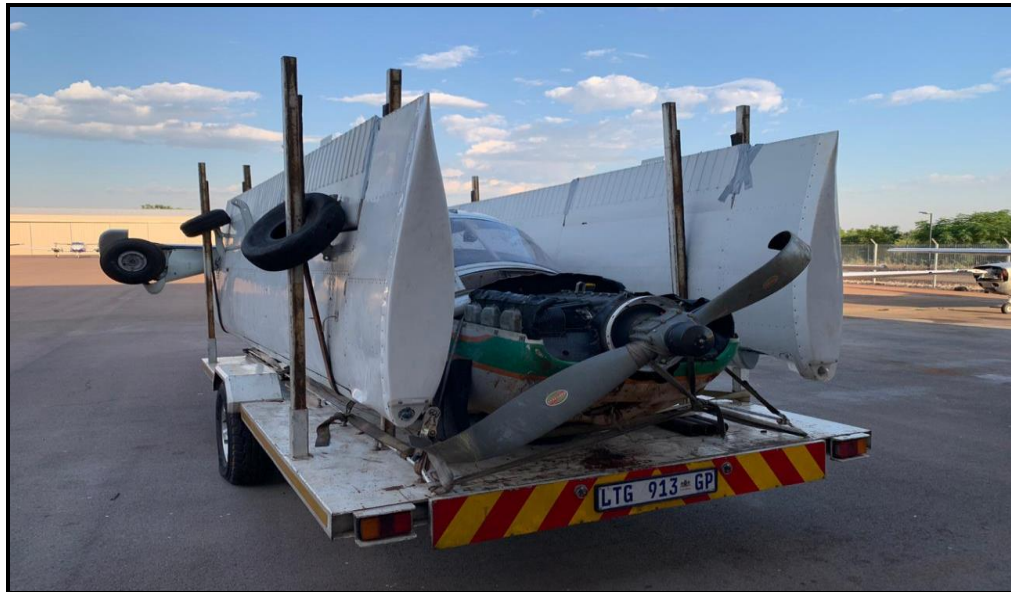
**Figure 3:** Damaged propeller blades.

1.12.2 The aircraft contacted the ground with the nose landing gear first, causing it to break off. The propeller struck the ground and sustained substantial damages. The damages on the propeller indicated that the engine was turning with power at the time of contact with both the maize crops and the ground during the accident sequence.

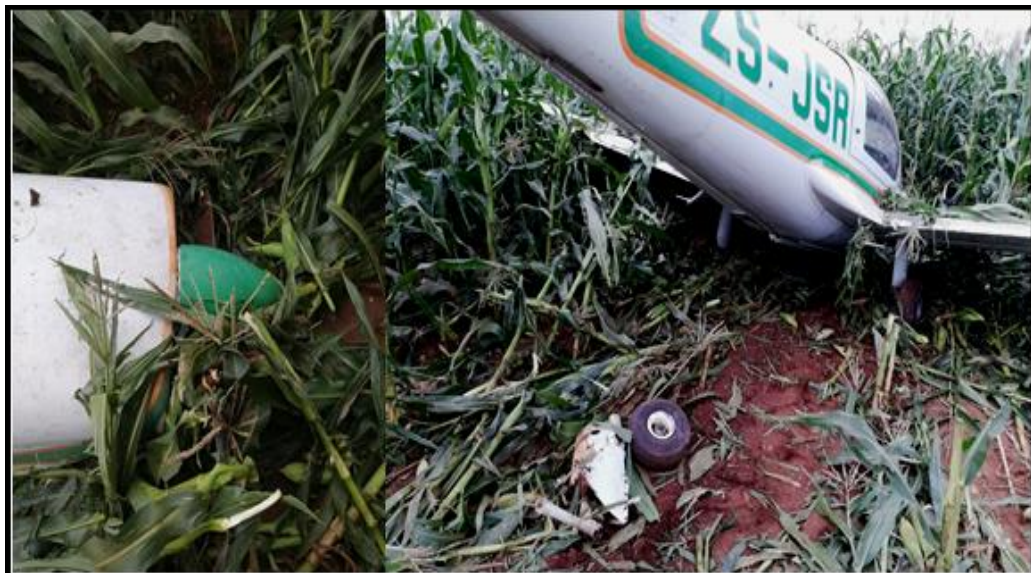
1.12.3 Both wings sustained damages to the leading edges. The damages on both leading edges were consistent with damages caused by impact with the maize crop during the initial contact speed of the aircraft.

**Figure 4:** Damage sustained by the aircraft.
