<b>LIMITED ACCIDENT INVESTIGATION REPORT</b>
--

<b>Reference Number</b>		CA18/2/3/9963						
<b>Classification</b>	Accident	<b>Date</b>	4 March 2021	<b>Time</b>	0545Z			
Type of Operation		Private (Part 24)						
<b>Location</b>								
Place of Departure		The Coves Airfield	Place of Intended Landing		The Coves Airfield			
Place Accident		1 nm east of The Coves Airfield in Gauteng Province						
GPS Co-ordinates		Latitude	S25°46'27"	Longitude	E027°48'42.3"	Elevation	3885 ft	
<b>Aircraft Information</b>								
Registration		ZU-FOK						
Model/Make		Fokker E3						
Damage to Aircraft		Substantial		Total Aircraft Hours		3.8		
<b>Pilot-in-command</b>								
Licence Type		National Pilot Licence		Gender		Male Age 46		
Licence Valid		Yes						
Total Hours on Type		3.8		Total Flying Hours		1987.6		
<b>People On-board</b>		1+0	Injuries	1	Fatalities	0	Other (on ground)	0
<b>What Happened</b>								
<p>On Thursday afternoon 4 March 2021, the pilot flying solo on-board a Fokker E3 aircraft with registration mark ZU-FOK took off from The Coves Airfield to conduct a proving flight. The Coves Airfield is situated approximately 32 kilometres (km) north of Lanseria Airport. The aircraft was iss

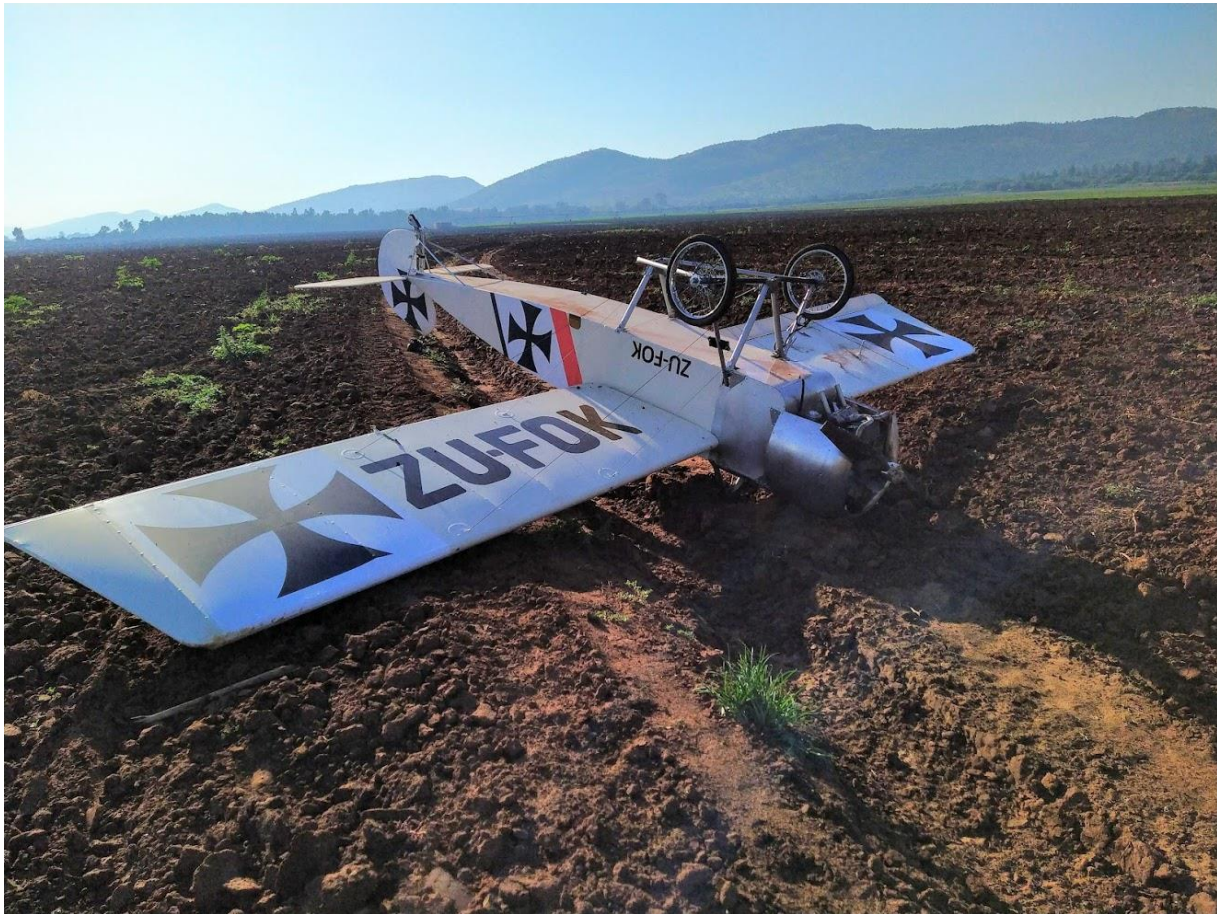
**Figure 1:** The aircraft as it came to rest. (Source: Pilot)

Investigation found that there were no anomalies with the engine and/or any other systems; and there was enough fuel for the flight on-board the aircraft.

The cause of engine failure was undetermined. The manufacturer indicated that this engine type could fail without warning at any phase of flight.

(1) It is recommended that the Director of Civil Aviation reviews the use of this engine type which contains a disclaimer that the engine may fail without warning at any phase of flight in all non-type certified aircraft (NTCA) as this poses a challenge when there is an accident or incident as a result of none accountability on the product/part by the manufacturer.
