AIRCRAFT ACCIDENT REPORT AND EXECUTIVE SUMMARY

Reference:		CA18/2/3/9964	
Aircraft Registration	ZS-CUU	Date of Accident	4 March 2021		Time of Accident	0754Z	
Type of Aircraft	Cessna 182E Skylane		Type of Operation		Private (Part 91)		
Pilot-in-command Licence Type	Commercial Pilot Licence		Age	63	Licence Valid	Yes	
Pilot-in-command Flying Experience	Total Flying Hours		1565.2		Hours on Type	850	
Last Point of Departure	Tzaneen Aerodrome (FATZ), Limpopo Province						
Next Point of Intended Landing	Nelspruit Aerodrome (FANS), Mpumalanga Province						
Damage to Aircraft	Destroyed						
Location of the accident site with reference to easily defined geographical points (GPS readings if possible)							
On the peak of Mariepskop Mountain at GPS co-ordinates determined to be S24°51'45" E30°17'62" at an elevation of 2821 feet							
Meteorological Information	Wind direction: 140,5°; Wind speed: 5 knots; Temperature: 23,4°C; Dew point: 15,3°C; Visibility: 10km; QNH:1009hPa

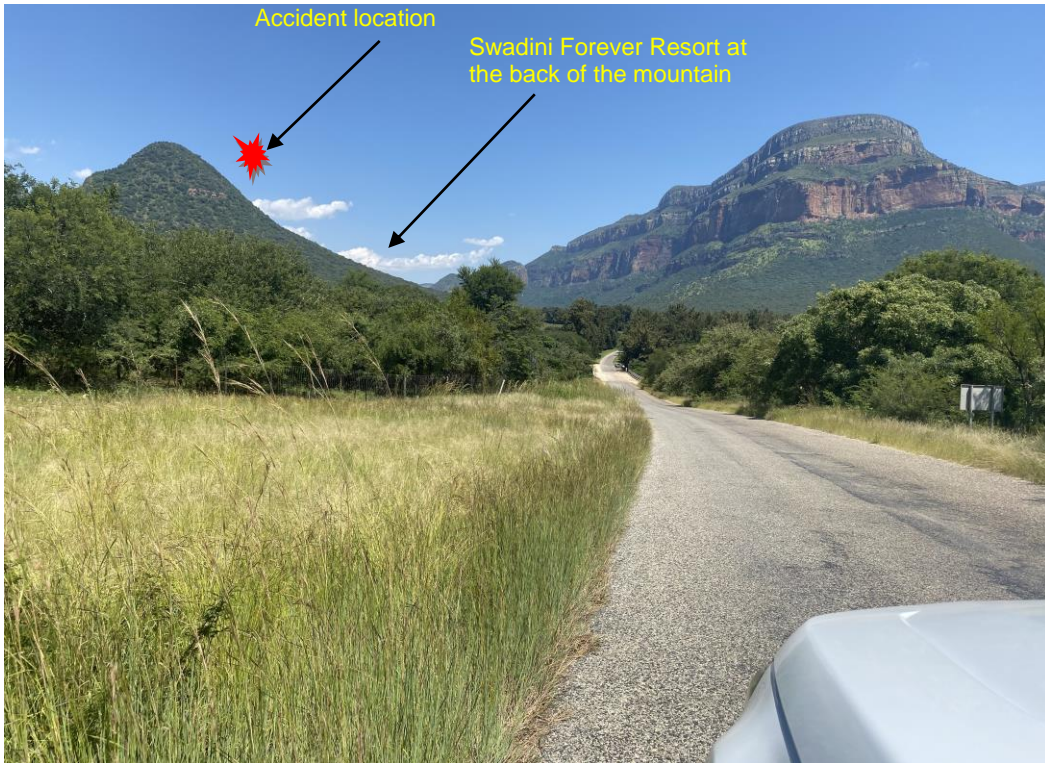
1.1.7 The accident occurred on the peak of Mariepskop Mountain at GPS co-ordinates determined to be S24°51'45" E30°17'62" at an elevation of 2821 feet.

Figure 1: The accident location and Swadini Forever Resort.

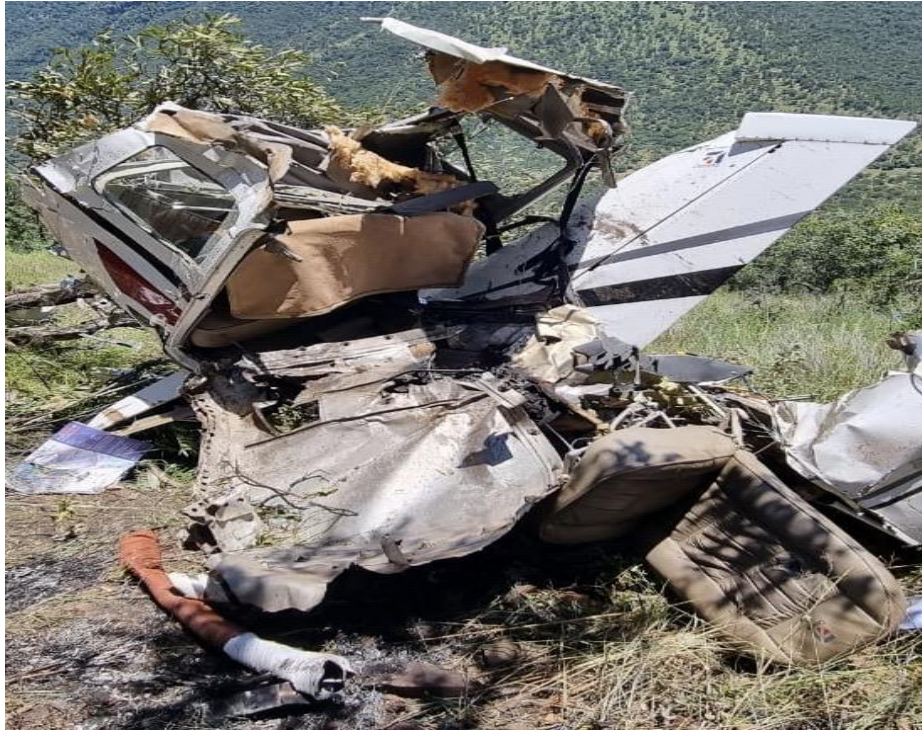
1.3.1 The aircraft was destroyed during the accident sequence.

Figure 4: The wreckage at the accident site.

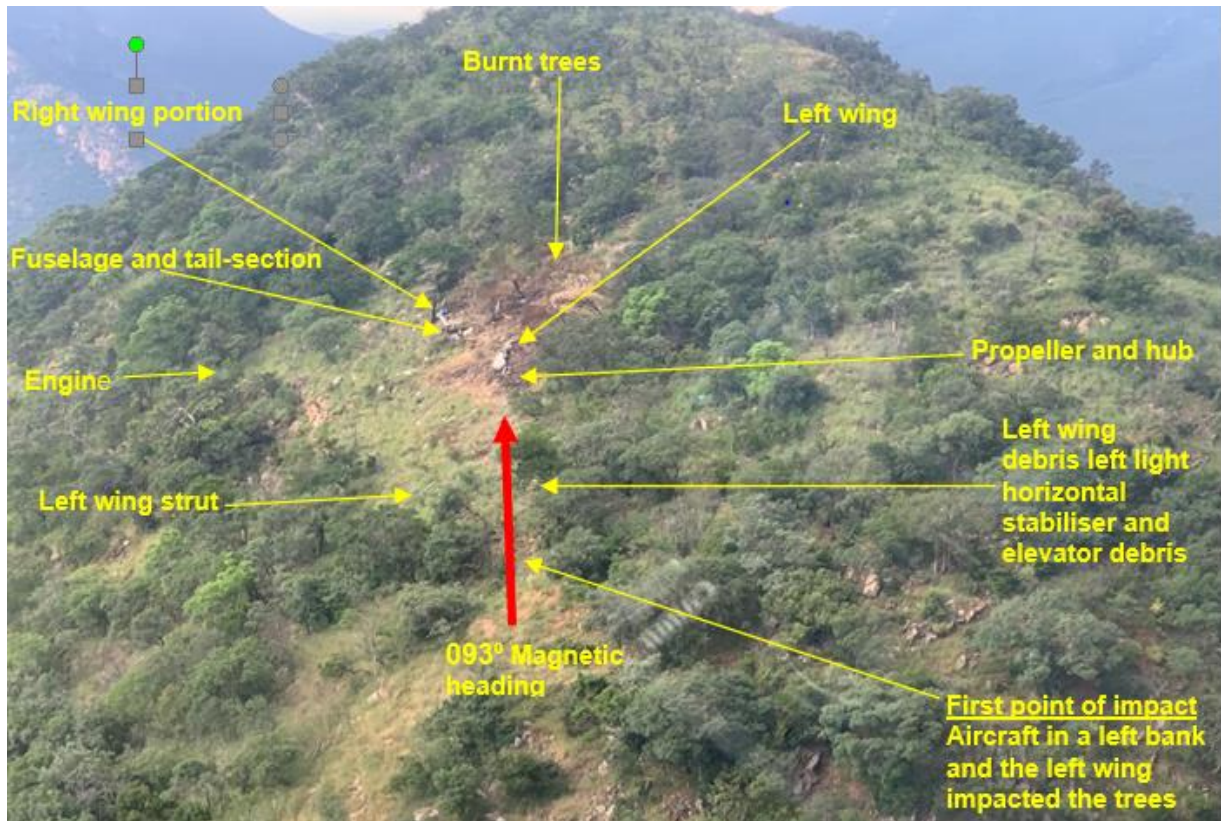
1.12.1 Examination of the accident scene showed that the aircraft impacted the mountain peak at 093° degrees Magnetic heading and in a slight nose-up attitude. The elevation of the mountain is about 3000 feet. The aircraft wreckage was distributed in a linear pattern of about 50 metres (m) in the direction of impact. The aircraft was intact on impact and no evidence of any pre-impact failures was observed. The propeller and the left main gear hit first, and the propeller separated from the engine crankshaft flange. The aircraft then spun 360°, whereupon the engine separated from the fuselage. The engine rolled downhill approximately 15m in line with the main fuselage where it came to rest in an inverted position. The cabin and the tail-section folded onto each other and were found towards the end of the wreckage trail. The pilot was ejected from the aircraft during the accident sequence and was found about 20 feet downhill from the main wreckage. The right-side seat (passenger) was found secured to the main wreckage.

1.12.2 The pilot's seat was found three metres in front and to the right of the main wreckage. The engine controls (throttle, propeller and mixture) were found fully forward.

Figure 7: Aerial view of the accident scene and wreckage distribution.

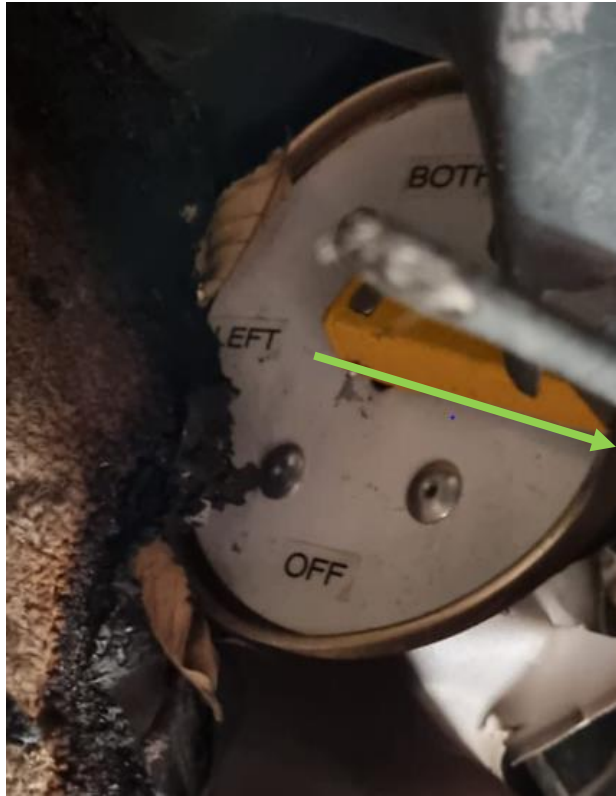
Figure 8: The fuel selector set to the right tank.

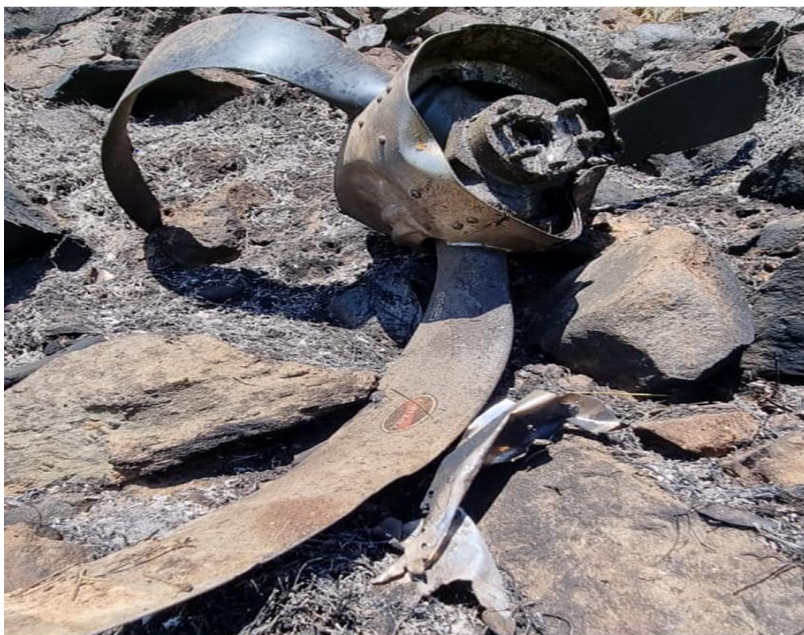
Figure 9: Fractured driveshaft and the propeller showing curled blades.

1.16.1 On-site investigation did not reveal any failure or malfunction of the engine and airframe prior to impact that might have reduced the aircraft's performance. The investigator-in-charge (IIC) did not find it necessary to conduct any tests or research on any part or component of the aircraft during the investigation. According to available aircraft documentation, no reported defects were recorded since the last maintenance inspection was certified. Examination of the propeller flange and the blades (Figure 9) indicated that the engine was producing a substantial amount of power at the time of impact.

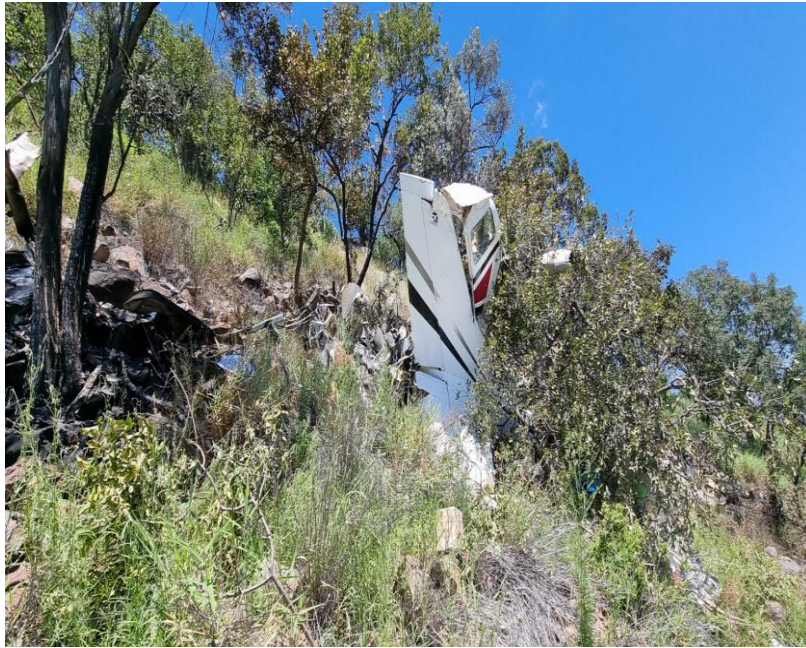
Figure 10: Close-up picture of the fuselage and tail section.

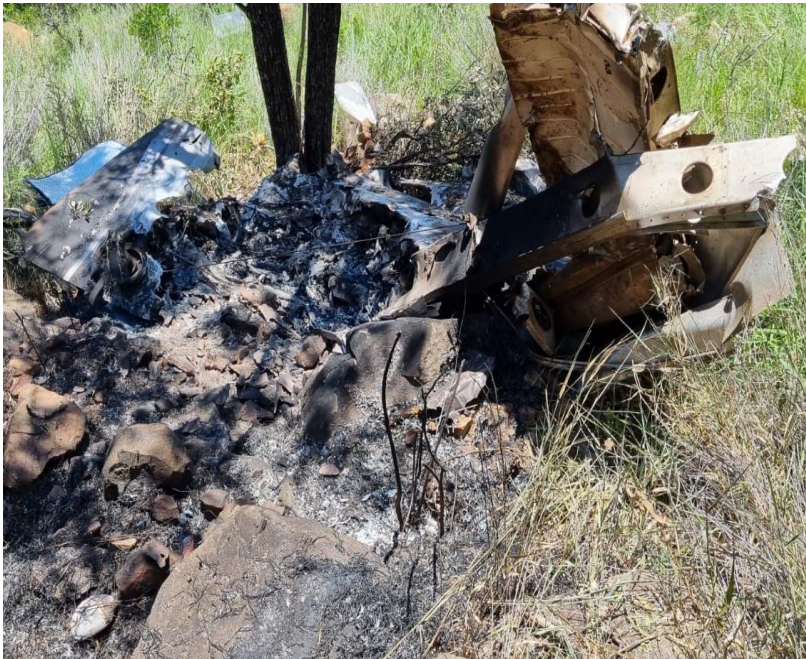
Figure 11: Close-up picture of the right wing.

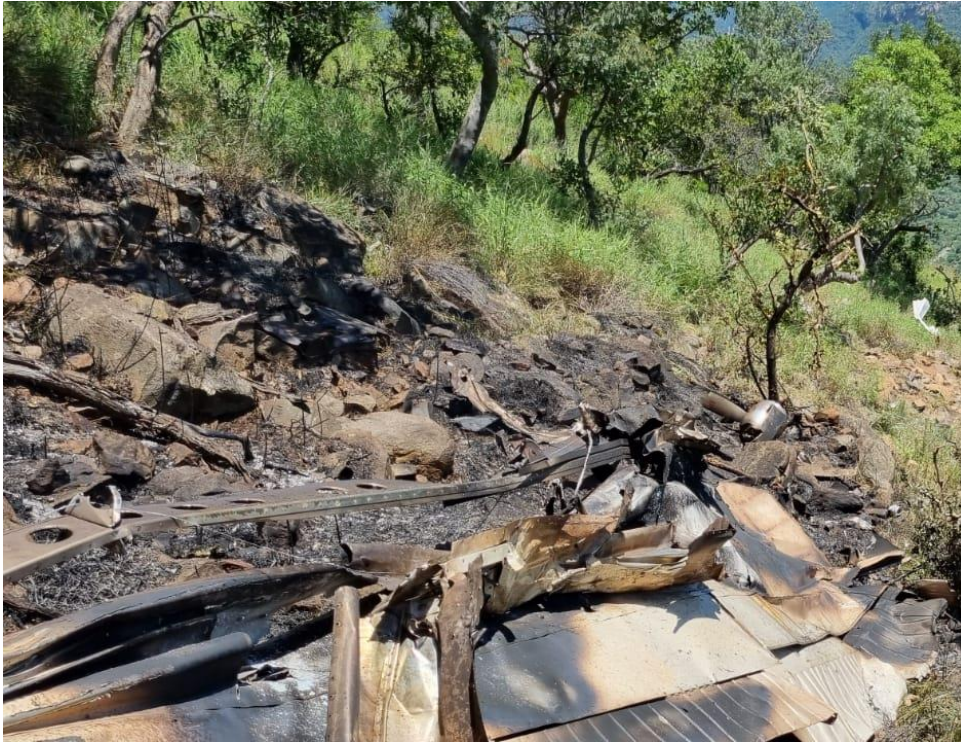
Figure 12: Close-up picture of the left wing.

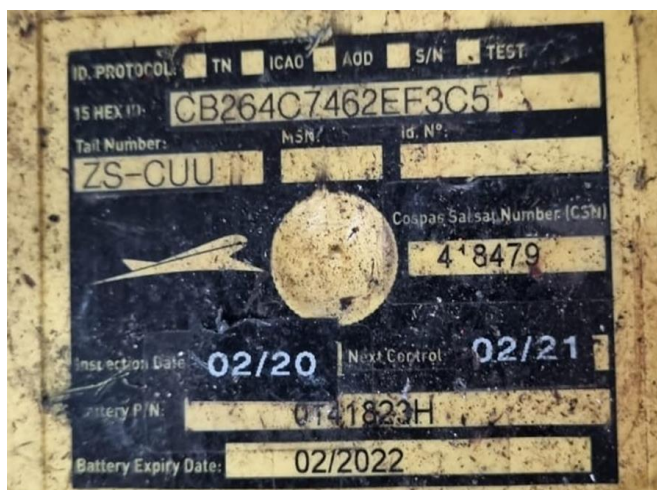
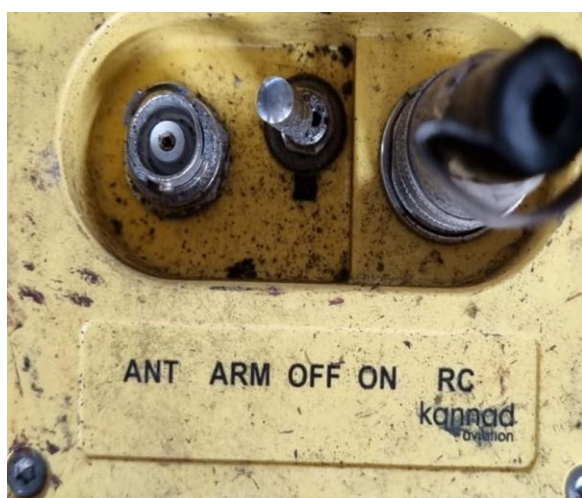
1.15.2 The aircraft was equipped with a Kannad 406-megahertz (MHz) emergency locator transmitter (ELT) part number S1840501-02, serial number KA0003438005 installed near the tail of the aircraft and was connected to an outside antenna. The ELT was installed so that the device's longitudinal axis was aligned with the aircraft's longitudinal axis. The ELT was last inspected by the aircraft maintenance organisation (AMO) during the mandatory periodic inspection (MPI) that was completed on 5 May 2020. When the on-site investigation was conducted, the ELT was found secured to its mounting position and undamaged. The ELT transmits signals on both the international civilian distress frequency 121.5 MHz as well as the military distress frequency 243.0 MHz to enable rescue teams to locate a crashed aircraft within a short period. The ARCC office in Johannesburg was consulted and it was reported that the ELT did not activate during the accident sequence.

1.15.3 The ELT was equipped with a three-position control switch labelled ON, OFF and ARM; the switch was found in the ARM position. In this position, automatic activation is supposed to occur when impact forces are sufficient. Manual activation occurs by selecting the control switch to the ON position. In this occurrence, the impact forces were severe, and the aircraft was destroyed. An impact of this nature will generally cause the shock sensor to activate the ELT automatically in the event of a crash. If the impact forces are adequate for activation but are insufficient along the ELT location (in this aircraft, the longitudinal axis), activation may not occur. The ELT was removed from the wreckage and tested, and it was determined that it was capable of functioning as designed.

Figures 13/14: The Kannad 406 ELT and the position of the switches.
