<b>AIRCRAFT ACCIDENT REPORT AND EXECUTIVE SUMMARY</b>
---

<b>Reference:</b>		CA18/2/3/9990	
<b>Aircraft Registration</b>	<b>ZS-PXI &amp; ZS-OMN</b>	<b>Date of Accident</b>	26 April 2021		<b>Time of Accident</b>	1711Z	
<b>Type of Aircraft</b>	Cessna 172M (Both Aircraft)		<b>Type of Operation</b>		Training Flights (Part 141)		
<b>Pilot-in-command Licence Type (ZS-PXI)</b>	Commercial Pilot Licence		<b>Age</b>	24	<b>Licence Valid</b>	Yes	
<b>Pilot-in-command Flying Experience (ZS-PXI)</b>	<b>Total Flying Hours</b>		685.2		<b>Hours on Type</b>	412.7	
<b>Pilot-in-command Licence Type (ZS-OMN)</b>	Commercial Pilot Licence		<b>Age</b>	31	<b>Licence Valid</b>	Yes	
<b>Pilot-in-command Flying Experience (ZS-OMN)</b>	<b>Total Flying Hours</b>		1 902.5		<b>Hours on Type</b>	1 022.9	
<b>Last Point of Departure (ZS-PXI)</b>		Lanseria International Aerodrome (FALA), Gauteng Province					
<b>Next Point of Intended Landing</b>		Lanseria International Aerodrome (FALA), Gauteng Province

**Reference number** : CA18/2/3/9990  
**Occurrence Category** : Category 1  
**Type of operation** : Training Flight (Part 141)  
**Name of operators** : Central Flying Academy and Skyhawk Aviation  
**Name of owner

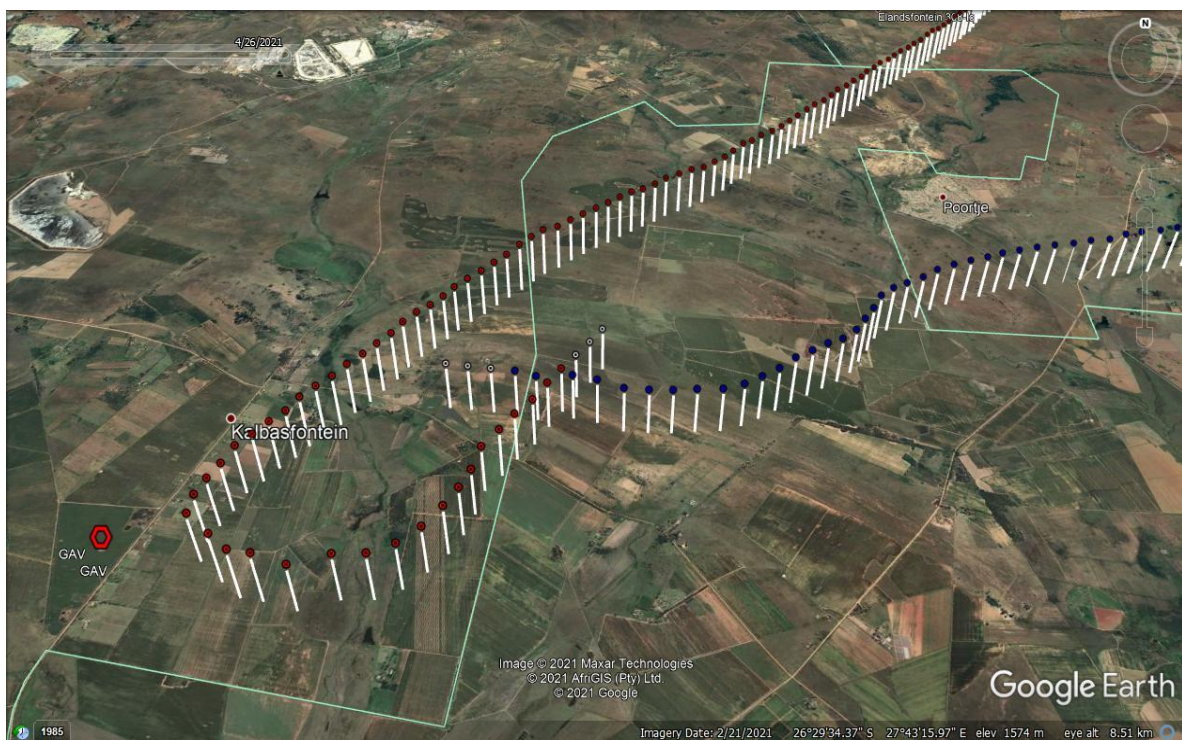
According to the Secondary Surveillance Radar (SSR), the two aircraft collided at approximately 17:11:29Z and about 1.4 nautical miles (nm) north-east of the GAV beacon at an altitude of 6 700 feet (ft). There were no witnesses to this accident. The two student pilots and the two instructors on-board both aircraft were fatally injured. Both aircraft were destroyed during the accident sequence.

**Figure 1:** Radar data showing the ZS-PXI path in red dotted track; and ZS-OMN path in blue dotted track. (Source: ATNS)

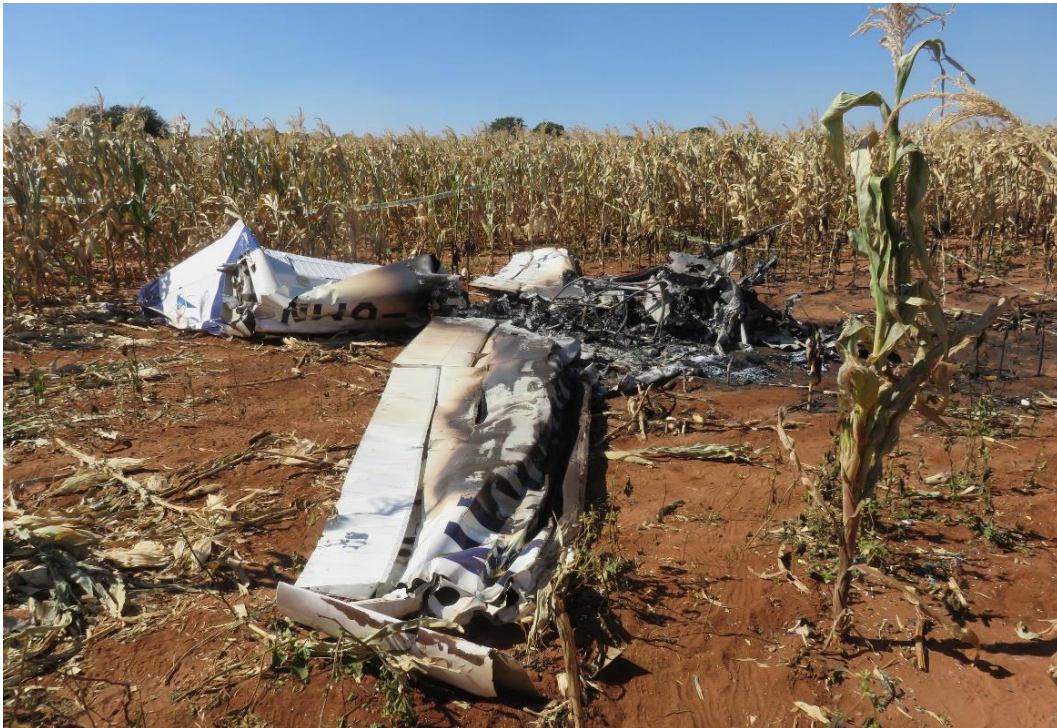
1.3.1 The ZS-OMN aircraft was destroyed by impact forces and the post-impact fuel-fed fire.

**Figure 3:** The wreckage of the ZS-OMN aircraft as it came to rest in an inverted attitude.

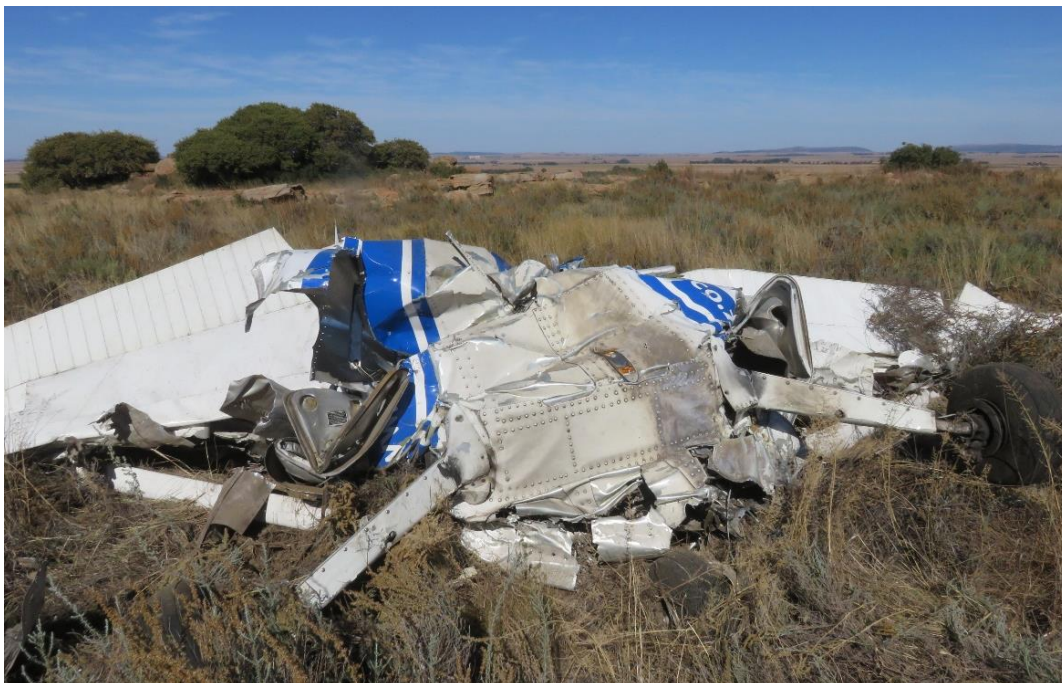
1.3.2 The ZS-PXI aircraft was also destroyed when it impacted a rocky terrain in a steep nose-down attitude.

**Figure 4:** The wreckage of the ZS-PXI as it came to rest.

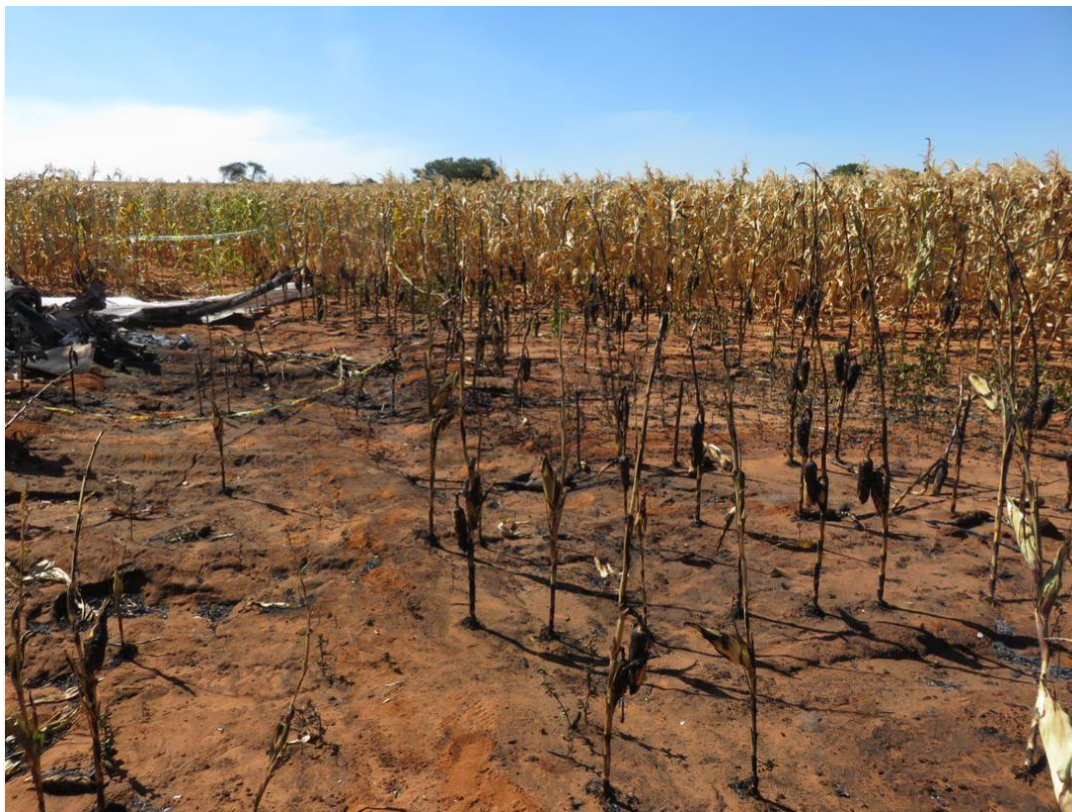
1.4.1 A section of the maize crop field on which the ZS-OMN aircraft crashed was destroyed by post-impact fuel-fed fire.

**Figure 5:** Some of the maize crops that were destroyed by the post-impact fire.

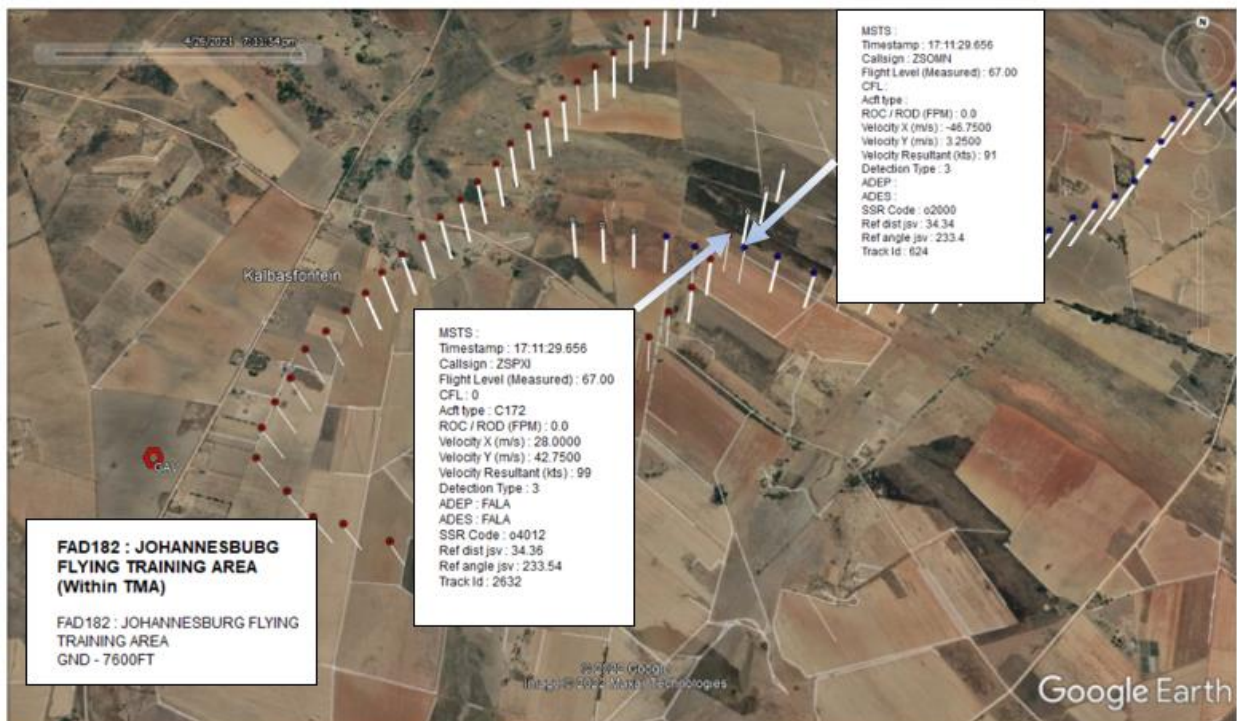
1.12.1 At approximately 17:11:29Z, the left wing of the ZS-PXI aircraft collided with the left aft fuselage of the ZS-OMN, which caused the entire left horizontal stabiliser and elevator assembly to break off. The ZS-PXI was flying a heading of 030° and the ZS-OMN was at a heading of 250°, and both aircraft were at an altitude of 6 700ft (see Figure 18).

**Figure 8:** Point of collision from the Radar data. Both aircraft's altitude was 6700ft. (Source: ATNS)

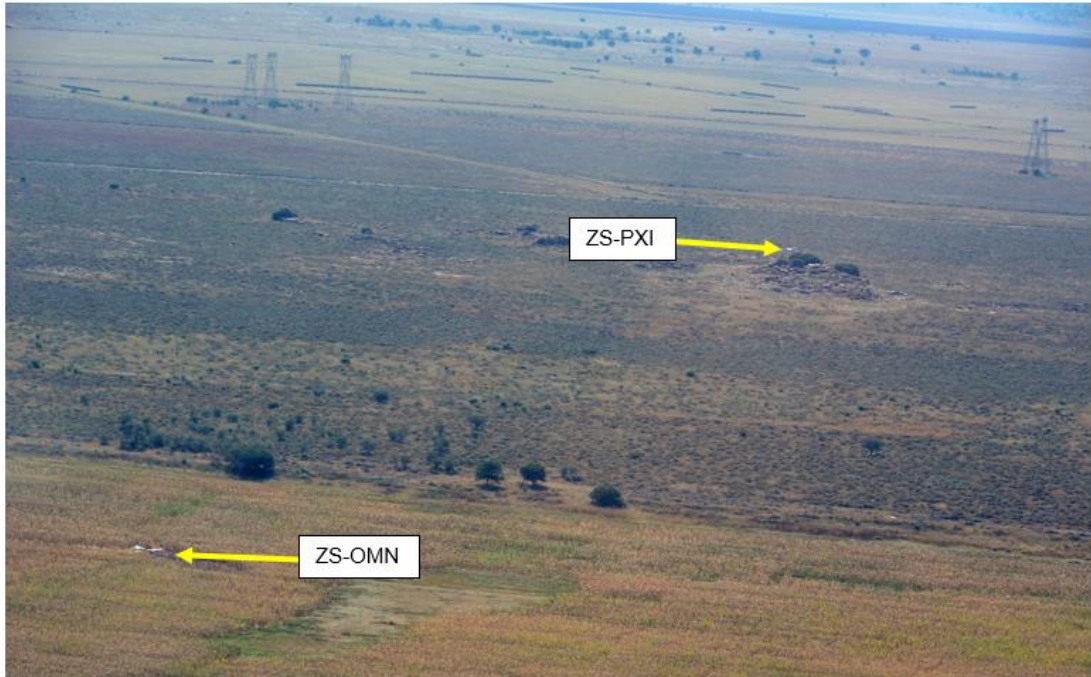
1.12.2 Following the mid-air collision, the ZS-PXI travelled approximately 600 metres (m) horizontally before impacting terrain in a steep nose-down attitude on an open field, while the ZS-OMN crashed in a maize field.

**Figure 9:** An aerial view indicating the two wreckages.

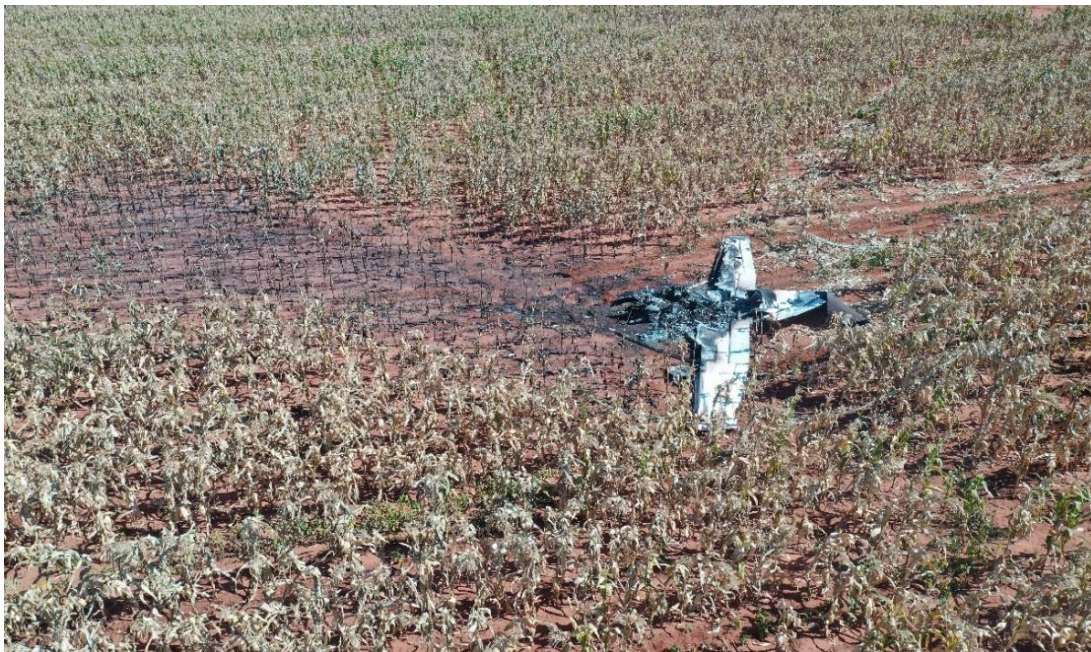
**Figure 10:** An aerial picture of the wreckage of the ZS-OMN aircraft.

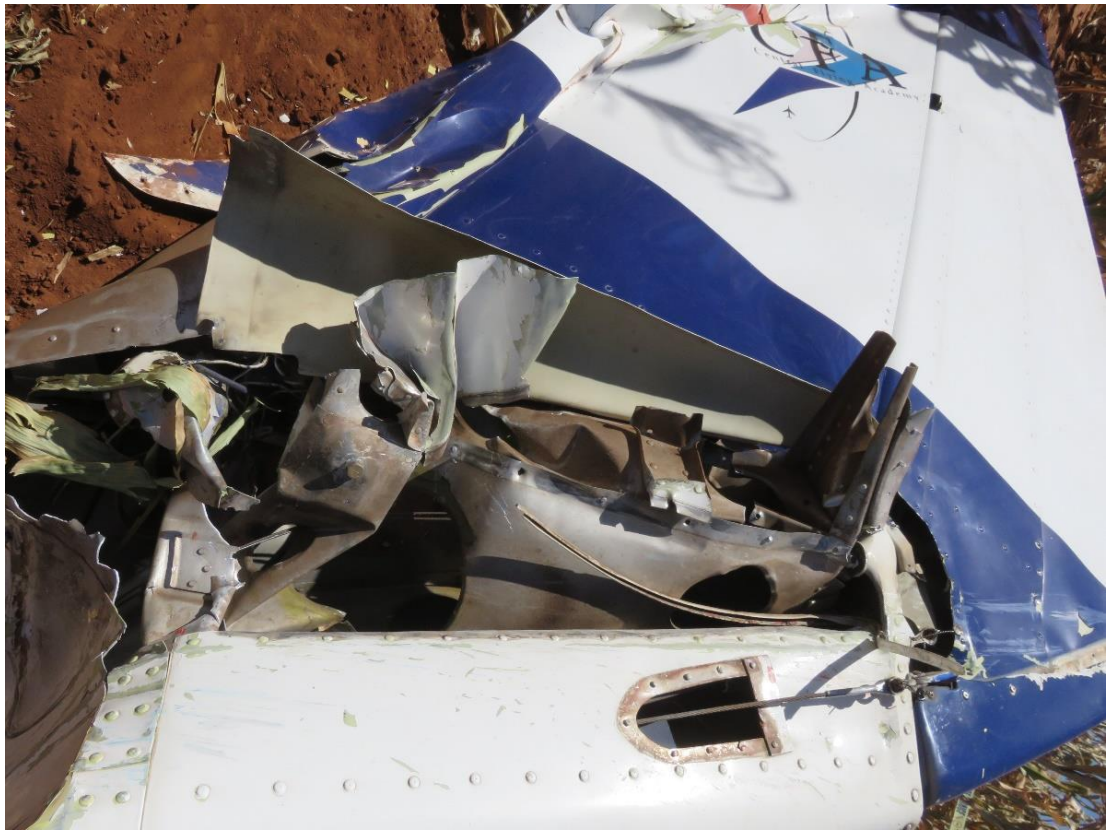
1.12.3 The left-side wing tip of the ZS-PXI severed the left-side horizontal stabiliser of the ZS-OMN.

**Figure 11:** The empennage of the ZS-OMN displaying the hardware deformation where the left horizontal stabiliser was installed.

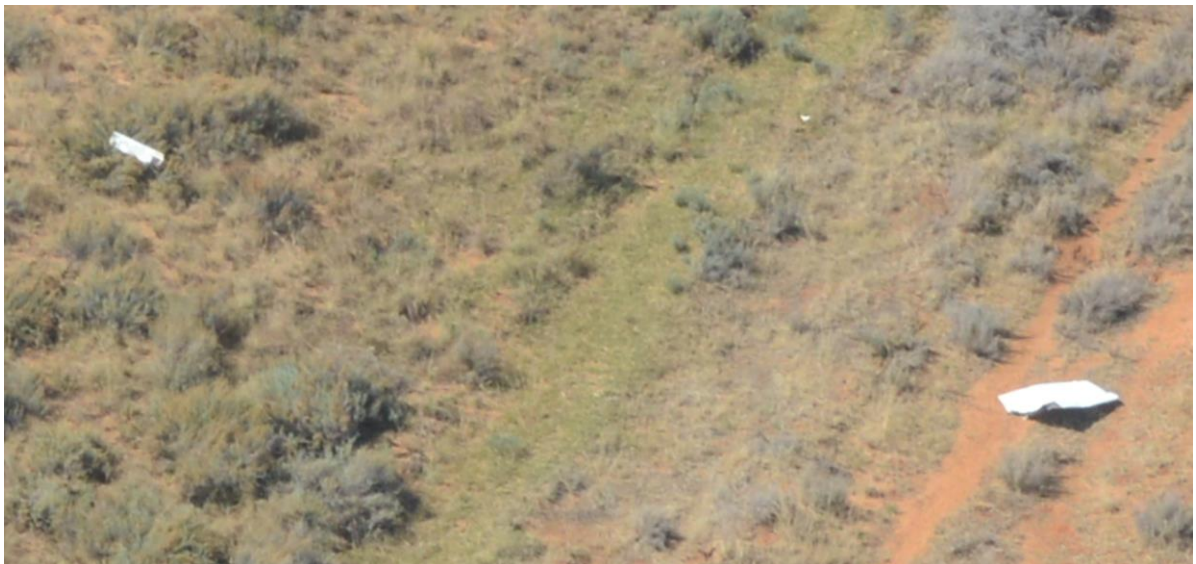
1.12.4 The entire left horizontal stabiliser of the ZS-OMN aircraft with the elevator still attached was located 155m towards the north of the main wreckage impact point.

1.12.5 The left-wing tip fairing of the ZS-PXI aircraft was located approximately 15m from the ZS-OMN left horizontal stabiliser.

**Figure 12:** The left ZS-PXI left-wing tip fairing on the left of the picture, and the ZS-OMN horizontal stabiliser on the right of the picture.

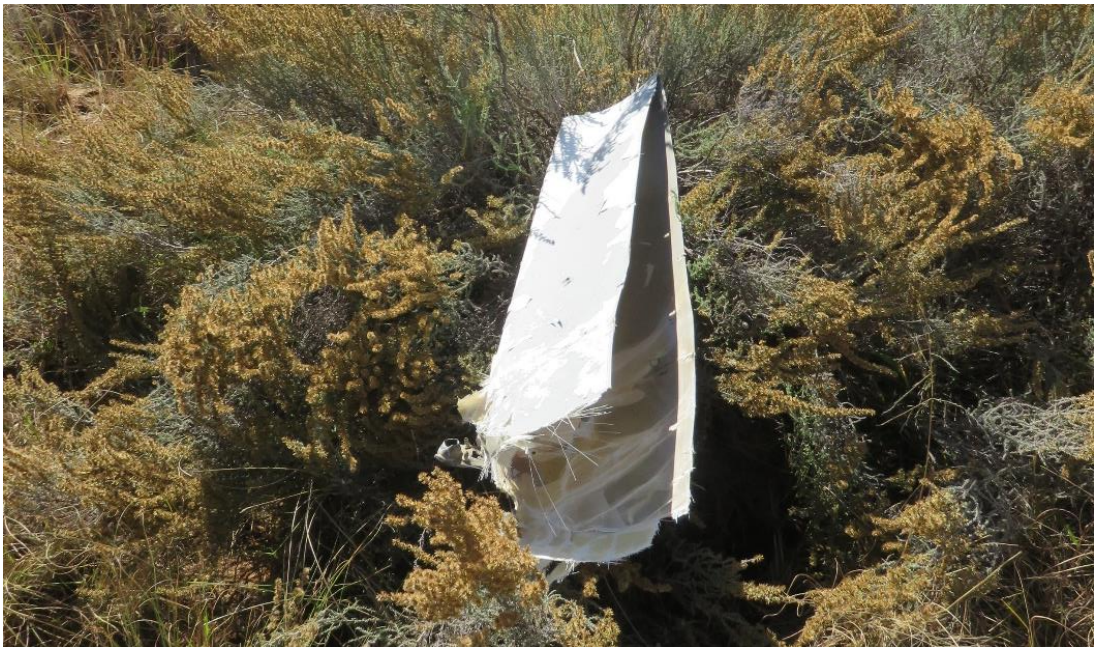
**Figure 13:** The left-wing tip fairing of the ZS-PXI aircraft.

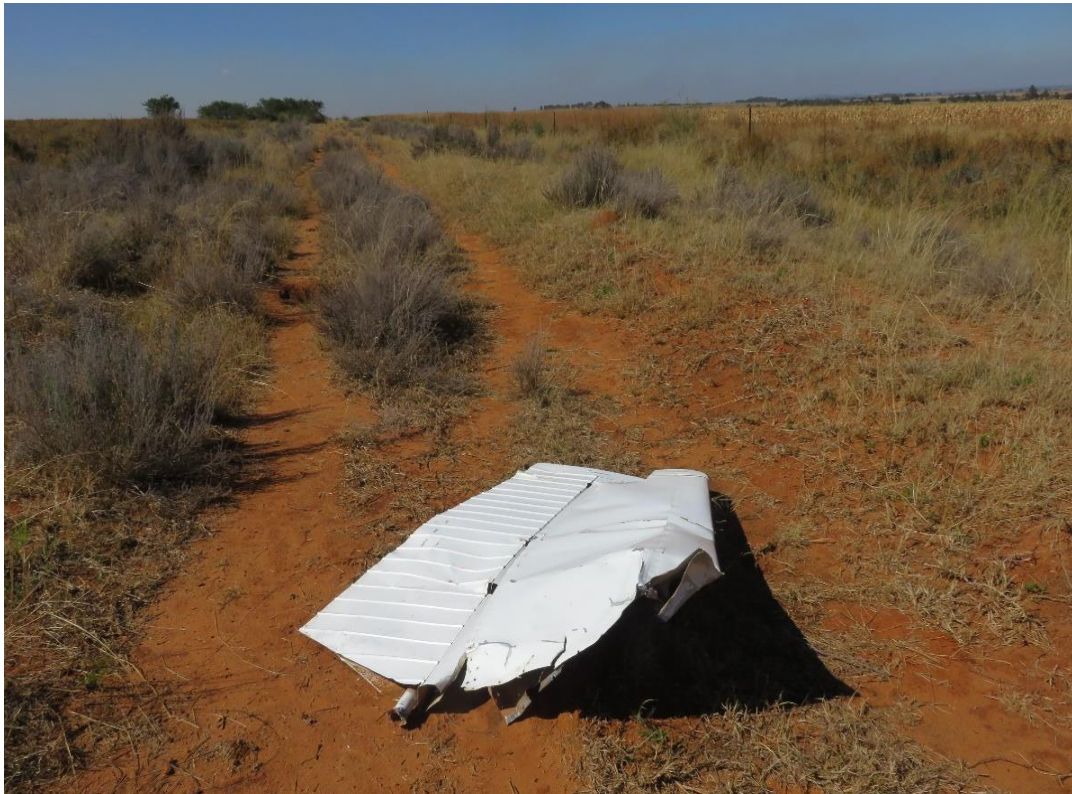
**Figure 14:** The left horizontal stabiliser and elevator of the ZS-OMN aircraft.

- 3.2.25 It was noted that the left vertical stabiliser and the elevator had separated from the aircraft and were located approximately 155m from the main wreckage of the ZS-OMN aircraft.

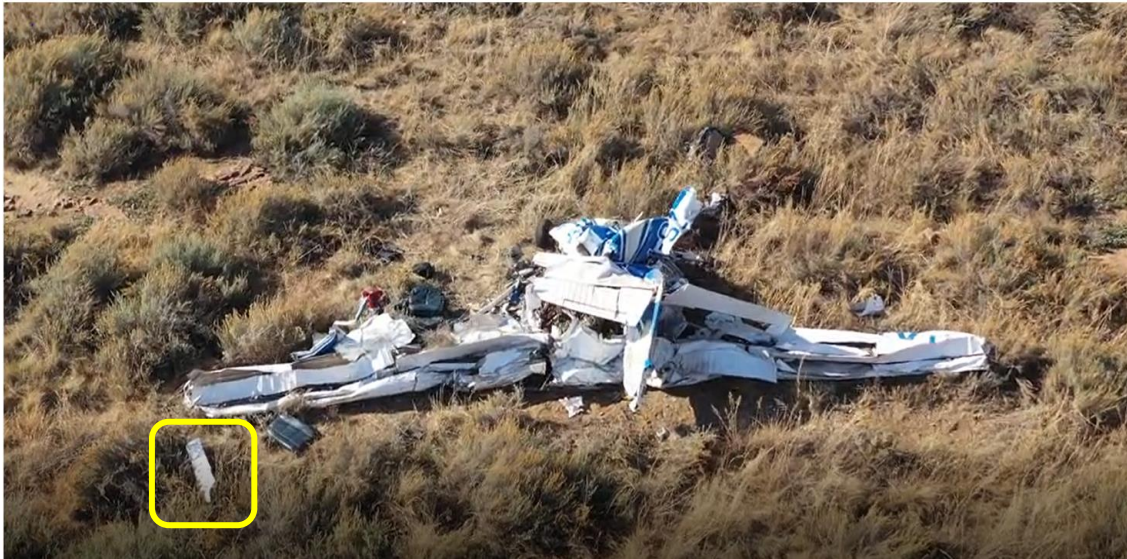
1.12.6 The right-wing tip fairing of the ZS-PXI aircraft was located next to the wreckage.

**Figure 15:** The ZS-PXI wreckage with the right-wing tip next to it in the yellow window.

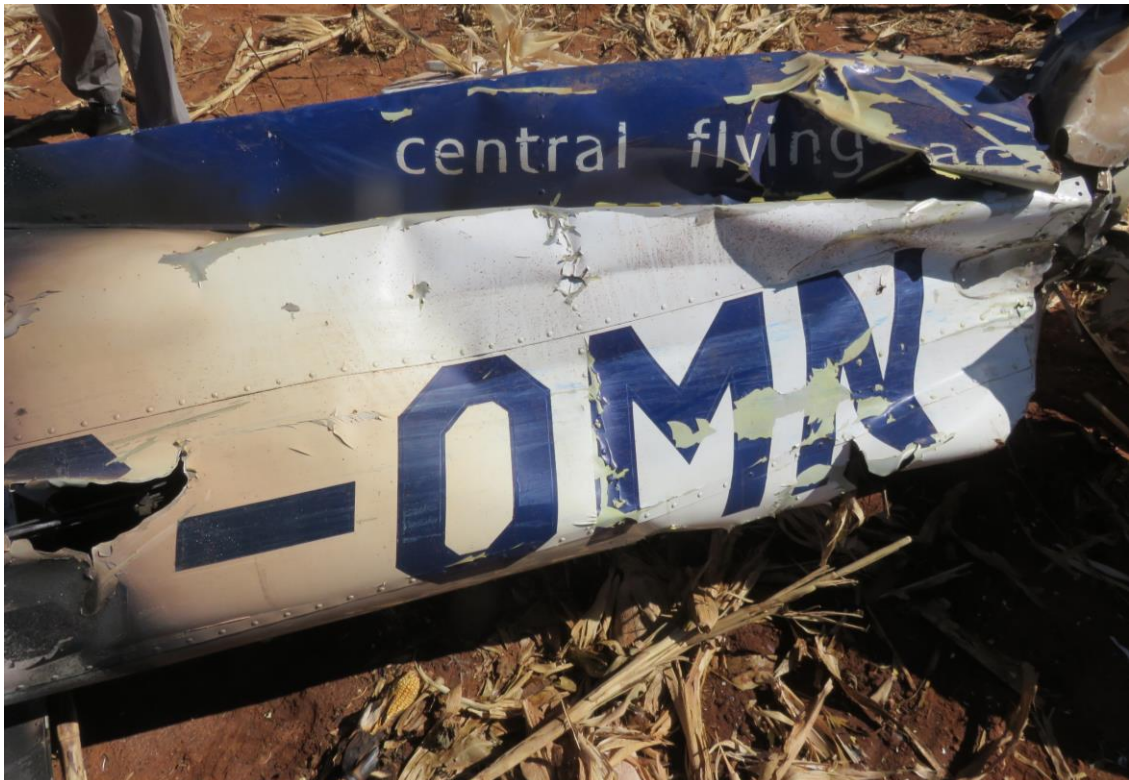
1.12.7 Figures 16 and 17 confirm that the left-wing leading edge of the ZS-PXI impacted the aft fuselage of the ZS-OMN in a wings level attitude. During the impact sequence, the left horizontal stabiliser of the ZS-OMN was severed from the fuselage, which compromised the entire aft structural integrity of the aircraft. During reconstruction of the ZS-OMN aircraft, the left horizontal assembly was recovered and placed in position (see Figure 18).

**Figure 16:** The impact markings caused by the left-wing leading edge of the ZS-PXI on the left aft fuselage of the ZS-OMN.

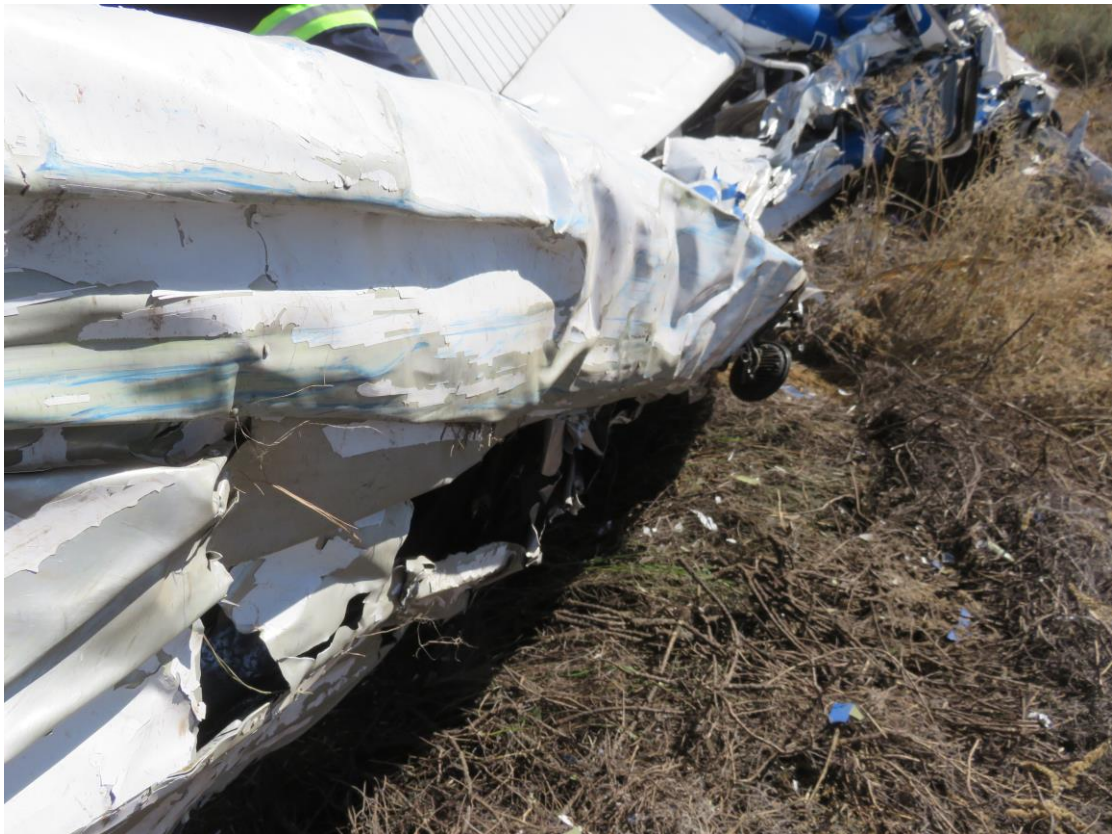
**Figure 17:** The compressed left-wing leading edge of the ZS-PXI that impacted the ZS-OMN, leaving traces of the blue paint of the registration mark on it.

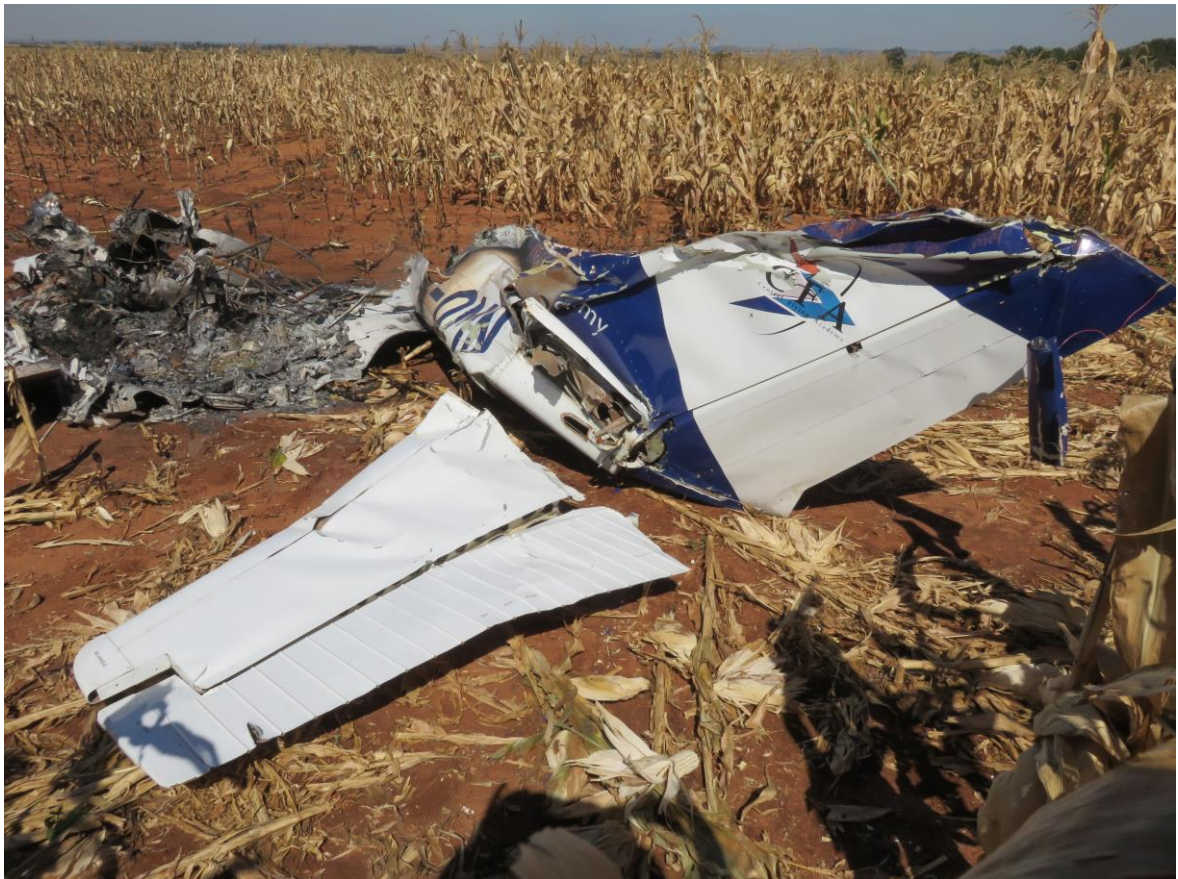
**Figure 18:** The left horizontal stabiliser was recovered and placed in position during reconstruction.

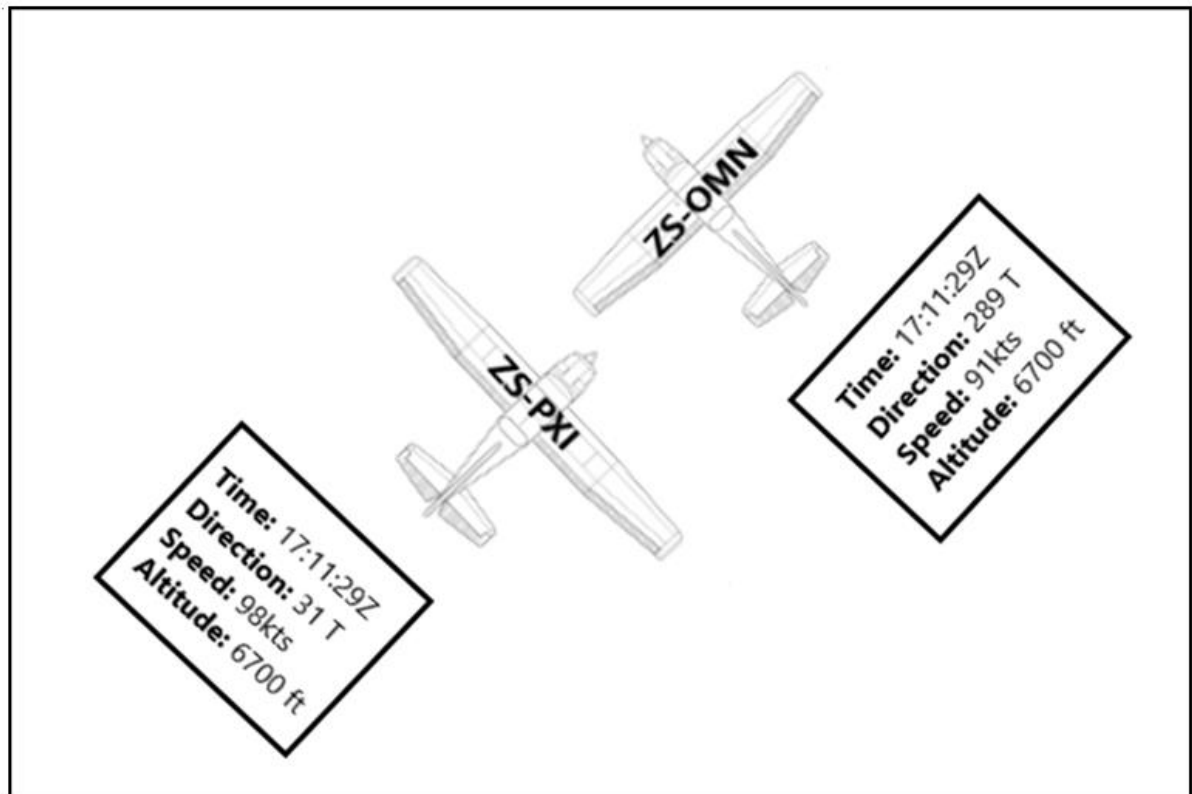
the hood or wearing goggles. However, with the flight instructor sitting on the right-side of the aircraft, it was difficult for him to see the ZS-PXI aircraft which approached from the left. It is also possible that the instructor was engaged with the student pilot's training and did not lookout for any traffic at that stage of the flight. The flight instructor of the ZS-PXI aircraft was reminded by another pilot (ZS-CPL) who was also airborne at the time from the same ATO that they should change their frequency to 122.35 MHz (FAD 182 frequency). The ZS-CPL pilot heard the MAYDAY call on frequency 125.80 MHz, which indicated that the crew of ZS-PXI did not change the frequency as advised earlier.

**Figure 20:** Aircraft position seconds before impact at 6 700ft.

It is likely that the crew of the ZS-PXI aircraft were occupied with navigational requirements of routing to their waypoint FAGC and did not see the ZS-OMN aircraft. At approximately 17:11:29Z, the time of impact, the ZS-OMN was positioned in level flight heading in a westerly direction when the left wing of the ZS-PXI impacted the left aft fuselage of the ZS-OMN.
