LIMITED ACCIDENT INVESTIGATION REPORT

Reference Number	CA18/2/3/9991						
Classification	Accident	Date	1 May 2021	Time	1148Z		
Type of Operation	Training (Part 141)						
Location							
Place of Departure	Port Alfred Aerodrome (FAPA), Eastern Cape Province			Place of Intended Landing	Port Alfred Aerodrome (FAPA), Eastern Cape Province		
Place of Occurrence	FAPA Runway 25						
GPS Co-ordinates	Latitude	33°33'20" S	Longitude	026°53'00" E	Elevation	315 ft	
Aircraft Information							
Registration	ZS-PBV						
Model/Make	Piper Seneca II PA 34						
Damage to Aircraft	Minor			Total Aircraft Hours	9474		
Pilot-in-command							
Licence Type	Airline Pilot Licence (Aeroplane)			Gender	Male	Age	22
Licence Valid	Yes						
Total Hours on Type	184.9			Total Flying Hours	1767.9		
People On-board	1 + 1	Injuries	0	Fatalities	0	Other	0
What Happened							
<p>On Saturday, 1 May 2021, an instructor and a student pilot were conducting circuit training on a Piper Seneca (PA34) with registration ZS-PBV at Port Alfred Aerodrome (FAPA) in the Eastern Cape province. The flight was conducted in visual meteorological conditions by day and under the provisions of Part 141 of the Civil Aviation Regulatio

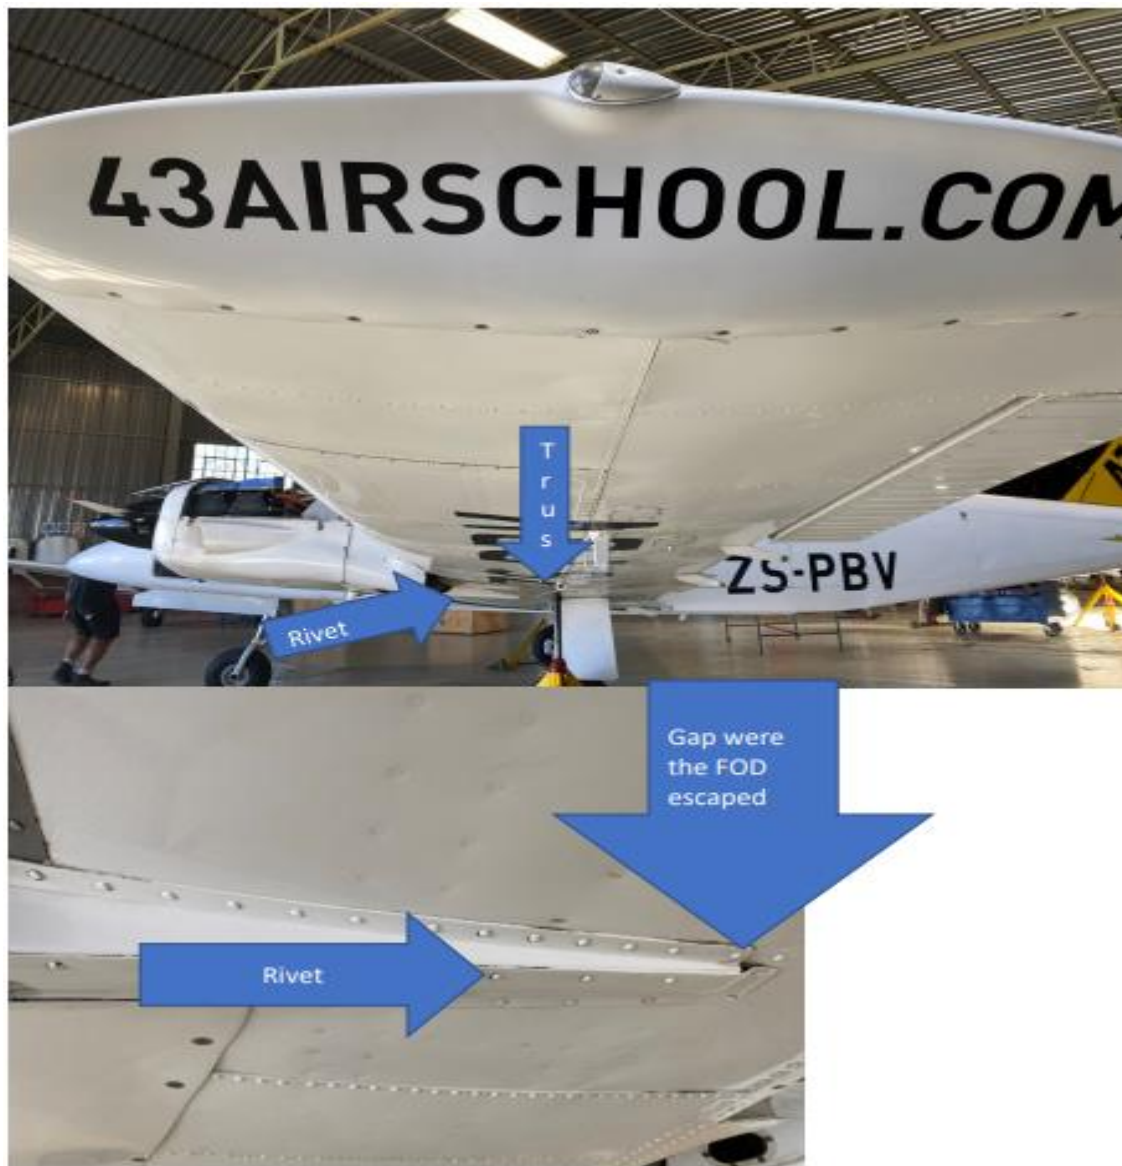
Figures 1 (top) and 2 (bottom): The left underwing showing the place where the rivet detached/loosen.

The rivet (FOD) was removed, and the dislodged rivet in the left main landing gear was replaced and, thereafter, the landing gear was tested for serviceability as per the Piper Maintenance Manual 753-817 revision dated 30 November 2019.

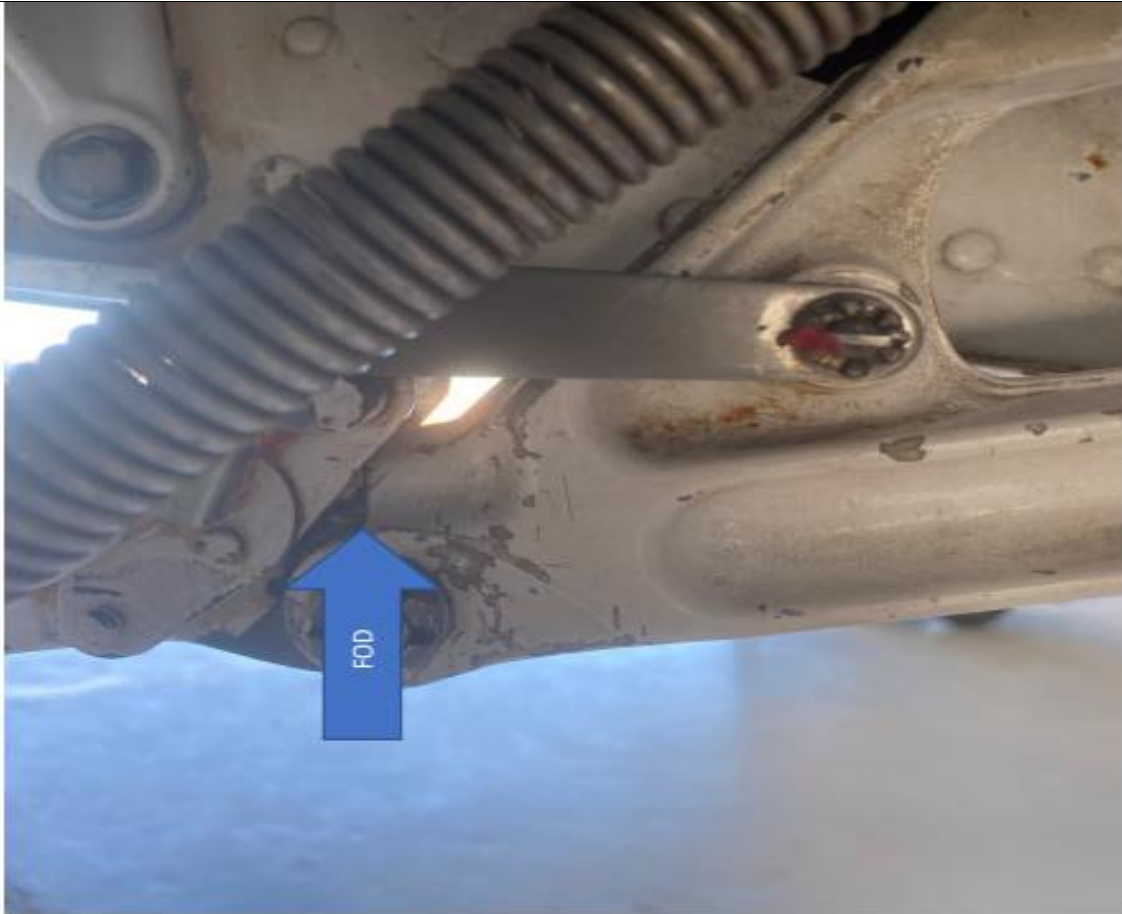
Post-accident inspection of the left main gear conducted by the aircraft maintenance organisation (AMO) revealed a foreign object debris (FOD) in the form of a CherryMAX rivet that was stuck in the grease between the two machined faces of the truss and the link assembly, preventing the gear down lock to engage. It is likely that the rivet (FOD) had dislodged from the nacelle and found its way into the left main gear. The dislodged rivet was replaced, and the landing gear was tested for serviceability as per the Piper Maintenance Manual 753-817 revision dated 30 November 2019.

Figure 3: An arrow indicates where the FOD was stuck on the left-side main gear.

The left gear down lock mechanism had a FOD in the form of a rivet stuck in the grease between the machined faces of the truss and the link assembly, preventing the down lock from engaging. This led to a gear collapse during landing roll.
