LIMITED ACCIDENT INVESTIGATION REPORT

Reference Number	CA18/2/3/9994						
Classification	Accident	Date	3 May 2021	Time	1155Z		
Type of Operation	Private (Part 91)						
Location							
Place of Departure	Ithala Game Lodge Airstrip, KwaZulu-Natal Province		Place of Intended Landing	Wonderboom Airport (FAWB), Gauteng Province			
Place of Accident	Runway 29 at Wonderboom Airport (FAWB) Gauteng Province						
GPS Co-ordinates	Latitude	S 25°39'13"	Longitude	E 028°13'40"	Elevation	4091 feet	
Aircraft Information							
Registration	ZS-NVE						
Model/Make	Cessna 402C						
Damage to Aircraft	Substantial		Total Aircraft Hours	12 410			
Pilot-in-command							
Licence Valid	Yes	Gender	Male	Age	26		
Licence Type	Commercial Pilot Licence (Aeroplane)						
Total Hours on Type	177.1		Total Flying Hours	1 491.4			
People On-board	1 + 0	Injuries	0	Fatalities	0	Other	0
What Happened							
<p>On 3 May 2021 at approximately 1045Z, the pilot on-board a Cessna 402C aircraft with registration ZS-NVE was repositioning the aircraft from Ithala Lodge Airstrip to Wonderboom Airport (FAWB). The flight was conducted under Instrument Flight Rules (IFR) by day.</p> <p>According to the pilot, the flight fro

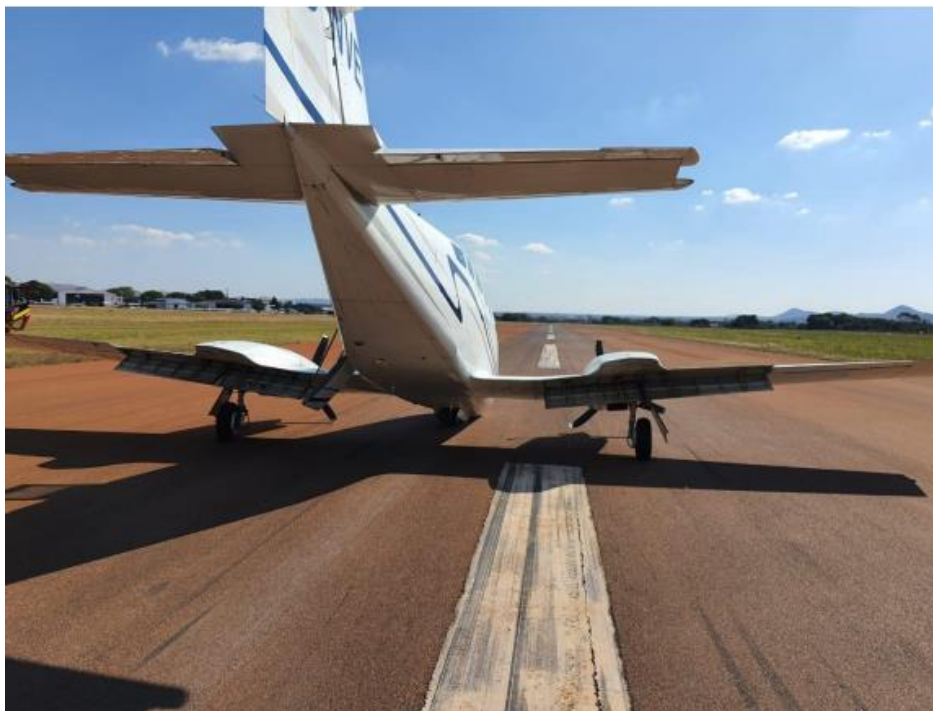
threshold, the nose landing gear collapsed and the aircraft subsequently stopped in the middle of the runway.

The aircraft sustained damages to the nose cone, nose gear doors, pitot tube and both the left and right engine propeller blade tips. The pilot did not sustain any injuries during the accident.

Figure 1: Aft view of the aircraft's final position. (Source: Pilot)

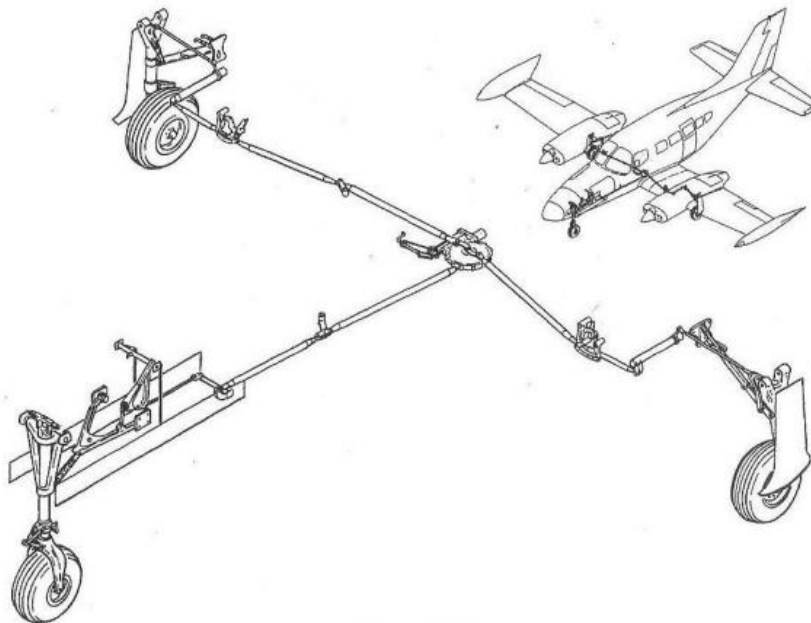
Diagram 1: Landing gear system.

During ground operation, accidental gear retraction, regardless of gear switch position, is prevented by a safety switch located on the left landing gear shock strut. When the weight of the airplane is on the landing gear, the shock strut is compressed, allowing the safety switch to open, thus preventing electrical power from reaching the landing gear motor.

The landing gear doors are mechanically linked to their respective landing gears, retracting and extending with each landing gear.

The landing gear is operated by a switch which is identified by a wheel-shaped knob. The switch positions are up, off (centre) and down. To operate the the gear, pull out the landing gear switch and move to the desired position. This allows the electrical power to energise the landing gear motor, bring the landing gear toward the selected position. The motor will continue to run until the up or down limit switch on the gear box disconnects the electrical power to the landing gear motor.
