**PRELIMINARY ACCIDENT REPORT**

**Accident and Incident Investigations Division**

Accident  
- Preliminary Report -  
AIID Ref No: CA18/2/3/10054

On Wednesday morning, 13 October 2021 at 0518Z, a Bombardier BD-700-1A10 aircraft with registration 9H-VJM was involved in an accident when the crew was taxiing through the Echo security gate at O.R. Tambo International Aerodrome (FAOR). As the aircraft approached the gate, the (motorised) gate had already started to close and it impacted the right-wing leading-edge slat of the aircraft, causing substantial damage to the number 2 slat. This was an international non-scheduled flight from FAOR to Dubai International Aerodrome (OMBD).

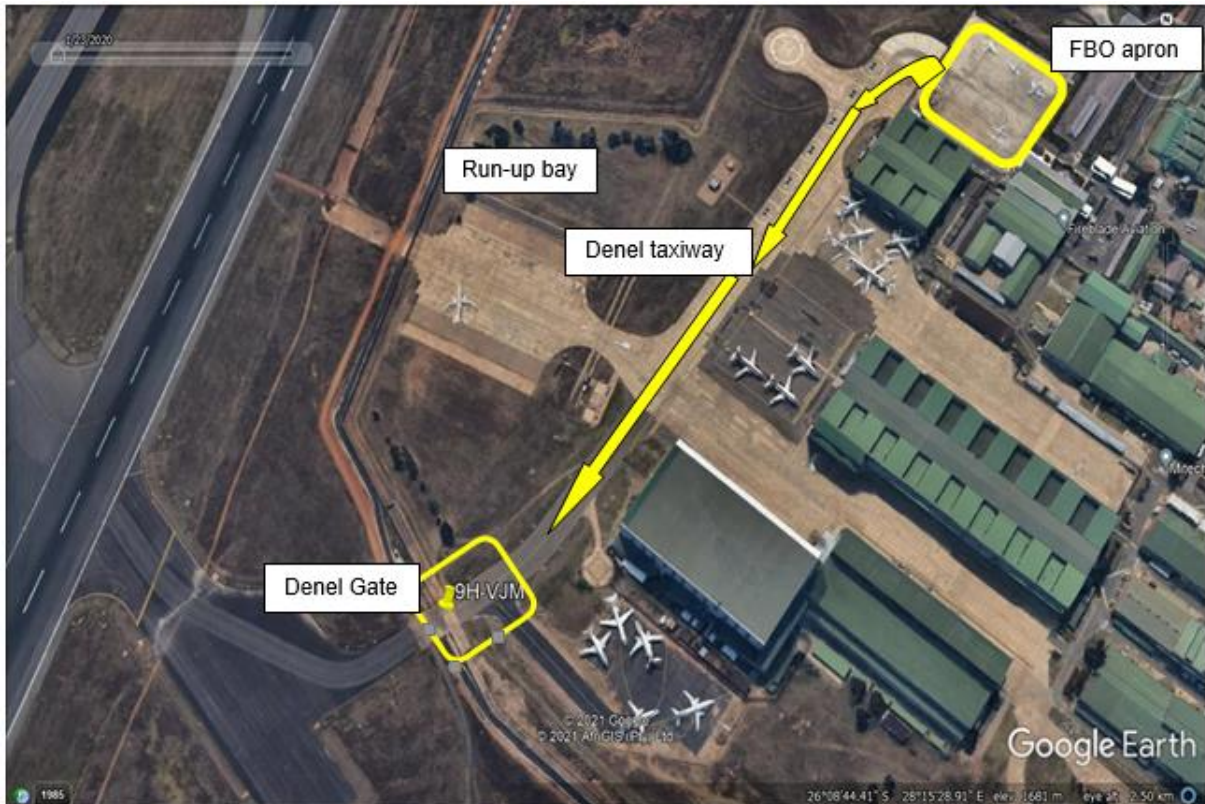
**Figure 2:** The yellow pin (9H-VJM) indicates the point of impact with the gate. (Source: Google Earth)

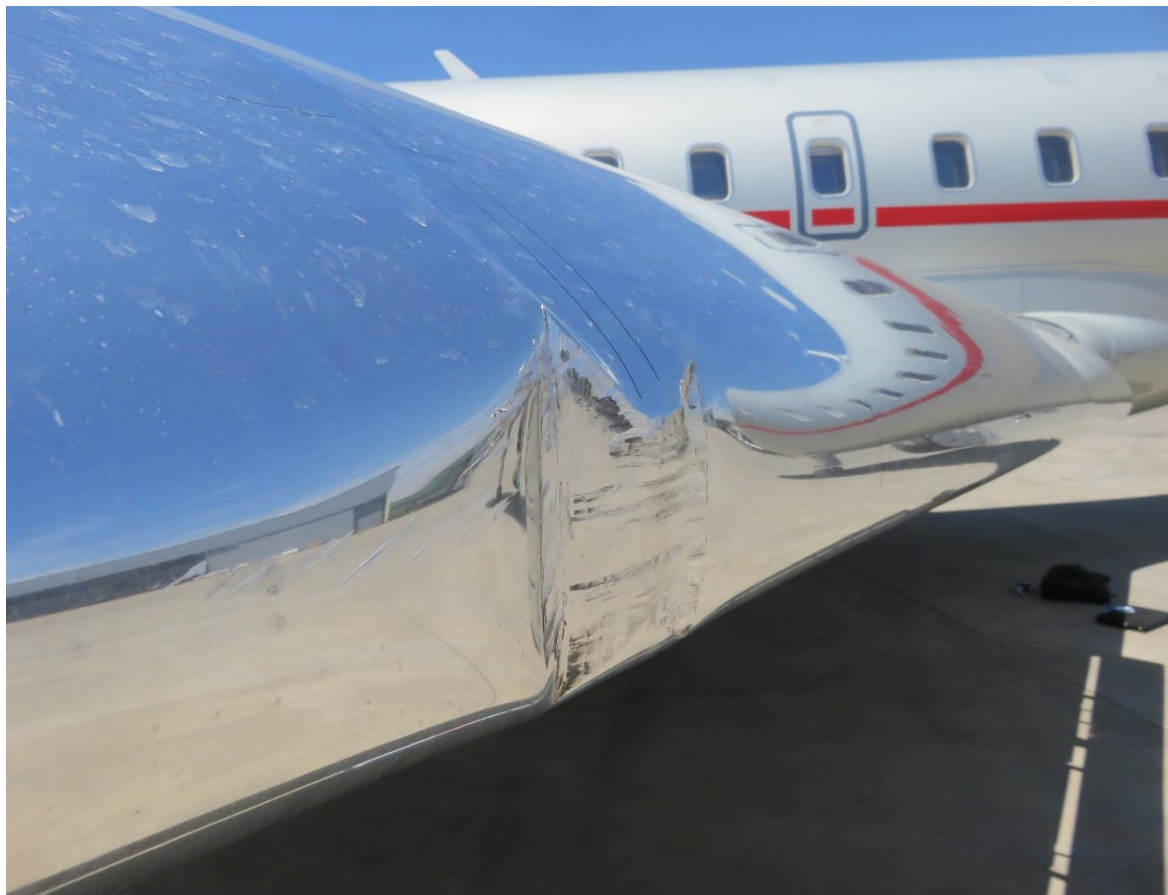
1.3.1 The number 2 leading edge slat on the right wing was substantially damaged.

**Figure 3:** Deformation of the number 2 leading edge slat on the right wing.

2.2.10 The number 2 leading edge slat on the right wing was substantially damaged and had to be replaced.

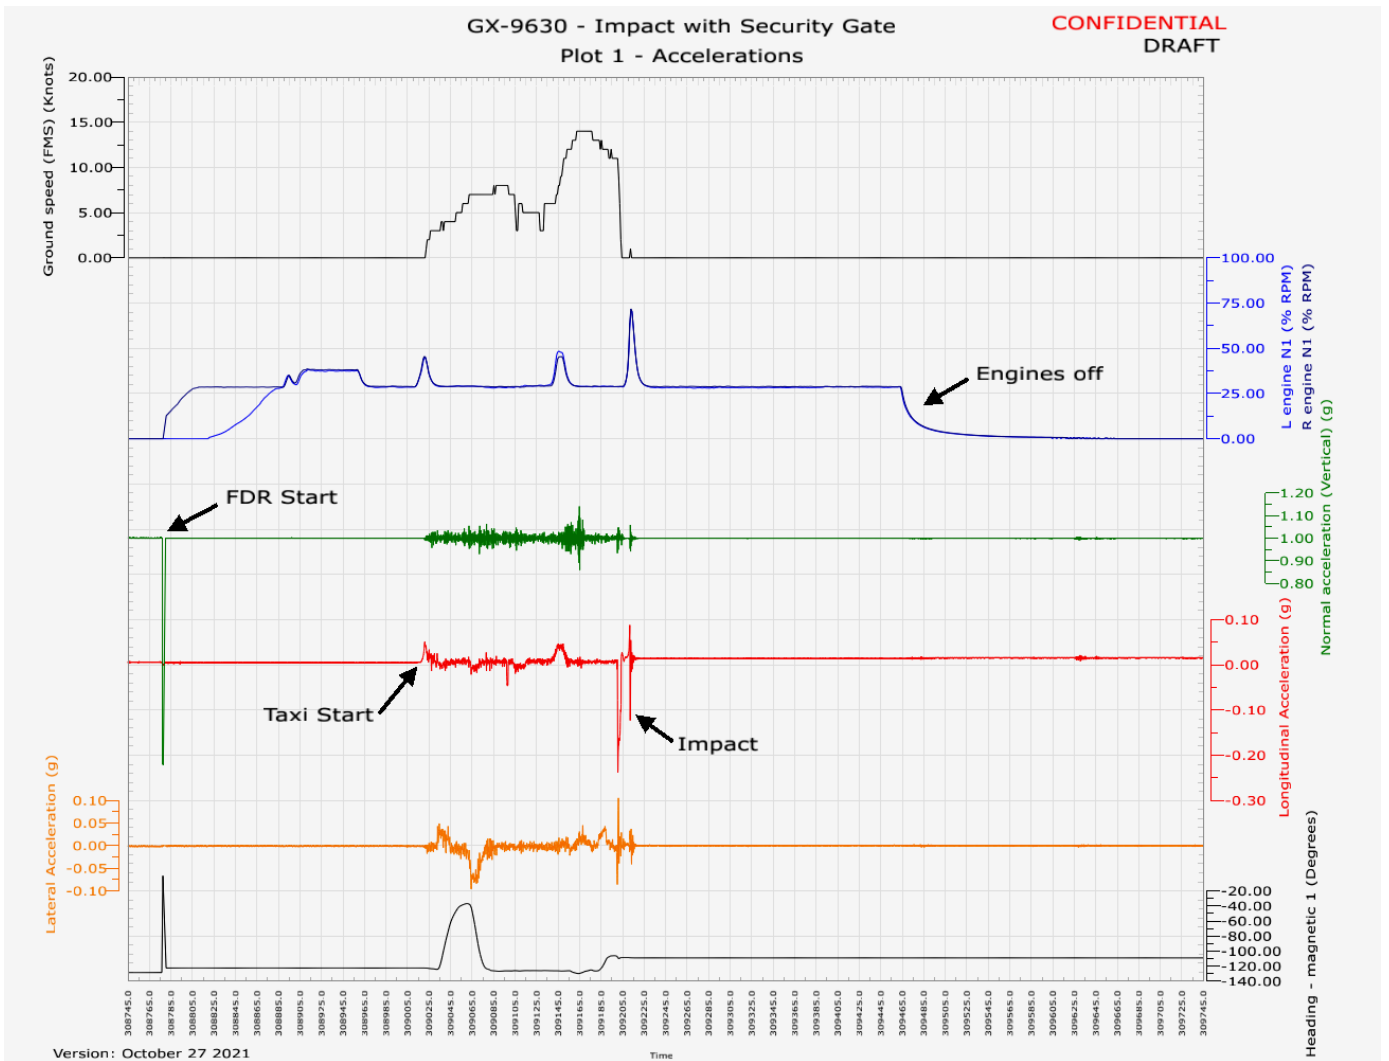
- 1.11.5 The FDR parameters downloaded showed that the aircraft and all its systems was serviceable at the time and could not have contributed or have caused the accident. The FDR data graph (below) displays no abnormalities with the operation of the aircraft.

**Graph 1:** The FDR data shows no abnormalities with the operation of the aircraft.

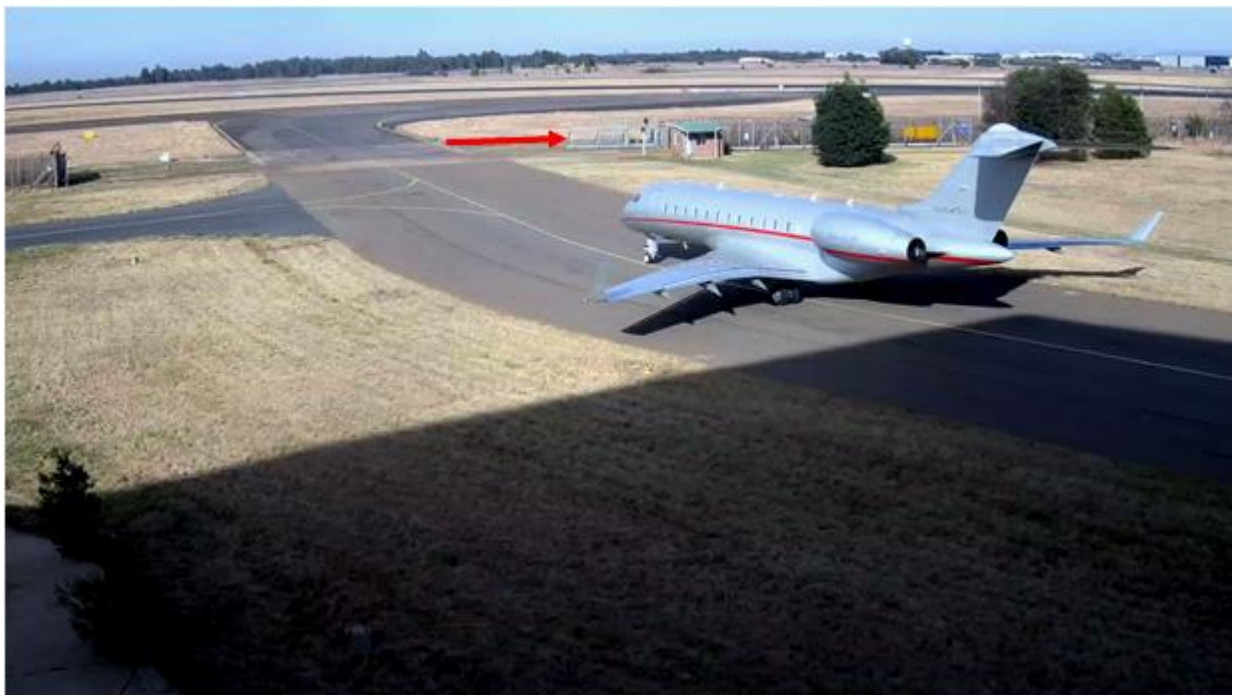
**Figure 6:** In this screenshot, the VJT850 aircraft approaches the gate, which had already started to close.

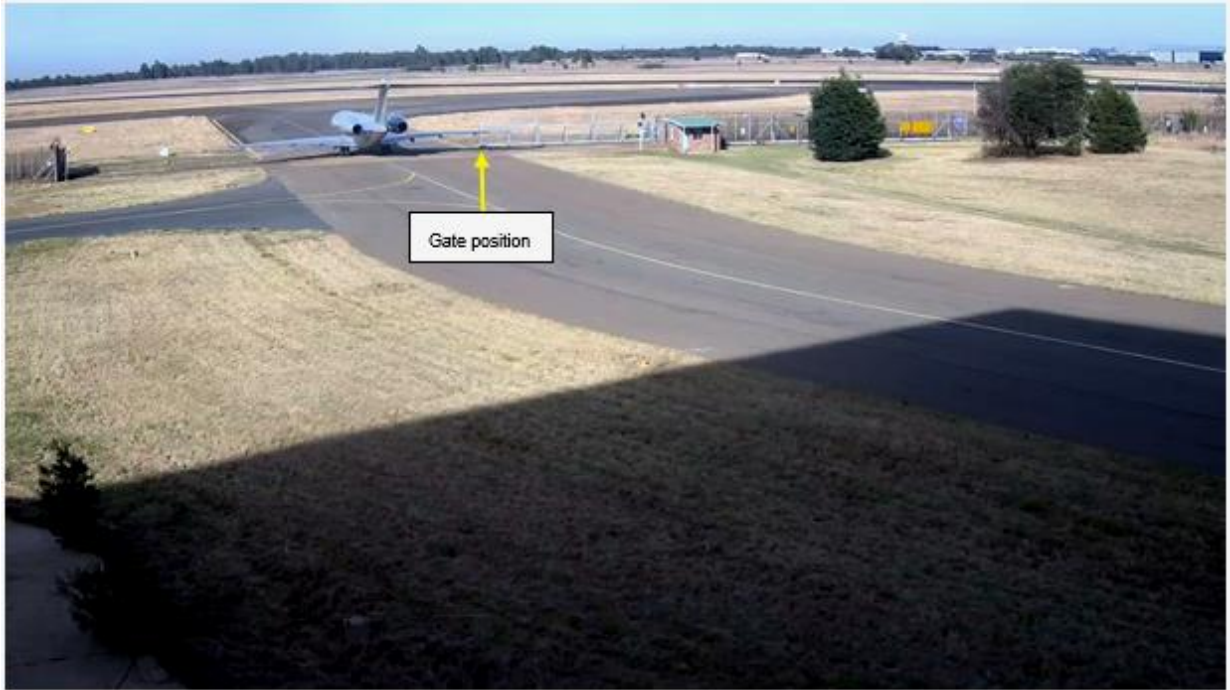
1.12.1 The aircraft was taxied from the FBO apron area (where it was parked) to the Echo gate. As the aircraft approached the motorised gate, the gate had already started to close. The last phase of taxi was captured on CCTV footage; four screenshots were taken (see Figures 5, 6, 7 and 8) which illustrate the sequence of events as the gate impacted the aircraft. Figure 9 (picture) was taken by the first responders to the accident scene; it illustrates the position of the gate relative to the damage on the leading edge slat, which was deployed to 20° as required for take-off.

**Figure 7:** In this screenshot, the VJT850 aircraft's right wing makes contact with the gate.

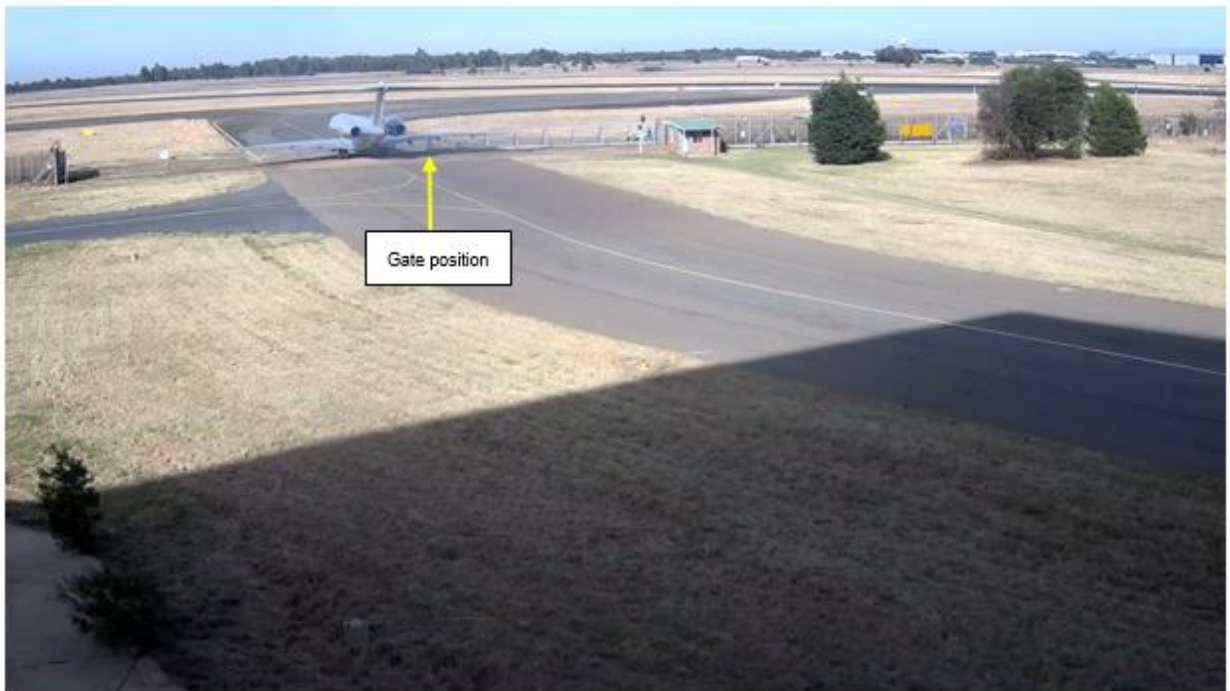
**Figure 8:** In this screenshot, the gate stops moving, which was 11 seconds after first contact with the right wing.

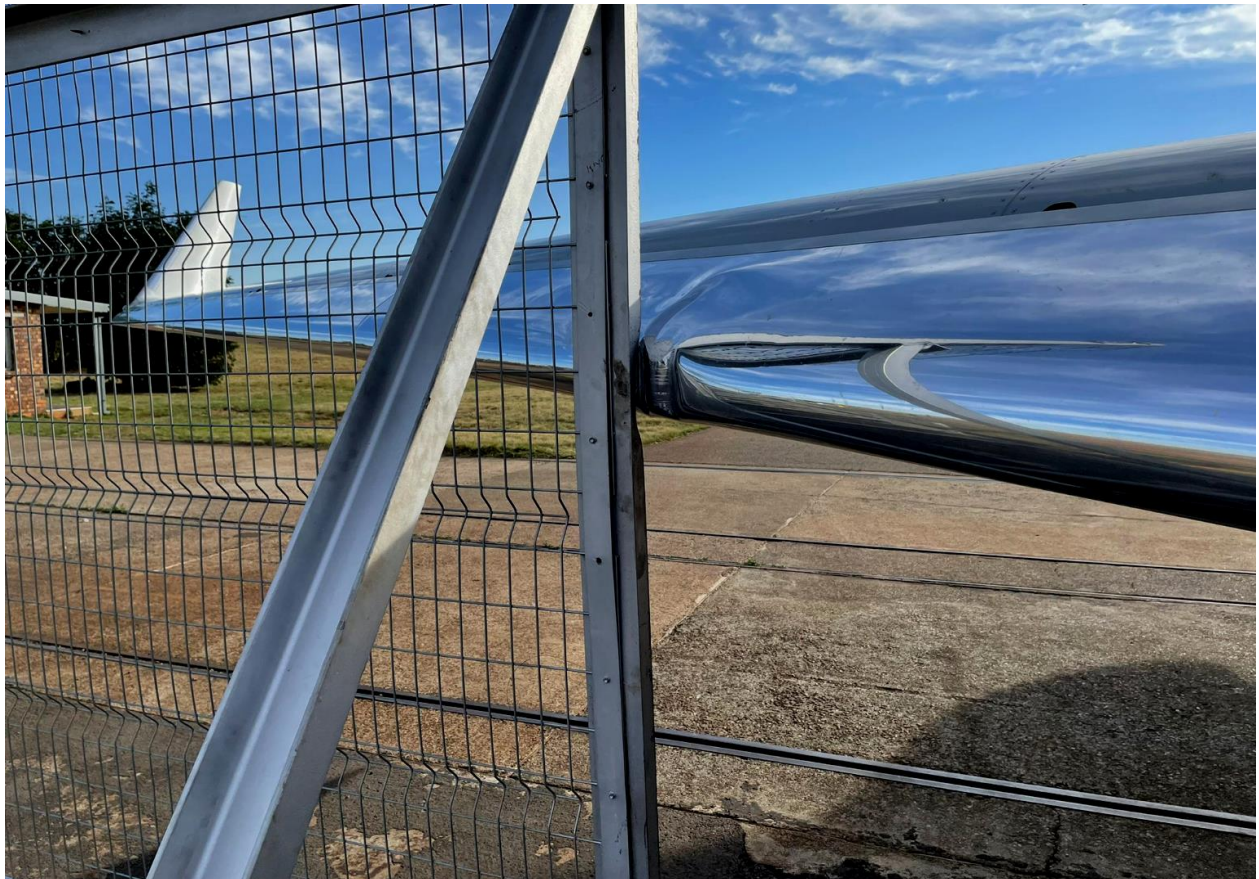
**Figure 9:** The gate whilst in contact with the leading-edge slat. (Source: Fireblade Aviation)

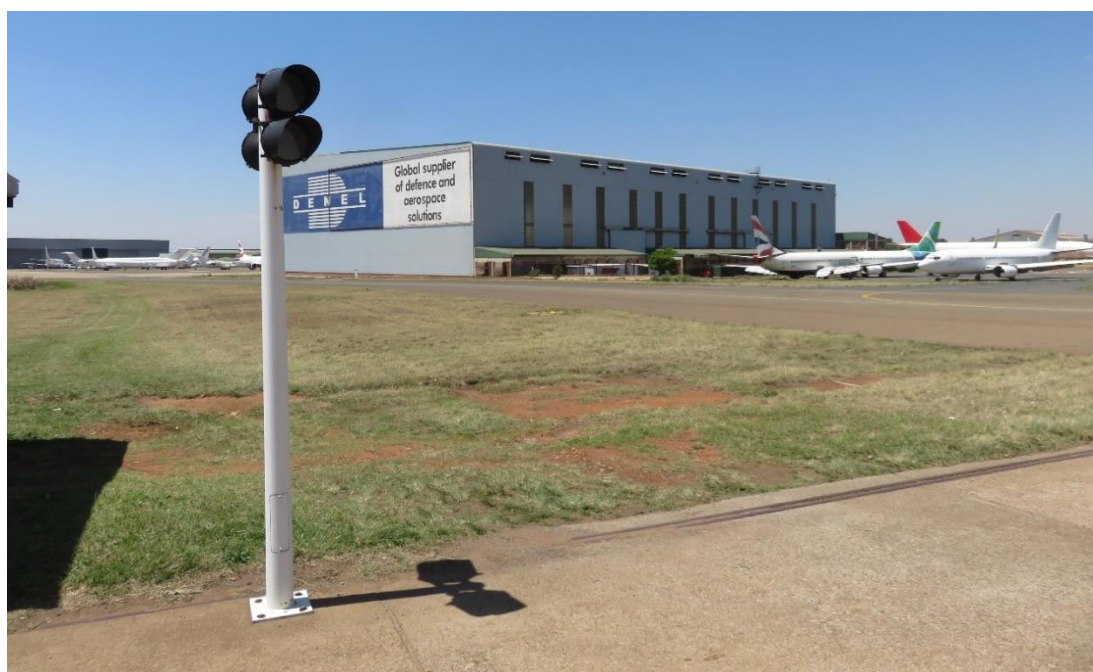
A traffic light at this gate is located next to the guard house. This light was not working as there was power failure in the area at the time. The traffic light is not connected to an alternate power supply in case of power failures.

**Figure 11:** The Denel Campus gate traffic light.

- 3.4 It is recommended that Denel Aviation consider installing an alternate power source for communication records at the Denel Campus Operations to prevent loss of communication should the main power source be unavailable.

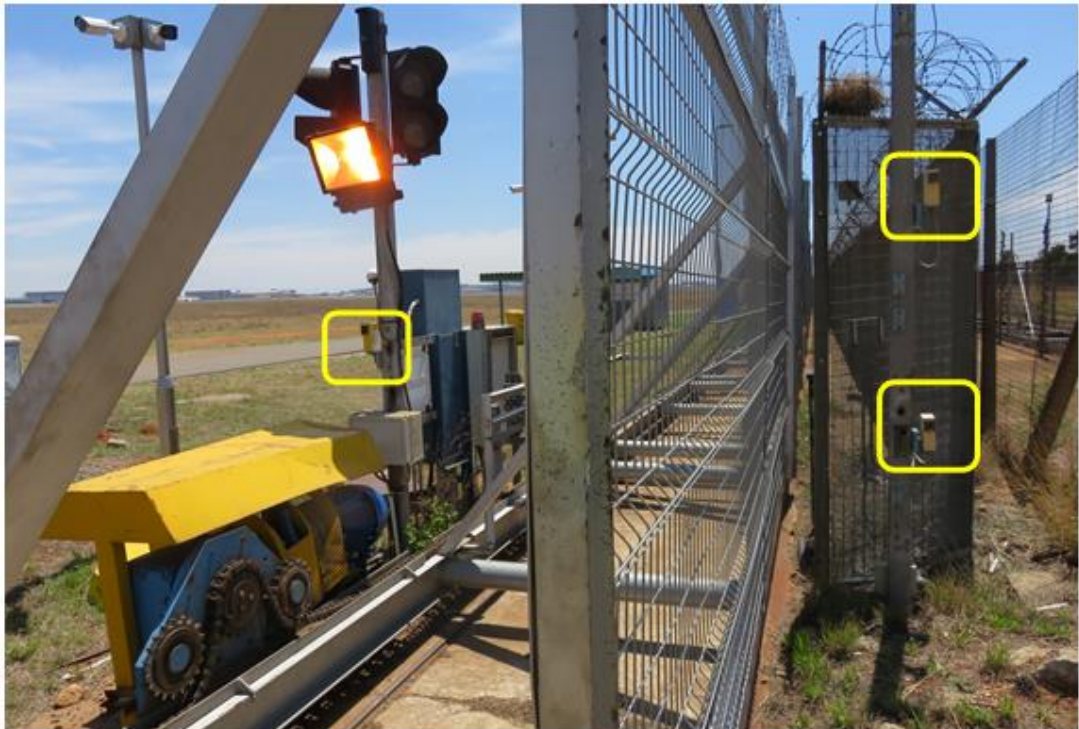
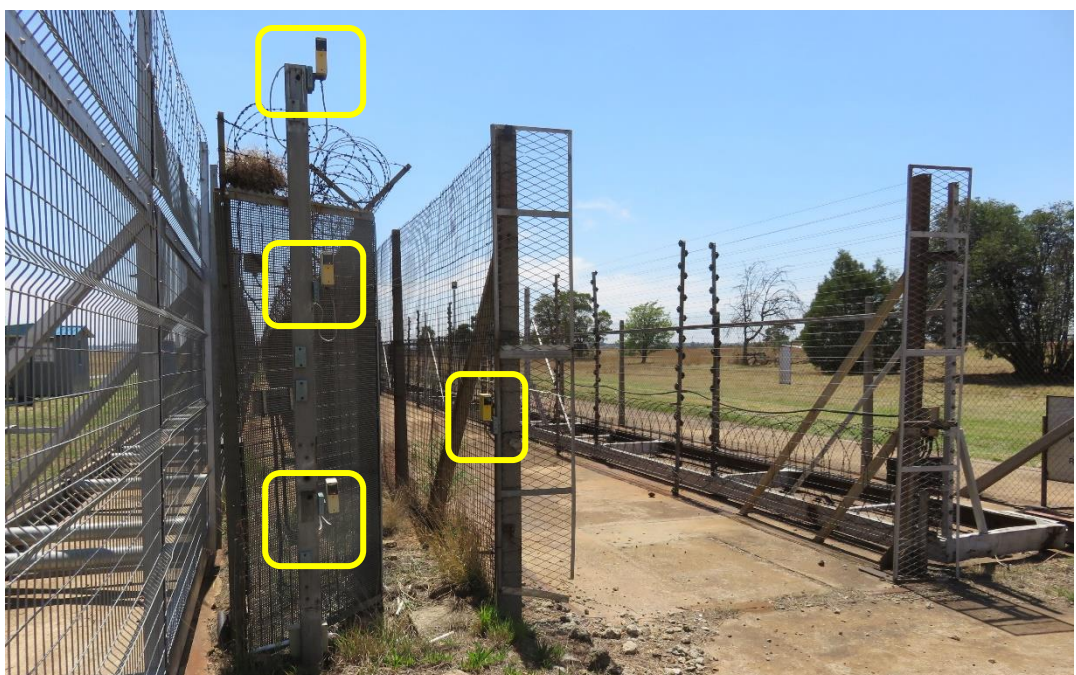
The aerodrome gate (Echo gate) was functional and was being controlled remotely. The gate was equipped with safety barriers which failed in operation on the day. At the gate, five safety beams are installed. When the gate is in motion and one of these beams is obstructed by an aircraft's fuselage, a vehicle or any similar type object, this gate should stop immediately. The fuselage of the aircraft obstructed all five safety beams, yet the gate did not stop, it continued to close for another 11 seconds after impacting the right wing of the aircraft before it finally stopped.

**Figure 12:** The Echo gate with three of the safety beams visible in the yellow windows.

**Figure 13:** The Echo gate with four of the safety beams visible in the yellow windows.

2.2.18 There are five safety beams installed at the gate, which are designed to stop the gate once the beam/signal is disturbed/obstructed by an aircraft's fuselage, vehicle, person, etc. This function was inoperative.

- 3.1 It is recommended that Airports Company South Africa (ACSA) and Denel Aviation consider moving the control (operation) of Echo (V4) gate (opening and closing) from the control room to the AMC building.
- 3.2 It is recommended that ACSA and Denel Aviation consider the installation of a stop sign on both sides of Echo (V4) gate and a visible notice board which must include the following statement:  
"BEFORE PROCEEDING THROUGH THE GATE, PLEASE CONTACT ACSA GATE CONTROL ON THE VHF FREQUENCY 122.65 MHZ."
- 3.3 It is recommended that ACSA and Denel Aviation ensures that the safety beams fitted at the gate to keep the gate opened when the aircraft brakes the beam are kept in working

condition. Alternatively, the gate should be kept opened at all times when the airport is in operation.

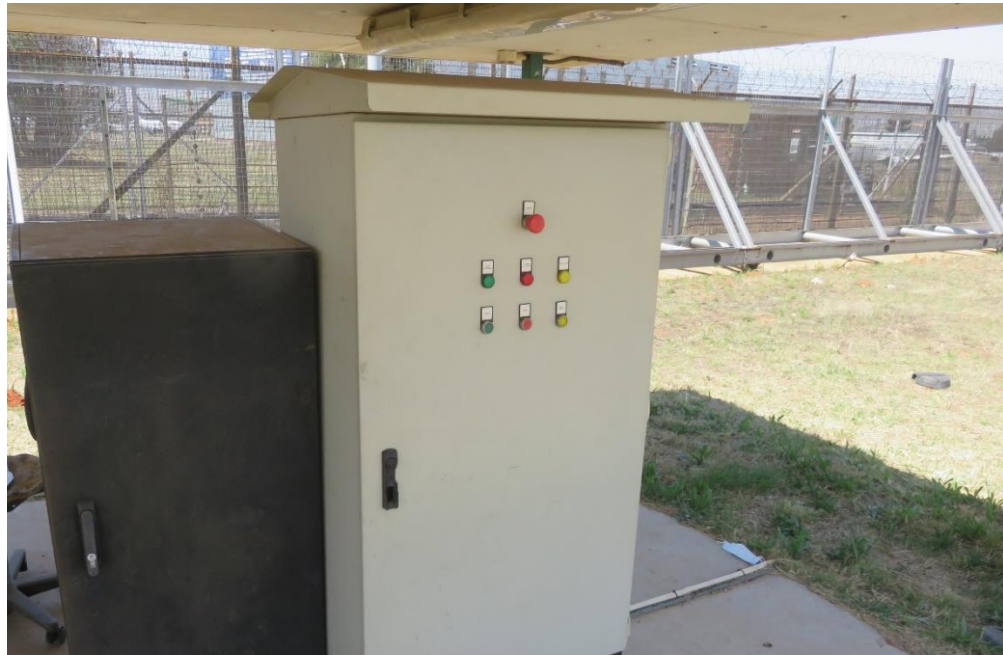
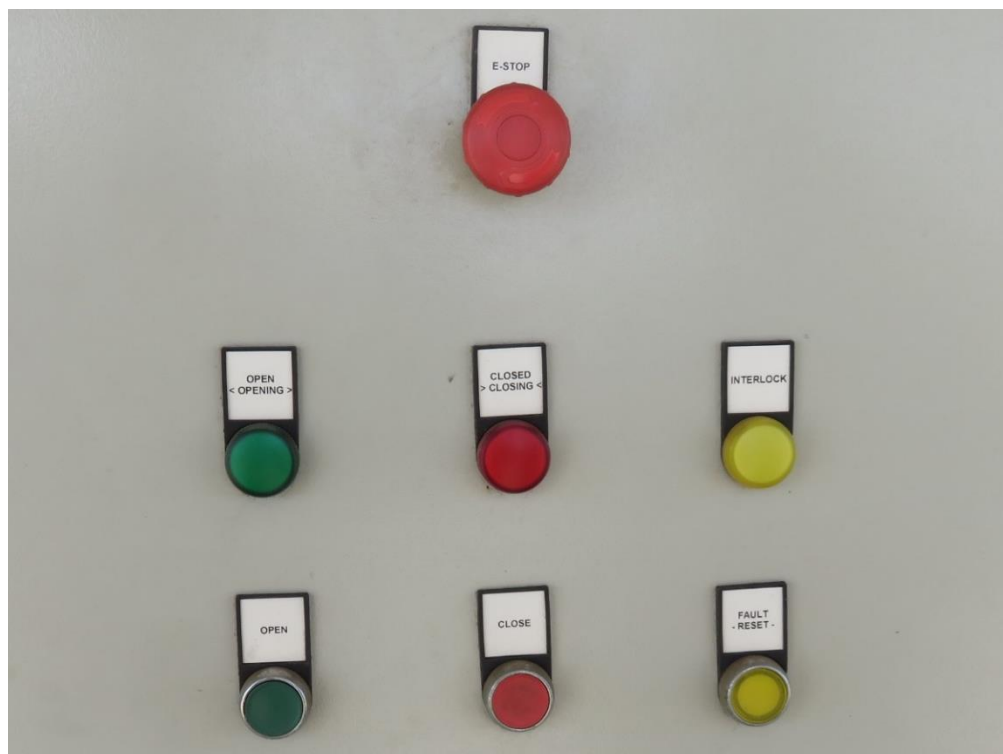
A gate control box with seven buttons is installed at the guard house at the Echo gate. The top red knob is the E-STOP (Emergency stop), which can be activated in case of an emergency, and which will bring the gate to an immediate stop. The security guard, who was the only person at this station, was not allowed to interfere with the operation of the gate and, therefore, did not activate the E-STOP knob. By the time this report was concluded, it was not clear who, and in what capacity was this person allowed to activate this E-STOP knob.

**Figure 14:** The gate control box installed at the guard house at Echo gate.

**Figure 15:** The gate control box with the E-STOP button at the top.

2.2.17 There is an E-STOP (Emergency Stop) button at the guard house at the gate, which when activated will stop the gate immediately. The security guard was not allowed to interfere with the operation of the gate and, therefore, did not activate the E-STOP button.
