**CIVIL AVIATION
AUTHORITY**

INTERIM ACCIDENT STATEMENT

Reference Number : CA18/2/3/9197

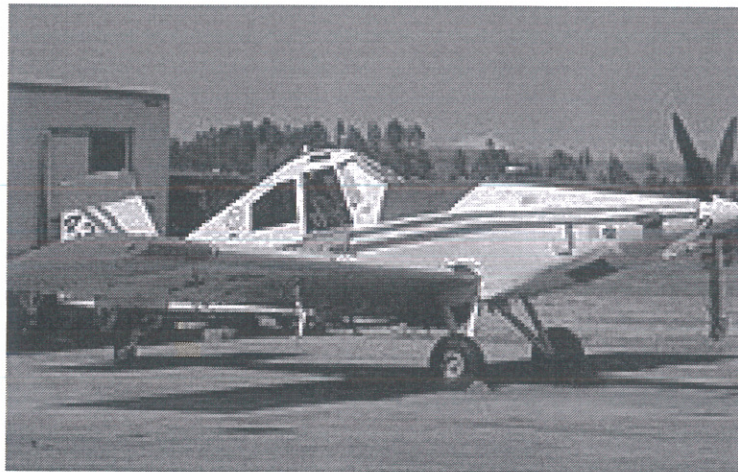
Ayres S2R-T Thrush powered by a Pratt & Whitney Canada PT-6 turboprop
