INTERIM STATEMENT

Accident and Incident Investigations Division (AIID)

Serious Incident
Boeing 737-400, ZS-OAF
AIID Ref No: CA18/3/2/1325

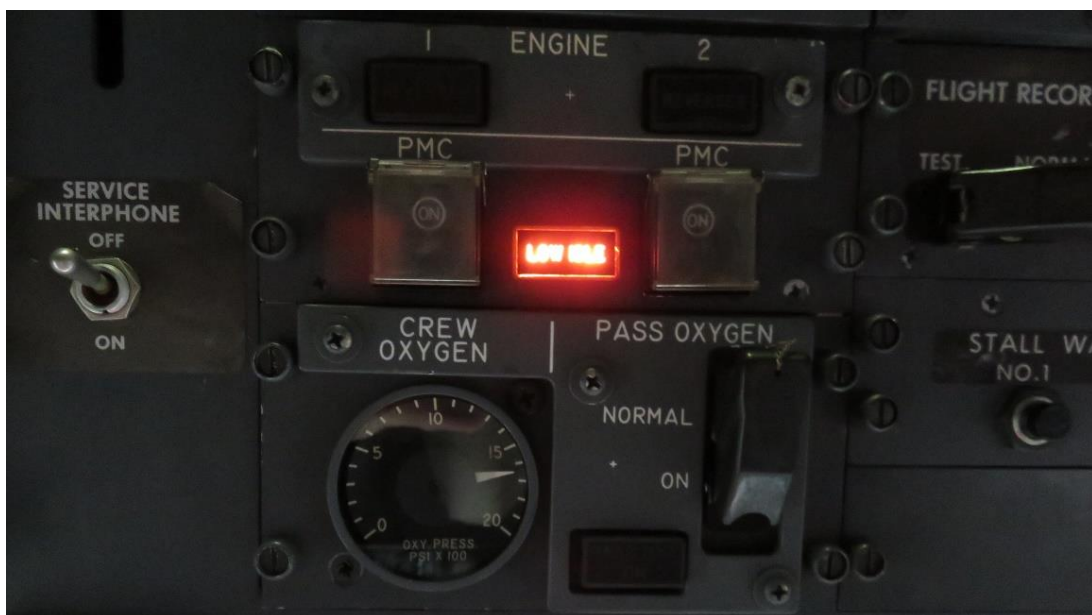
During the initial stages of the descent, the thrust levers retarded to LOW IDLE (N1 decreased to approximately 30%, according to Quick Access Recorder (QAR) data) with an amber warning activation on the overhead panel (see Figure 2) for both engines. This was supported by an amber alert speed (SPD) activation on the electronic attitude director indicator (EADI) (see Figure 3). Engine thrust was increased to achieve flight idle. The cabin rate of descent started to reduce, and the crew decided not to deploy the passengers' oxygen masks.

Figure 2: LOW IDLE warning for both engines, located on the overhead panel.

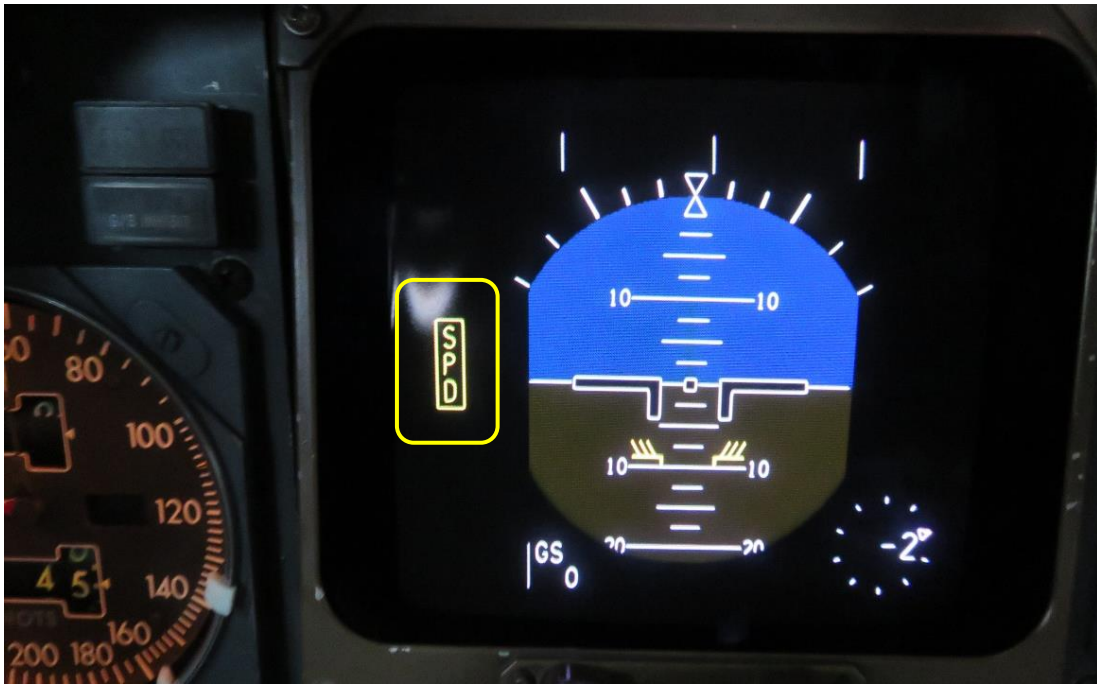
Figure 3: Amber SPD warning (in yellow window) displayed on the EADI (aircraft in ground mode).

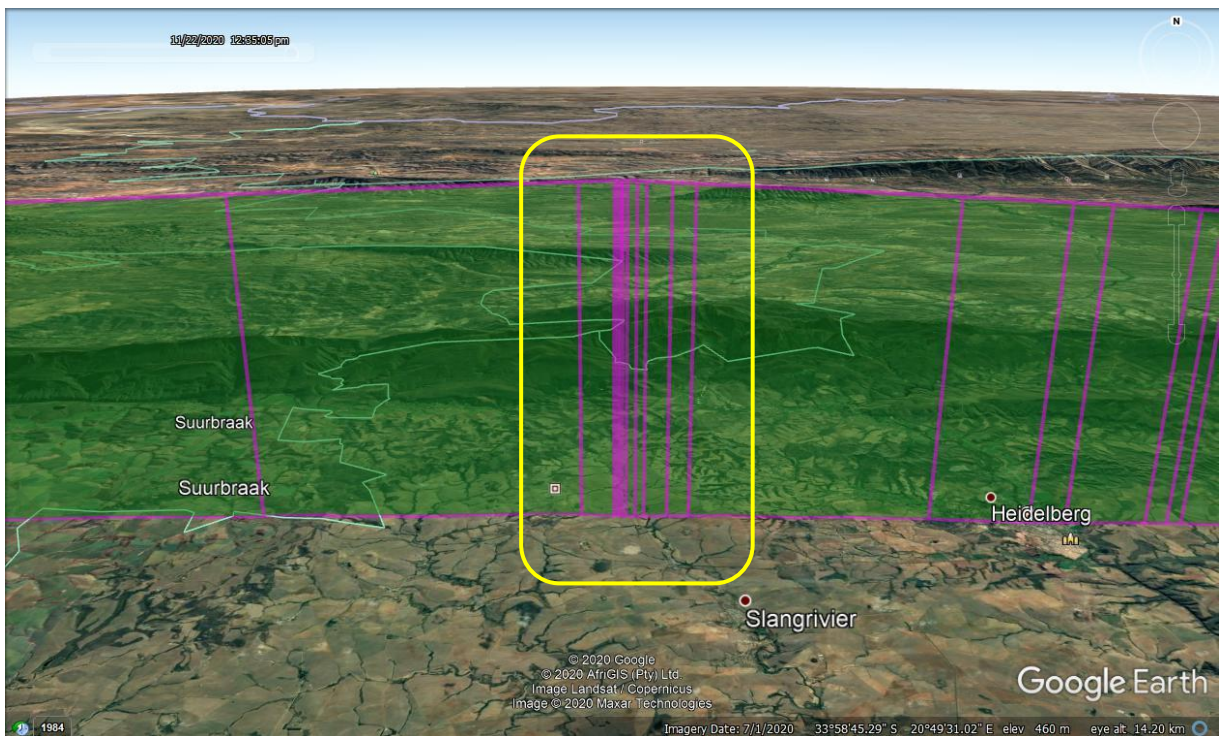
Figure 5: Overly indicating events where the Cabin Altitude, as well as the engine low idle warning activated. (Source: Google Earth)

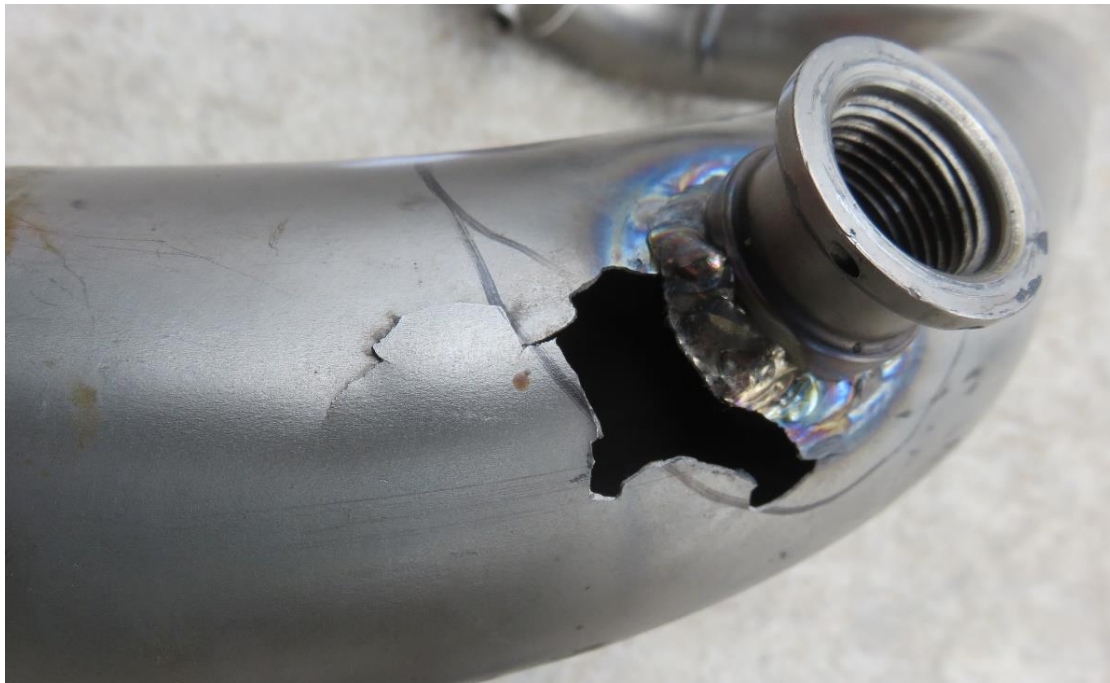
The Aircon Bay Pack/Machine Compressor Outlet Duct Assembly with Part No. 65-51552-8 that was installed on the left air-conditioning pack was found to have fractured in an area that was subjected to a previous welding repair (see Figure 6). The air duct was subjected to a metallurgical examination.

The cause of the failure of the ducting was due to an incorrect welding procedure, resulting in material embrittlement as a result of oxygen contamination. The mechanism of failure was initial brittle fracture that continued with a fatigue mechanism.

Figure 6: Damage to the Aircon Bay Compressor Outlet Duct (left air-conditioning pack).

- 1.9 The air duct with Part No. 65-51552-8 located on the left air-conditioning pack was found fractured in the area where a previous repair was made (as per Figure 6), which drastically reduced the efficiency of the left-side air-conditioning pack system.

- 2.1 It is recommended that the aircraft maintenance organisation conducts a fleet inspection to check the status of the air duct with Part No. 65-51552-8 located on the left air-conditioning pack that was found to have failed during operation. Such inspection should be conducted at the aircraft's next maintenance inspection despite the type of maintenance the aircraft is scheduled for.
- 2.2 It is recommended that the operator issues a notice to cockpit/flight deck crew that the absence/unavailability of transponder data during the flight renders the aircraft not being interrogated by SSR. The aircraft was only visible on primary surveillance radar reflected as a signal, with no altitude or speed data available to the controller.

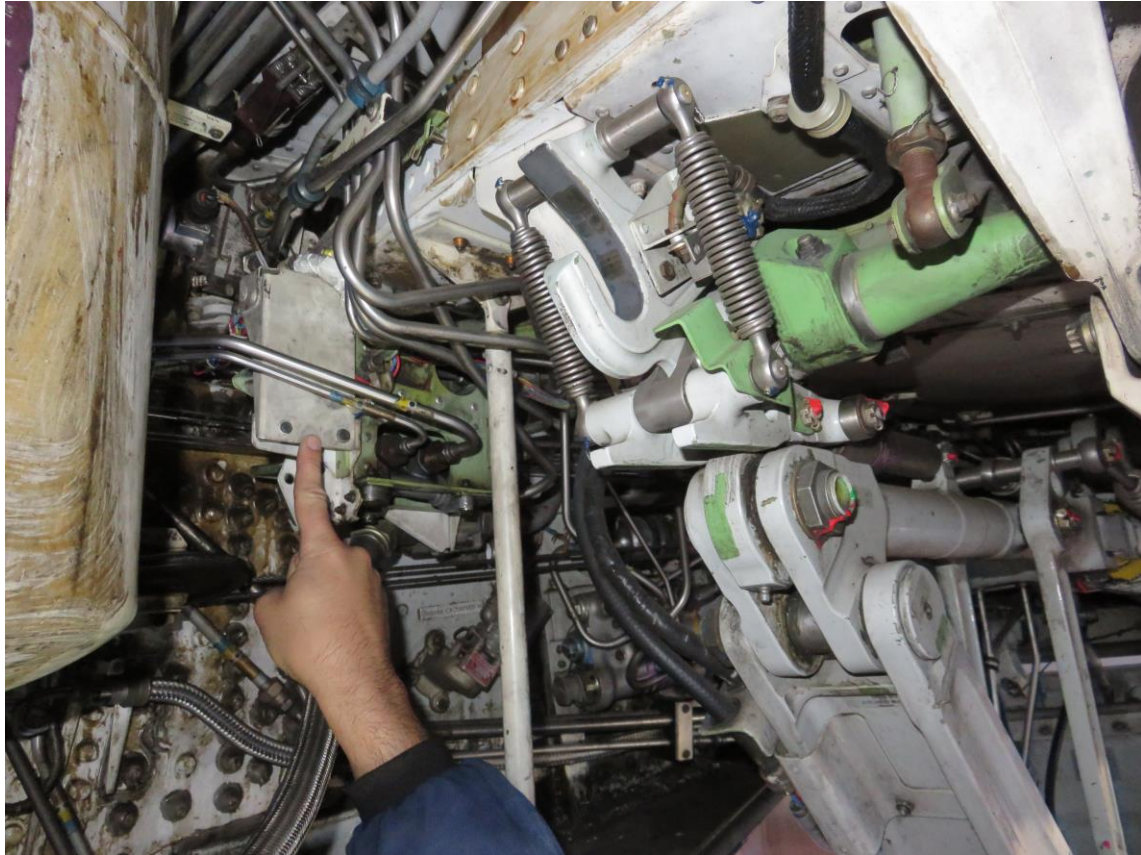
The Air/Ground proximity sensor located in the right main landing gear wheel well was found to be defective and was replaced. The aircraft was then jacked up and several retractions were performed to confirm correct operation of the switch. A post-maintenance acceptance (confidence) flight was performed, and all operations were found to be normal. No adjustments were made to the Teleflex cable on the right main gear. This sensor was found to have caused numerous warnings that the crew encountered in the cockpit during the flight.

Figure 7: The Air/Ground proximity sensor pointed out in the right main wheel well.

- 1.12 The Air/Ground proximity sensor located within the right wheel well was found to be defective and was replaced. This unit caused multiple cockpit indications and also contributed to the transponder being inoperative while the landing gear was in the retracted position. The transponder only became live (being detected by radar) after the landing gear was lowered for landing Runway 29 at FAGG.

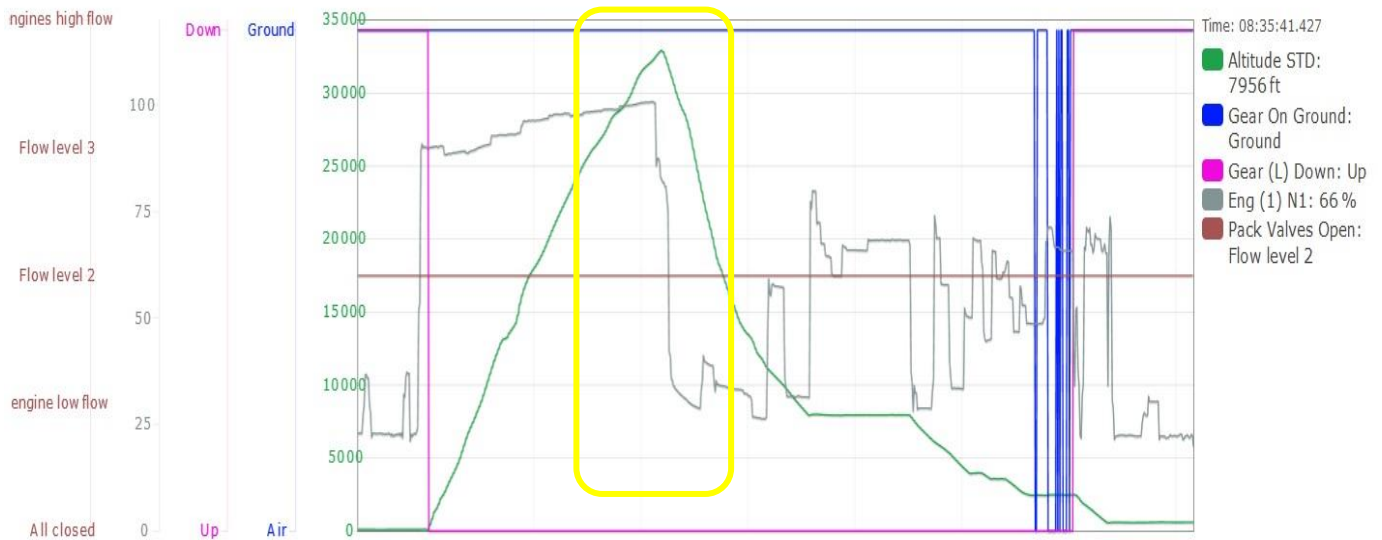
The aircraft was equipped with a flight data recorder (FDR) and a cockpit voice recorder (CVR). The FDR and QAR data were secured by the operator, but the CVR data was not. From the graph below, the yellow window indicates when the crew commenced with the descent (green line) after the Cabin Altitude Warning activated and both engines' N1 decayed to approximately 30% (grey line).

Graph 1: The graph of the serious incident flight with essential data captured. (Source: Safair)
