INTERIM STATEMENT

Accident and Incident Investigations Division (AIID)

Accident
- ZS-CBI Interim Statement -
AIID Ref. No: CA18/3/2/1187 Premier 1

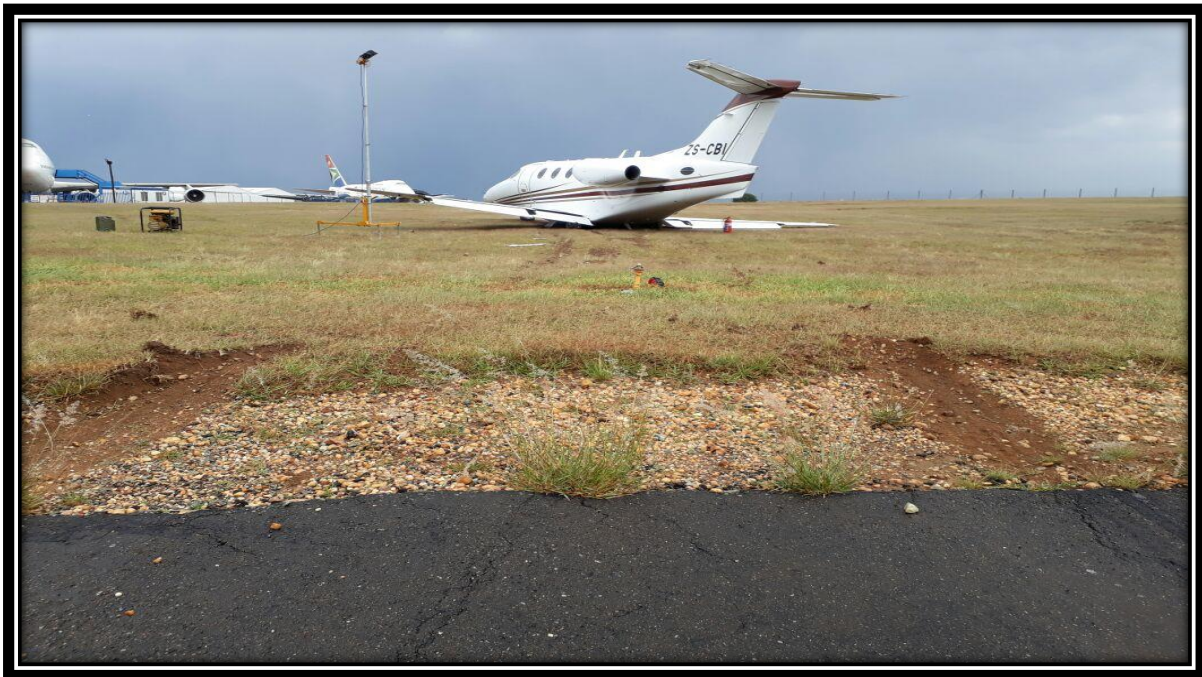
Figure 1: Aircraft as it came to rest.

The aircraft skidded with the main hubs on the surface until it overshot the runway and hit the soft ground. At the end of the runway there was an embankment of approximately 200 mm in height. The nose gear dug into the embankment and broke off, followed by the main undercarriage. The aircraft continued to skid on its belly, collided with a runway light left of the centreline and came to rest with the nose pointing slightly to the left of the centre line. The aircraft was destroyed and other damage being to the runway light.
