SOUTH AFRICAN

INTERIM STATEMENT

1. The South African Civil Aviation Authority (SACAA) is conducting a safety investigation into a ferry flight involving ZS-HXS, a Robinson R22 Beta which crashed immediately after take-off on 23 March 2016 at Rand Airport (FAGM).
2. The investigation is being conducted in accordance with the international protocol set out by the International Civil Aviation Organisation (ICAO). The occurrence is investigated by a team of two investigators from the South African Civil Aviation Authority.

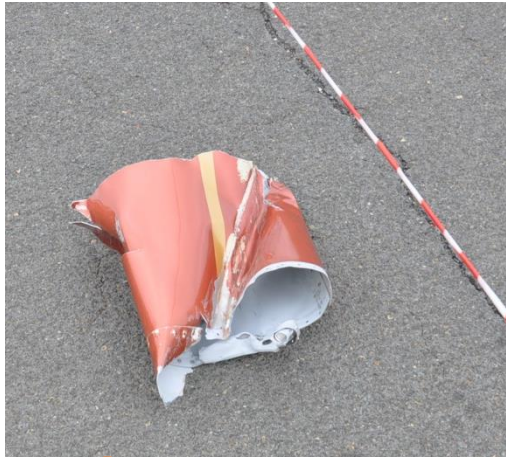
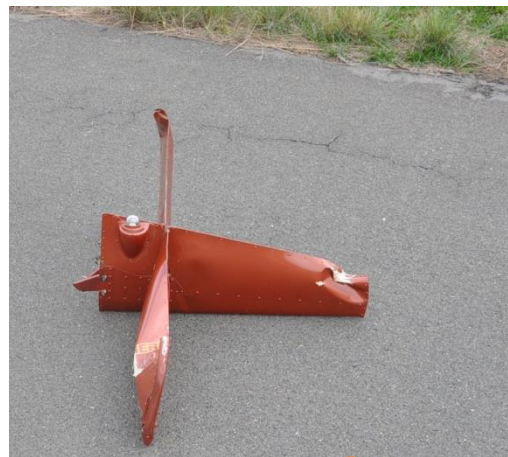
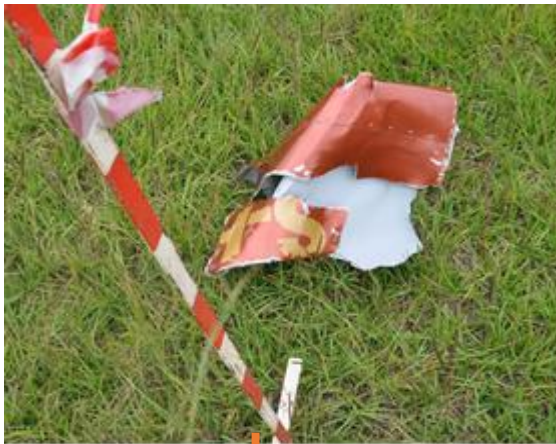
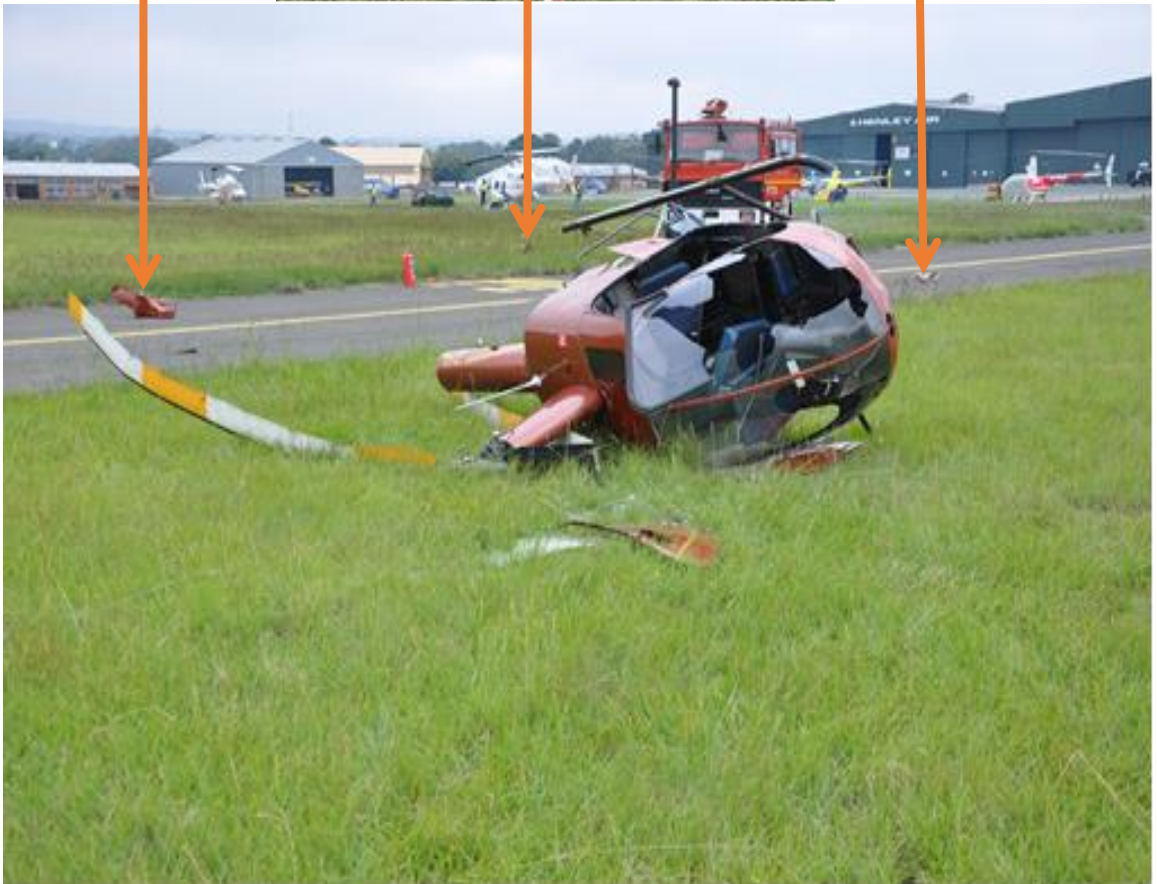
needles on the tachometer gauge dropping. The pilot stated that he rolled the throttle to increase power to the engine, went back slightly on the cyclic to gain height and then moved the cyclic forward to increase airspeed. The helicopter started losing height rapidly and the skids contacted the ground. The main rotor blades severed the tail boom into pieces and the helicopter came to rest on its right hand side.

FIGURE 2: Other parts of the wreckage as found at the accident site.
