**INTERIM STATEMENT**

1. The South African Civil Aviation Authority (SACAA) is conducting a safety investigation into a fire bombing flight involving ZS-TBW Air Tractor AT802 which flew into terrain on 15 September 2014 at 1520B near Piet Retief Airfield.
2. The investigation is being conducted in accordance with the international protocol set out by the International Civil Aviation Organisation (ICAO). The investigation team includes Investigator In-Charge (IIC) from the South African Civil Aviation Authority.

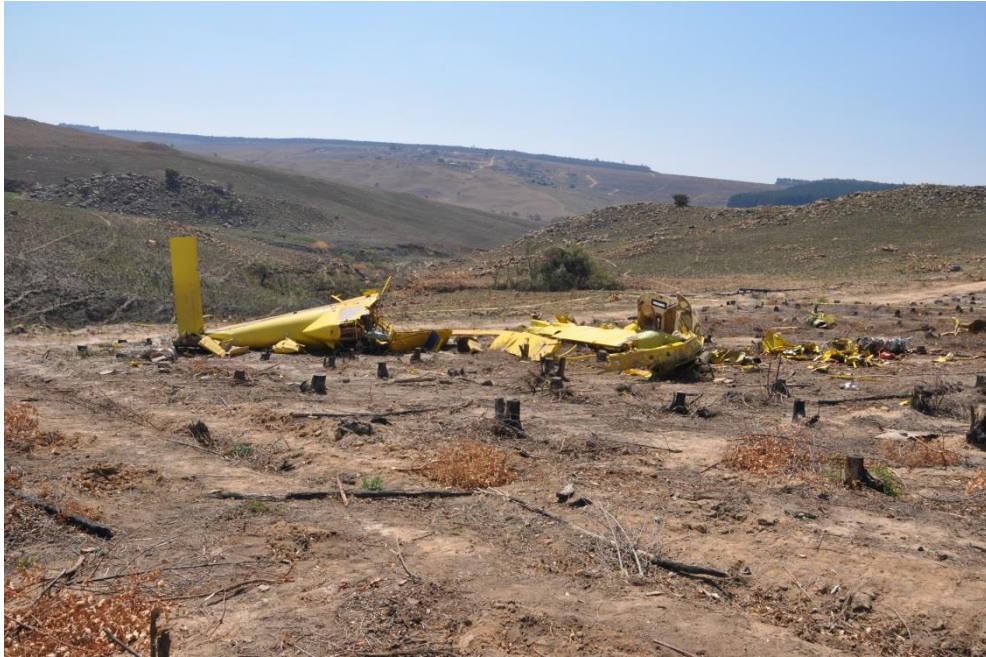
- b) He saw ZS-TBW running in to drop his load approximately half way up the right flank of the fire. The load of water did not come out and he collided with the trees ahead of him. The trees severed his right wing, he pitched up and rolled over inverted with nose dropping to the ground. He hit the ground at an angle of 70°.

- c) The aircraft then flipped over and nose face back to the direction he came from. There was no visible fuel leak except for the burst of water as he hit the ground. The wind direction was North Easterly and cloud and visibility was ok with maximum temperature of 32°C. There was no pre or post fire erupted after the aircraft hit the ground. The aircraft was completely destroyed.

Figure1 Shows the position of the wreckage

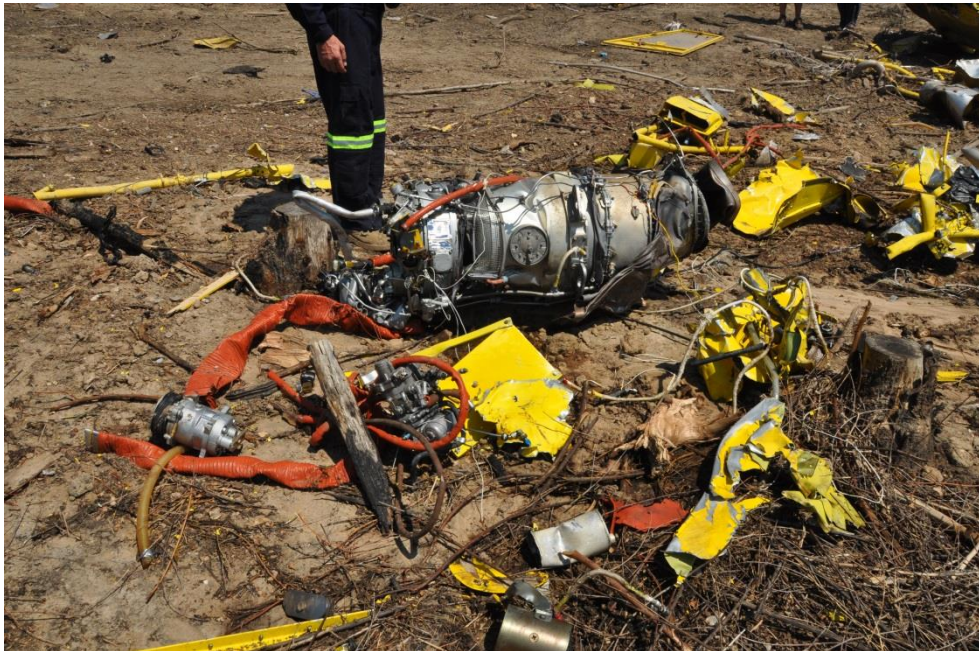
Figure 2: Shows the condition of the engine as found on the scene.
