PRELIMINARY OCCURRENCE REPORT

Reference Number : CA18/2/3/9579
Name of Owner : Aircraft Asset Finance Corporation (Pty) Ltd
Name of Operator : Aircraft Asset Finance Corporation (Pty) Ltd
Manufacturer : Piper Aircraft Corporation
Model : PA-250-60
Nationality : South African
Registration Marks : ZS-TDO
Place : Keerboskloof (GPS position: 33°29.200' South 019°43.801' East)
.Date : 31 October 2016
Time : 12:30 UTC

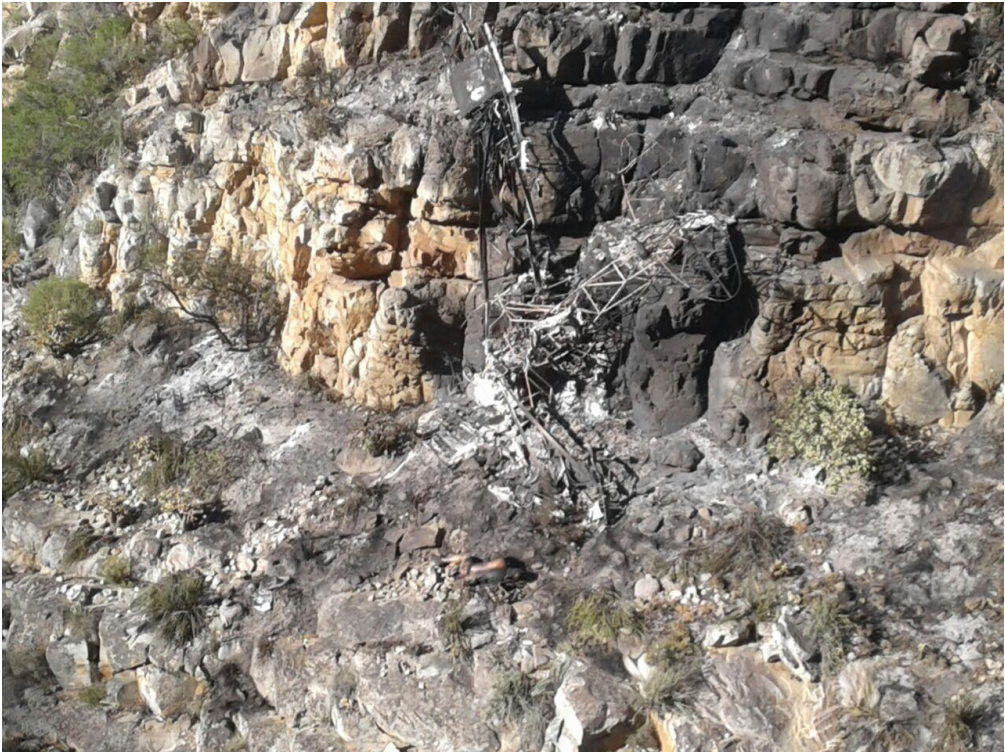
Figure 1. The wreckage destroyed by fire

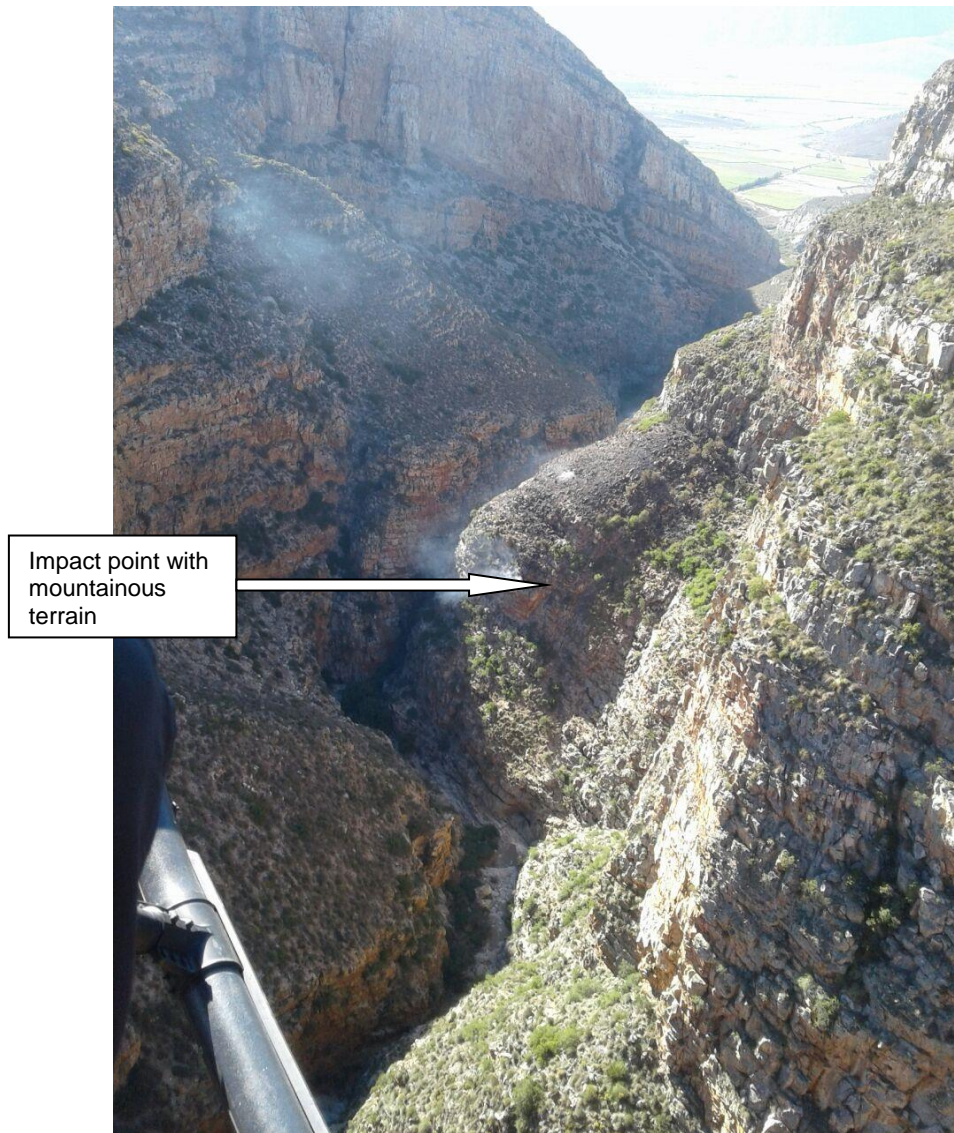
Figure 2. The terrain
