INTERIM STATEMENT

1. The South African Civil Aviation Authority (SACAA) is conducting a safety investigation into a Robinson R22 Beta flight involving ZT-RAS which flew into terrain on 25 February 2017 near Hluleka, Umtata in the Eastern Cape Province.
2. The investigation is being conducted in accordance with the international protocol set out by the International Civil Aviation Organisation (ICAO). The investigation team includes Investigator In-Charge (IIC) from the South African Civil Aviation Authority.

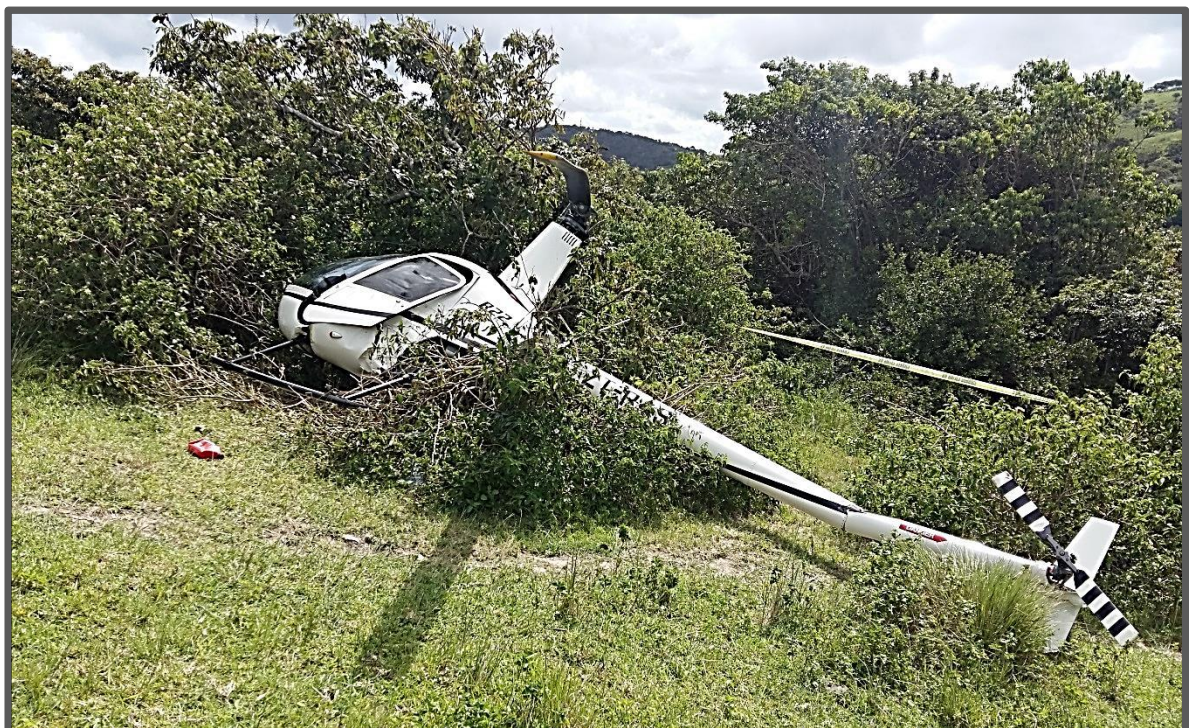
Figure 2: Helicopter as it was found

According to the eyewitnesses, strong coastally wind prevailed in the area of the accident site. The helicopter was found lying on its belly with its right hand side against the tree and both skid gears spread sideways. The helicopter sustained substantial damages during the accident sequence. According to the residents who helped to remove the pilot from the helicopter wreckage, the pilot stated that he switched off the engine ignition switch prior to impact during a forced landing. The pilot however passed on as they carried him up the hill away from the wreckage.

3.4 The damages on the helicopter wreckage are consistence with hard impact during contact with the ground.
