INTERIM STATEMENT

Accident
- ZU-CBR Interim Statement -
AIID Ref. No: CA18/2/3/9735 Windlass Aquilla

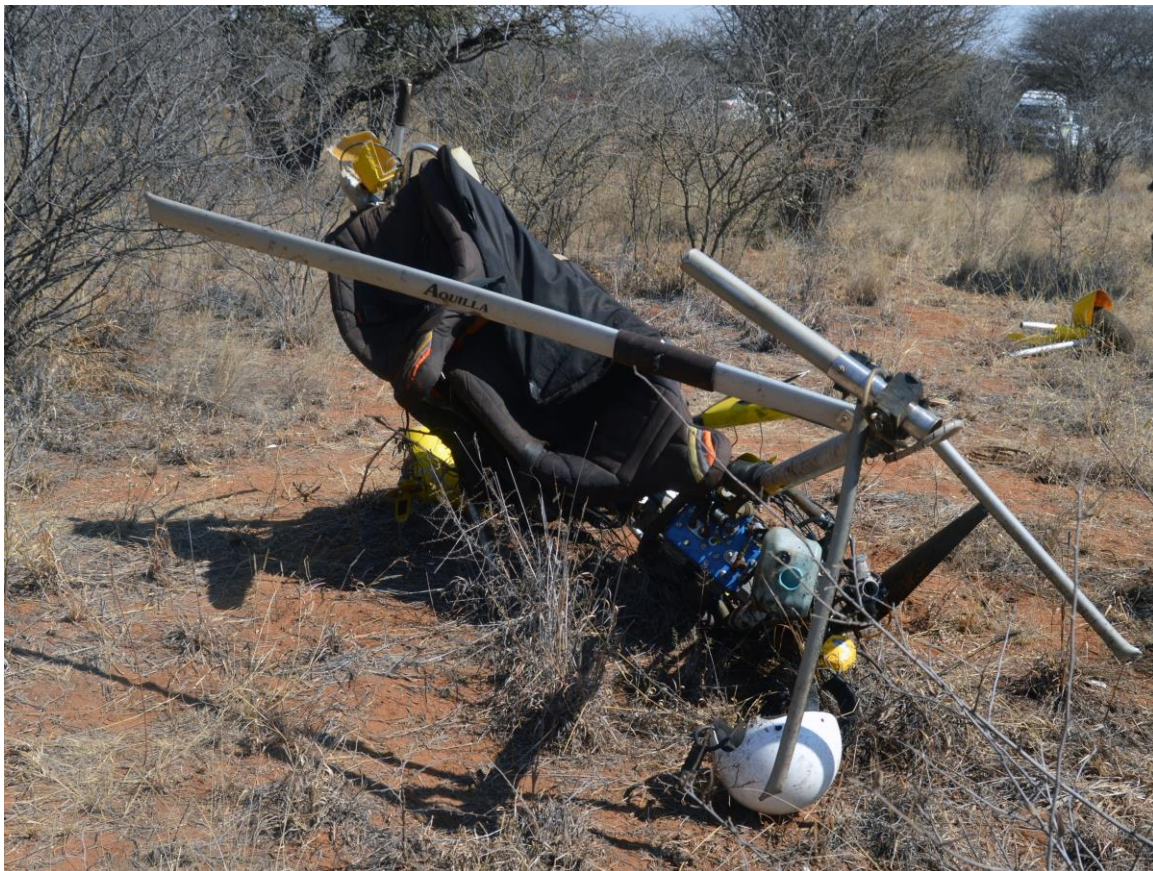
Figure 1: Wreckage as found at the accident site

The wing detached from the aircraft during approach for a landing resulting in the aircraft impacting with the ground.

- 2.5 Both pilot and passenger safety harness failed during the accident sequence.
- 2.6 The preliminary report established that the wing separated in flight during an approach for landing and the aircraft lost control and crashed.
