## INTERIM STATEMENT

Accident  
- ZU-RKJ Interim Statement -  
AIID Ref. No: CA18/2/3/9666 Trojan Gyro

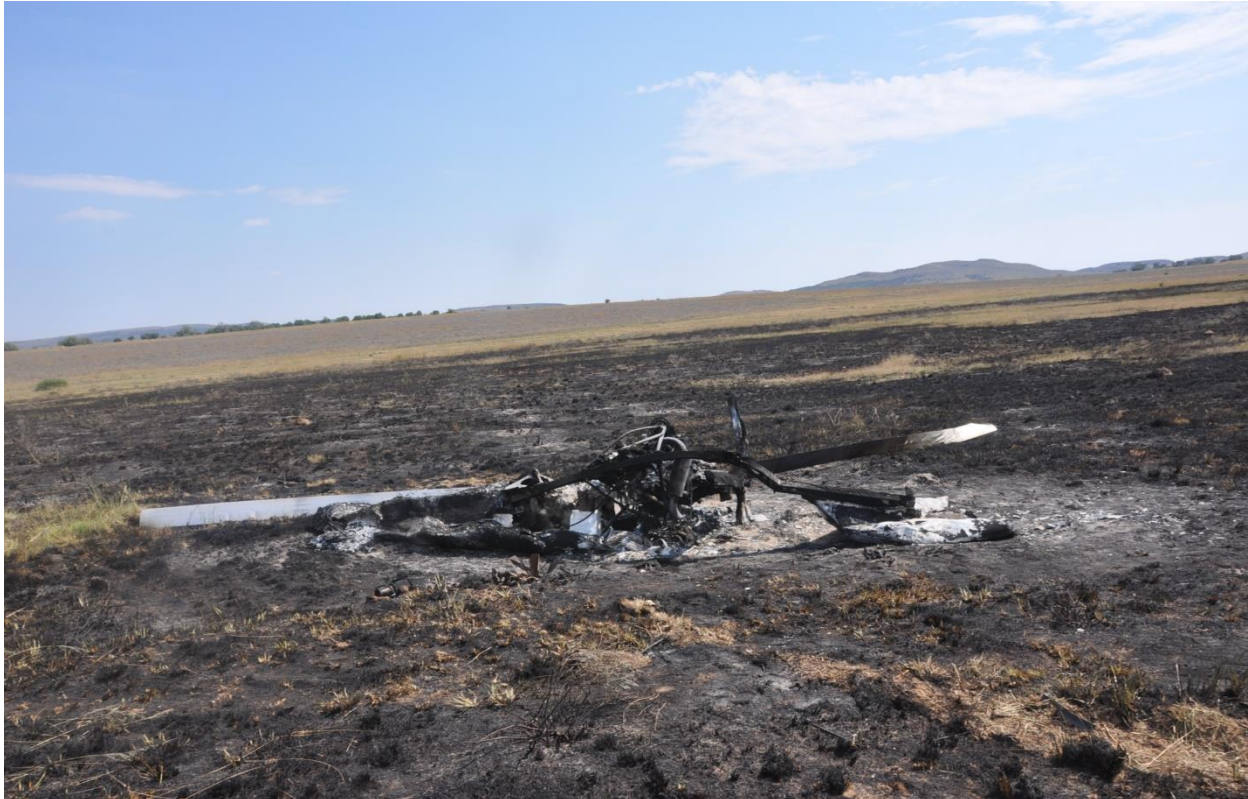
**Figure 1:** Wreckage as found at the accident site after been consumed and destroyed by post impact fire.

The engine was taken to an approved Aircraft Maintenance Organisation (AMO) for further investigation, which determined that the engine was operating normal before impact. The main rotor blades damage indicate that the rotor was operating at a fairly low RPM on impact with the ground.
