INTERIM STATEMENT

1. The South African Civil Aviation Authority (SACAA) is conducting a safety investigation into a Bell 205 flight involving ZU-UHI which crashed into a game reserve on 22 April 2015 at Bainskloof area, Western Cape Province, at GPS coordinates 33°36'30.68"S, 19° 6'29.18"E.
2. The investigation is being conducted in accordance with the international protocol set out by the International Civil Aviation Organisation (ICAO). The investigation team includes Investigator In-Charge (IIC) from the South African Civil Aviation Authority and the operator.

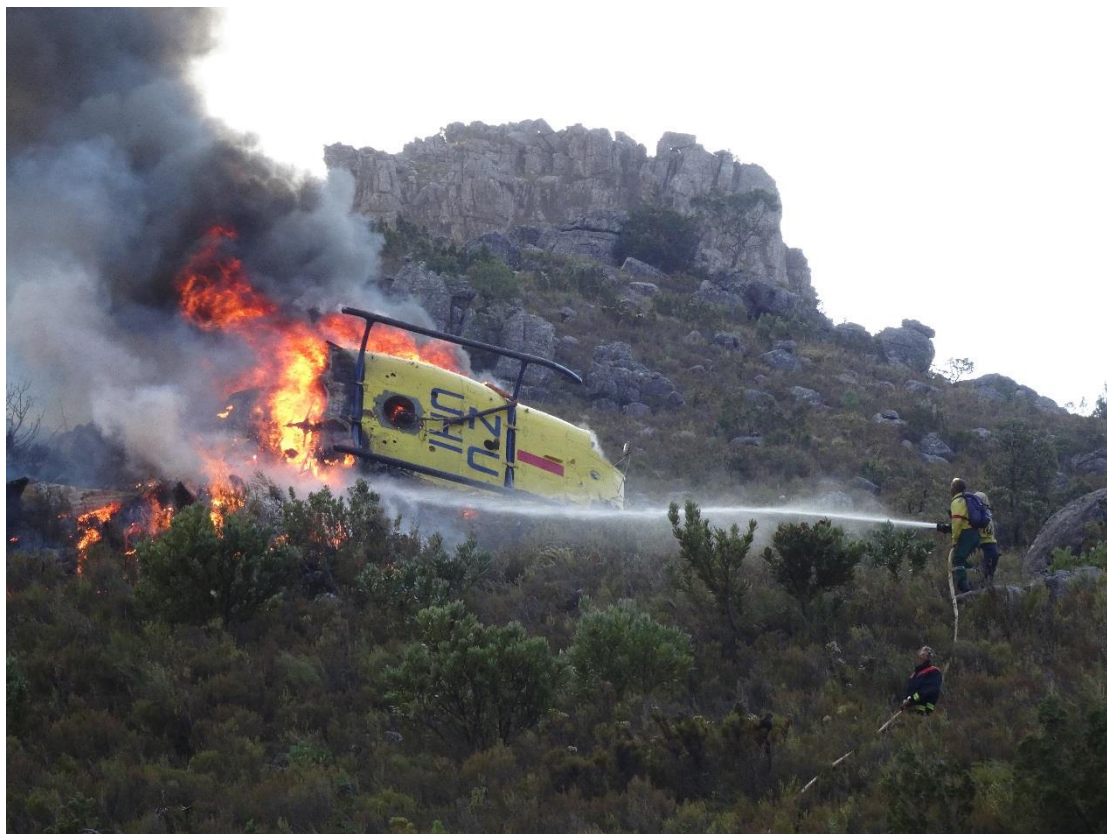
- 1.1.5 At approximately 16:10B the wreckage starts burning and the Spotter advised helicopter (A) to put his load over the burning helicopter and he also asked the Incident Commander to assist personnel (pilot and the assistant). Helicopter (A) and kept on dropping water on the wreckage. The wreckage and the surrounding area were secured.

Figure 2: Photo of the aircraft after catching fire.
