## INTERIM INCIDENT STATEMENT

**Reference Number** : CA18/3/2/1020

1. The South African Civil Aviation Authority (SACAA) is conducting a safety investigation into a Gabonese flight involving TR-LSR (Embraer EM 120 ER) which had a brake and steering system failure on 27 November 2013 at Lanseria International Aerodrome in Gauteng Province.
2. The investigation is being conducted in accordance with the international protocol set out by the International Civil Aviation Organisation (ICAO). The investigation team includes Investigator In-Charge (IIC) from the South African Civil Aviation Authority and representatives from the National Civil Aviation Agency (ANAC) Gabon, the operator La Nationale Regionale Transport (NRT), Transport Safety Board of Canada (TSB) and Centro de Investigacao e Prevencao de Aciodnte (CENIPA ).

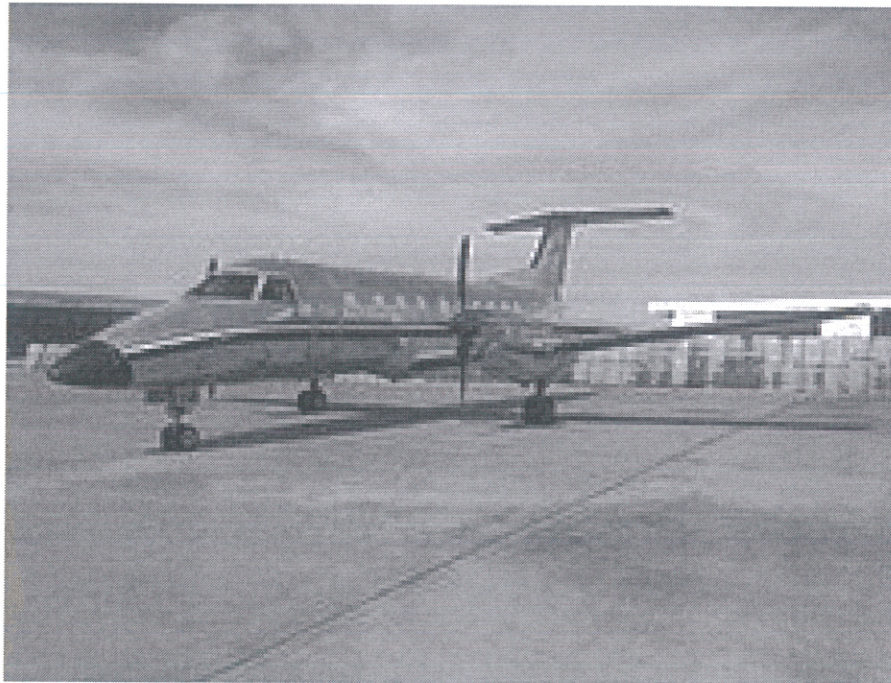
Embraer EM 120 ER
