**PRELIMINARY SERIOUS INCIDENT REPORT****Accident and Incident Investigations Division**

Serious Incident  
- Preliminary Report -  
AIID Ref No: CA18/3/2/1336

**Reference Number** : CA18/3/2/1336  
**Name of Owner/Operator** : Mango Airlines SOC (Ltd)  
**Manufacturer** : Boeing Aircraft Cooperation  
**Model** : Boeing 737-800  
**Nationality** : South African  
**Registration Marks** : ZS-SJF  
**Place** : In-flight  
**Date** : 25 January 2021  
**Time** : 1232Z

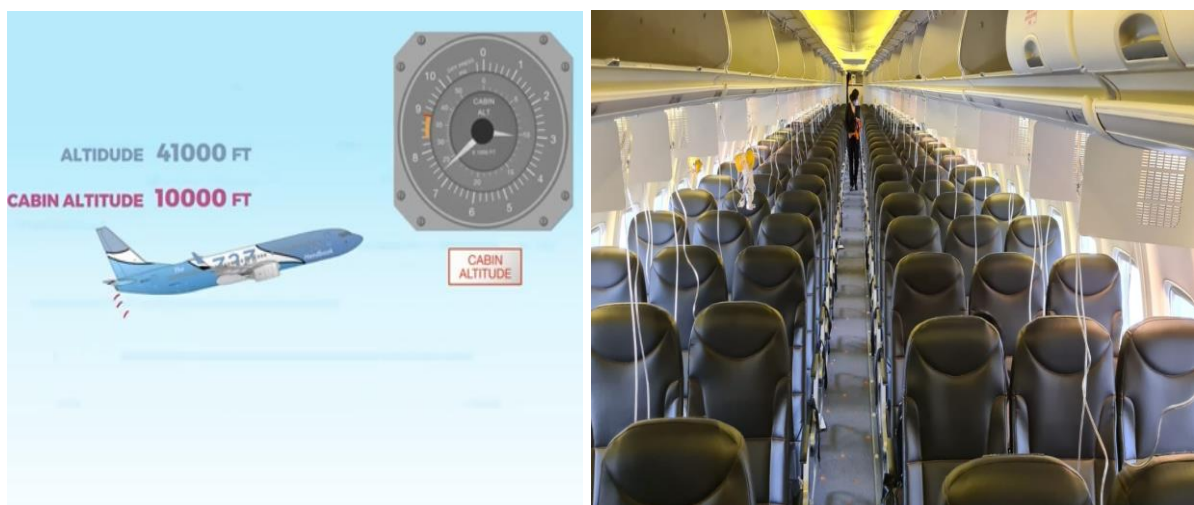
1.1.4 The AME disconnected his headset and waited on the left-side of the aircraft where he subsequently received a thumbs up. The aircraft was taxied to the holding point for Runway 03L departure. At that time, the cabin crew carried out the safety briefing and demonstration to the passengers in the aircraft. Passengers in the seats next to the over-wing emergency exits were given a short briefing on their role in the event of an emergency and were asked to study the information in the safety briefing card. In the cockpit, the PF advanced the thrust levers forward and stabilised the engines at 95% N1. Take-off roll was normal with moderate weather conditions prevailing; the aircraft rotated without incident. The aircraft climbed and levelled off at FL350. The aircraft standard cabin pressure was normal. During the descent phase to FALE at 1232Z and after passing FL270, the “Cabin Altitude” rapid decompression warning light illuminated followed by an aural warning. The captain then took over control of the aircraft. The crew promptly donned their oxygen masks and manually deployed the passengers’ oxygen masks.

**Figures 2 & 3:** An illustration of a B737 aircraft animation snap shot showing the illuminated “Cabin Altitude” warning and the Cabin Altitude at 10000 feet (left); and a picture of ZS-SJF aircraft showing the deployed oxygen masks (right).

2.1.9 The cabin oxygen masks were deployed during the serious incident and oxygen generators activated on all the masks that dropped. Some oxygen masks did not drop, resulting in the

cabin crew moving the passengers to the unoccupied seats with deployed masks.

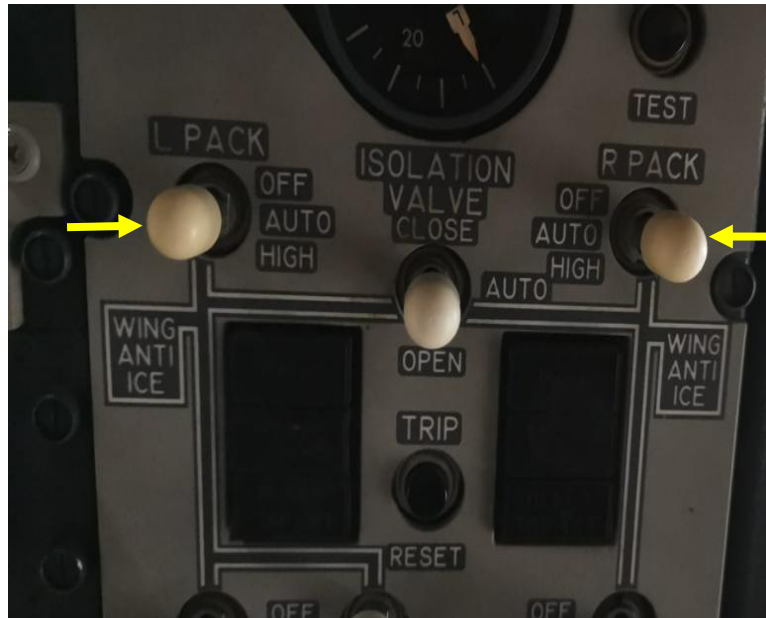
**Figure 5:** The aircraft pneumatic panel showing the pre-flight set position of the air-condition packs toggle switches (Bleed 1 & 2) on Auto.

2.1.7 The cabin pressurisation was configured with the cruise altitude (FL350), and the destination airport altitude (304 ft above mean sea level) was set. The pre-flight checklist was executed accordingly.

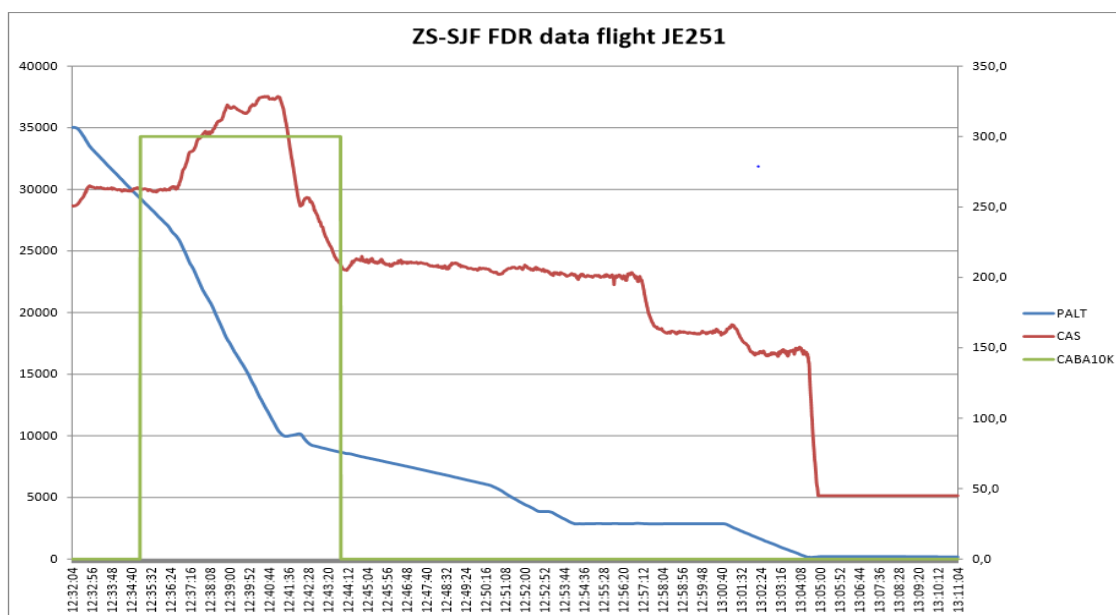
1.11.2 From the FDR graph (Figure 12), it is evident from the Aircraft Information Management System (AIMS) that the aircraft packs were operating engine 1 Low and engine 2 High, which is in correlation to the aircraft's configuration as it departed FAOR.

1.11.3 At 1232Z, the crew commenced their descent, and while passing FL270, the crew got a "Cabin Altitude Warning" and, according to the captain's written report, declared an emergency. The crew continued with the descent at a maximum of 330kts to FL110 where a deceleration to 250kts was made.

Figure 12: The graph of the serious incident flight with the captured essential data.  
(Source: Mango Airlines)
