PRELIMINARY SERIOUS INCIDENT REPORT

Serious Incident - Preliminary Report -AIID Ref No: CA18/3/2/1391

Reference Number	: CA18/3/2/1391
Name of Owner/Operator	: Spectrem Air (Pty) Ltd and Comair
Manufacturer	: McDonnell Douglas Corp and Boeing Company
Model	: DC3-TP67and B738
Nationality	: South African
Registration Mark	: ZS-ASN and ZS-ZWF
Place	: 7.17nm final approach RWY 07 FALA
Date	: 8 February 2022
Time	: 0830Z

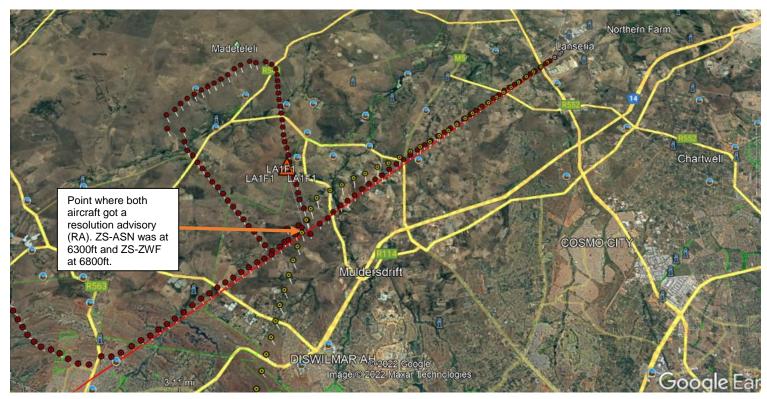
Figure 3: Serious incident location, 7.17nm from RWY 07 at FALA. (Source: Google Earth)

1.10.1 The serious incident occurred at approximately 7.17nm on final approach for Runway 07 at FALA.
