**PRELIMINARY ACCIDENT REPORT**

**Accident and Incident Investigations Division**

Accident  
- Preliminary Report -  
AIID Ref No: CA18/2/3/10152

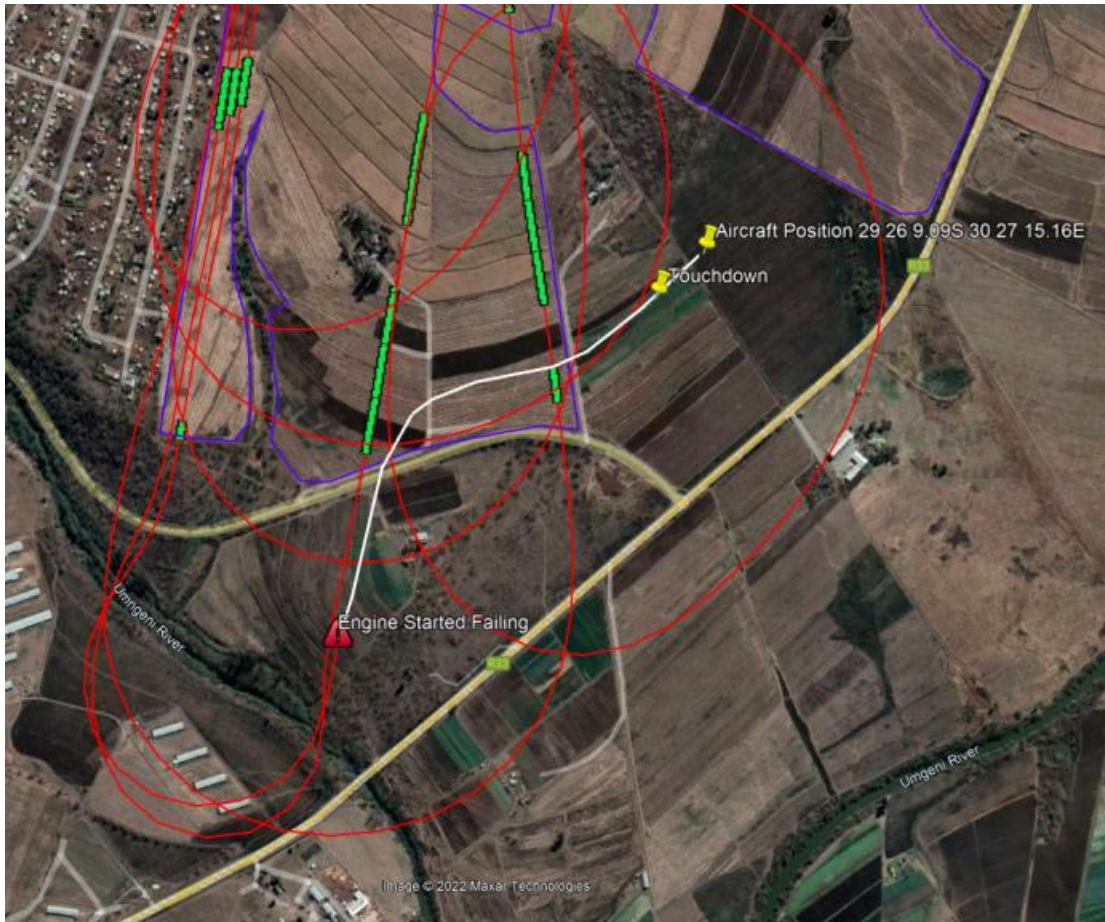
- 1.1.2 The pilot stated that after completing five swath lines and was on the climb to line up for the sixth swath line of spraying the crops at the farm, he made a left turn to line up the aircraft at approximately 100 feet (ft) above ground level (AGL). At this time, the engine started to run rough whilst the aircraft experienced abnormal vibrations. The pilot also noted that the aircraft's engine had lost power. He then turned right towards an open field in the vicinity to perform a forced landing. During the (right) turn, he heard loud noises which sounded like spluttering emanating from the engine compartment. The pilot stated that he leaned the mixture and turned on the carburettor heat to remedy the situation, but this was in vain. However, he successfully forced-landed the aircraft on the open field and continued to roll on the ground for approximately 60 metres (m) before the propeller blades impacted a perimeter fence and flattened it. The aircraft continued to roll to the other side of the fence, ground-looped and impacted some bushes before coming to a stop.

**Figure 2:** The white line shows the flight path of the aircraft from the point the engine started running rough to where it came to a stop. (Source: Pilot)

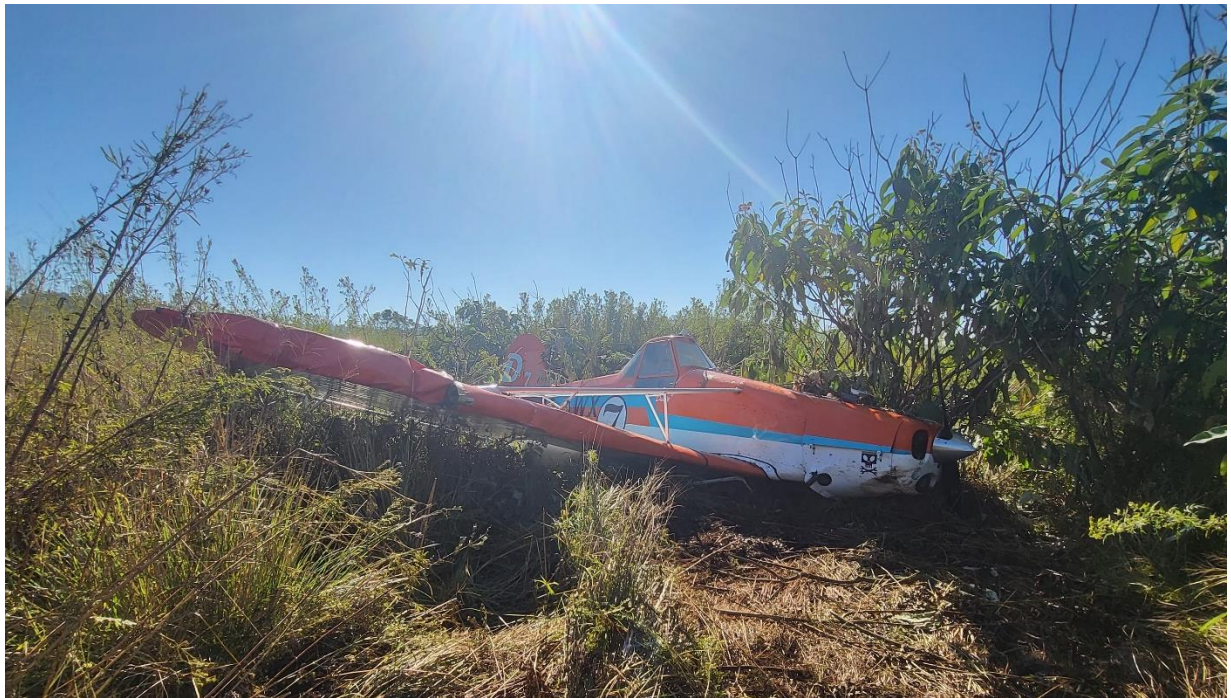
1.3.1. The aircraft sustained damage to the propeller, undercarriage, both wings' leading edges, left elevator, spinner and the spray system equipment.

**Figure 3:** The aircraft on site post-accident.

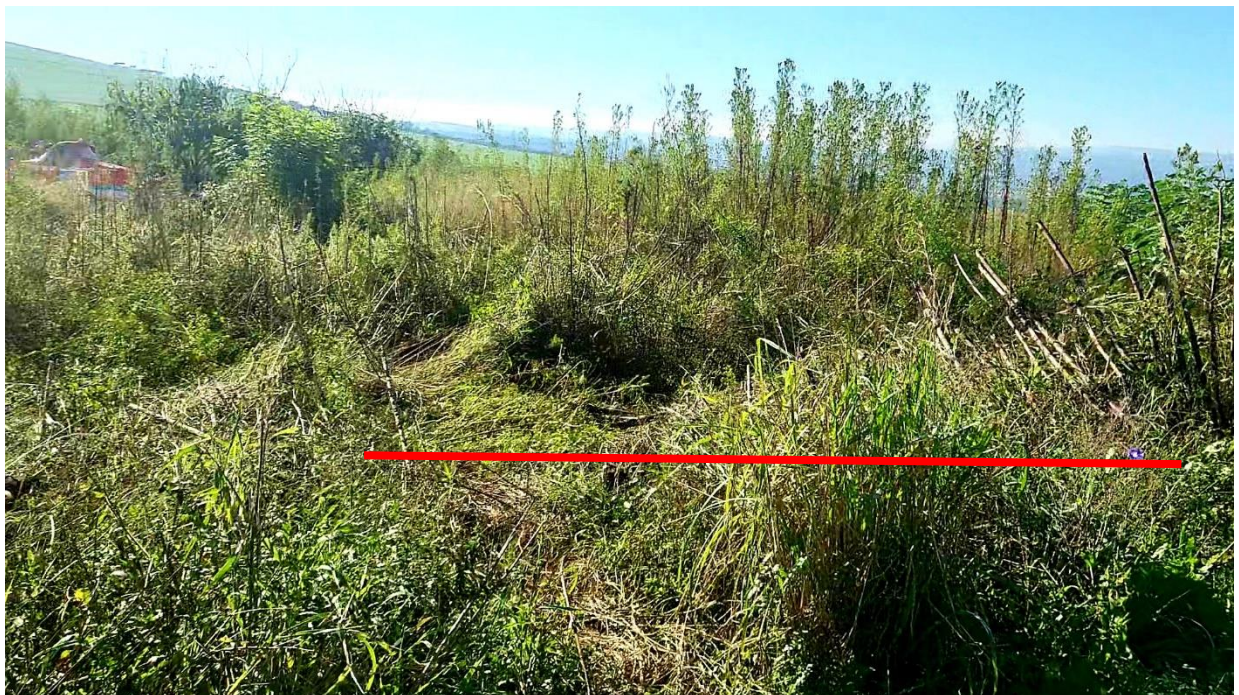
1.4.1. The aircraft impacted a perimeter fence and flattened it.

**Figure 4:** The perimeter fence (red line) constructed from wood poles and barb wire.

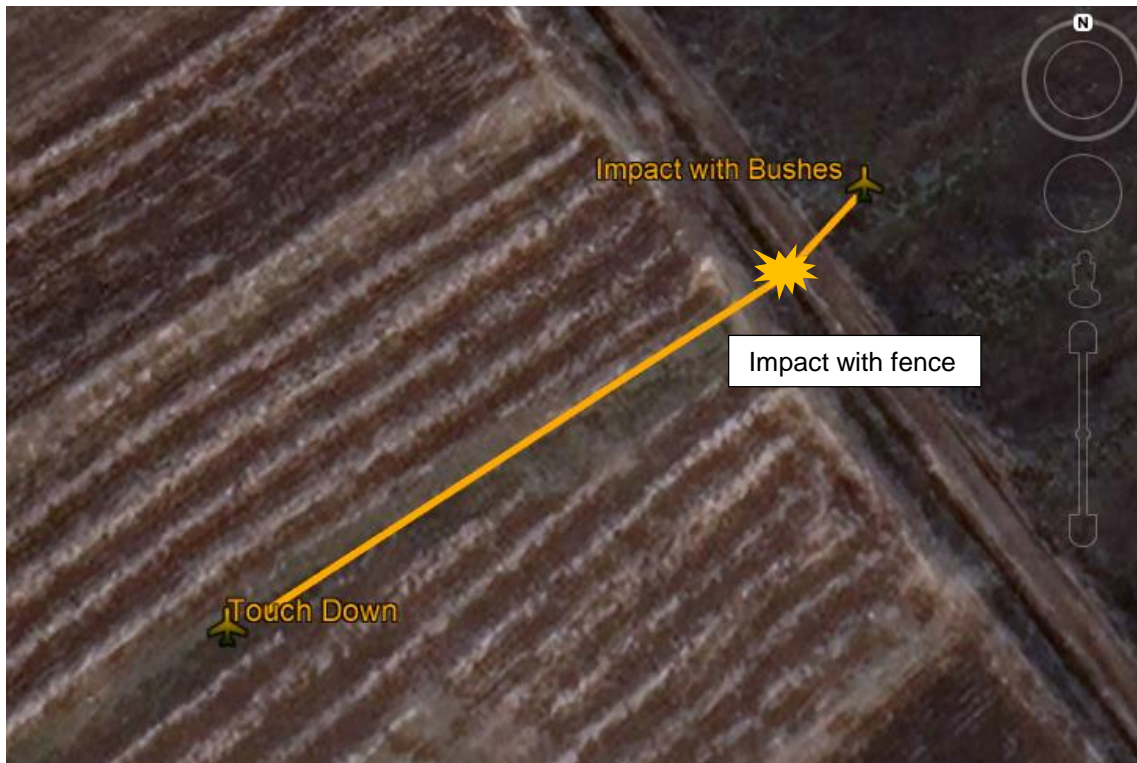
1.12.1. The aircraft successfully touched down after the forced landing and rolled on an uneven terrain for 60m before the propeller blades impacted a perimeter fence, flattening it. The aircraft continued to roll to the other side of the fence, ground-looped whilst making an approximate 90° turn. It then impacted some bushes before it came to a stop with the nose facing south-east.

**Figure 5:** The path of the aircraft after touchdown. (Source: Google Earth)

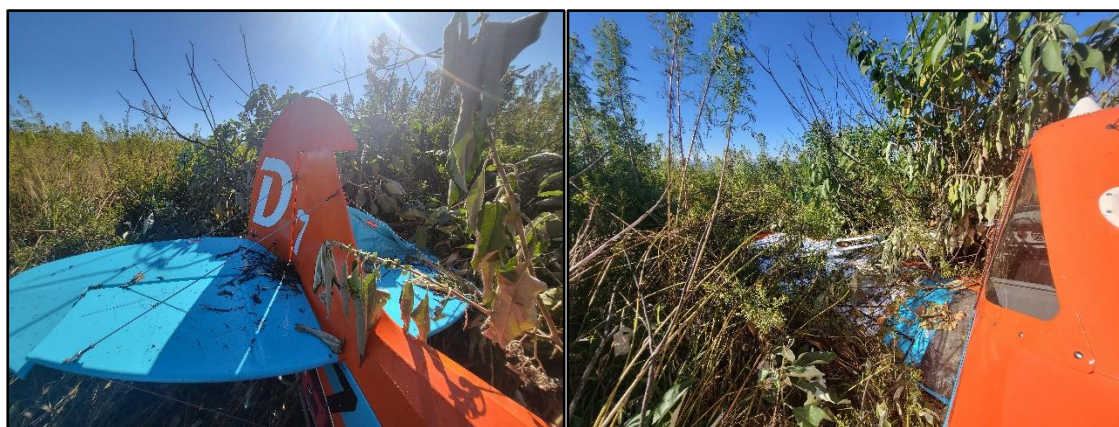
The fuselage was fairly intact with signs of damage on both wings' leading edges after impacting the perimeter fence. The left elevator and left-wing leading edge sustained greater impact damage as the aircraft's left-side impacted the bushes and the spray system equipment.

**Figure 6 and 7:** Damage to the left elevator (left); and left-side wing embedded in the bushes (right).

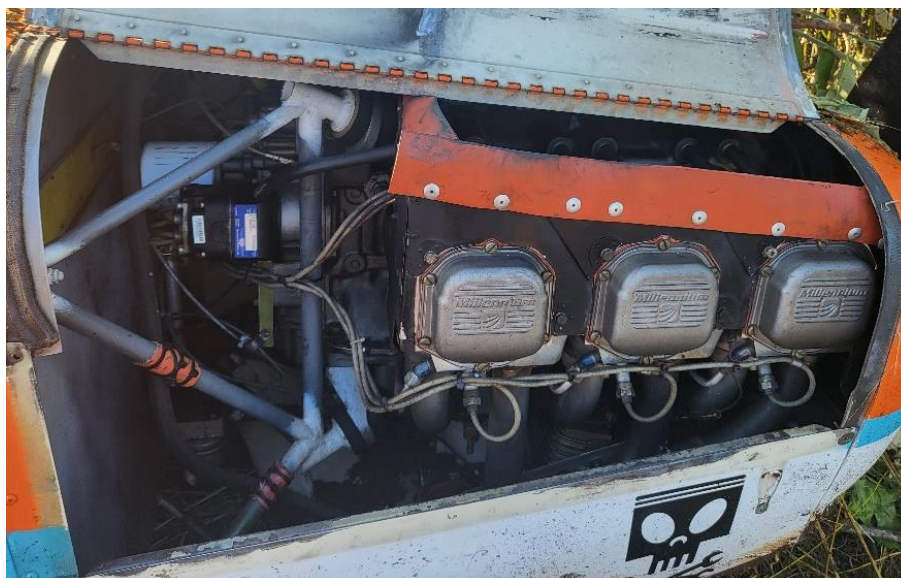
The engine was intact and was found still attached to the cradle with no sign of oil or fuel spillage. Both propeller blades were still attached to the hub with no signs of rotational signatures. One blade was found lodged firmly into the ground.

**Figure 8:** The condition of the engine compartment as it was found at the accident site.

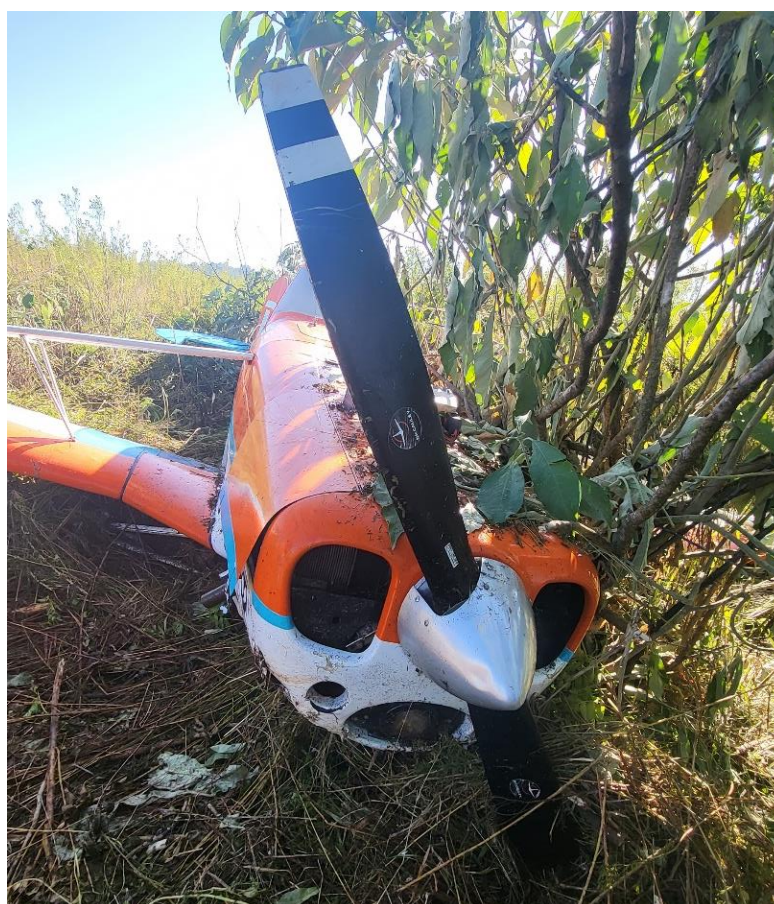
**Figure 9:** The final position of the propeller.
