PRELIMINARY ACCIDENT REPORT

Accident and Incident Investigations Division

Accident
- Preliminary Report -
AIID Ref No: CA18/2/3/10144

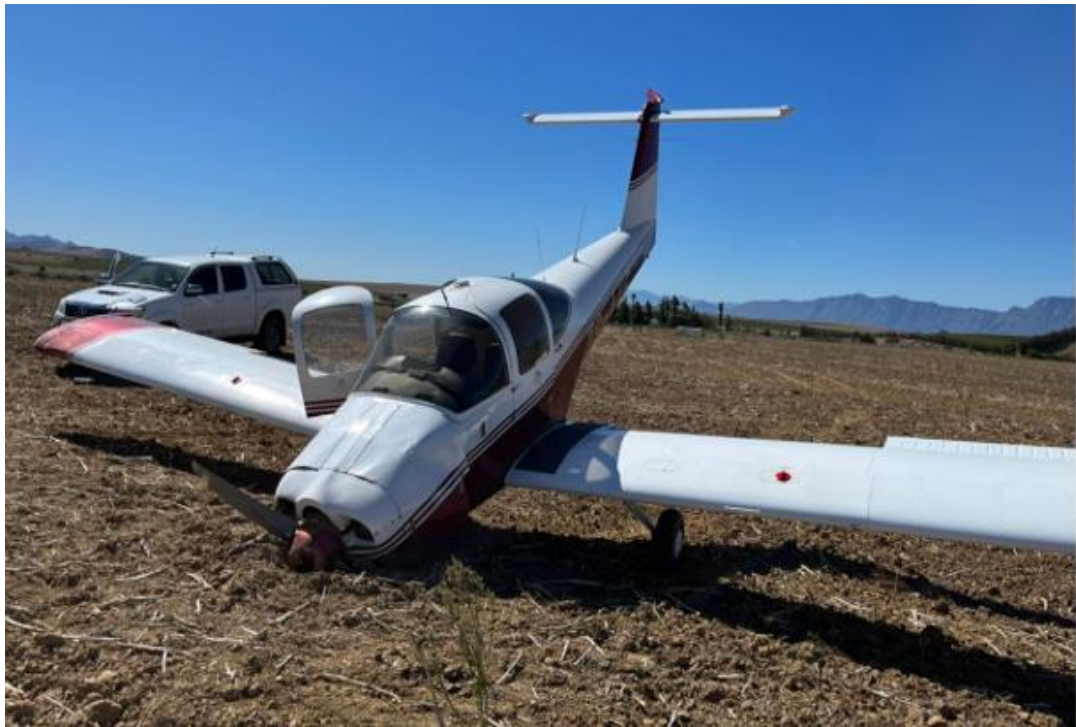
- 1.3.1. The aircraft sustained substantial damages to the nose landing gear and nose section, as well as the propeller hub.

Figure 2: The aircraft as it came to rest. (Source: ATO)

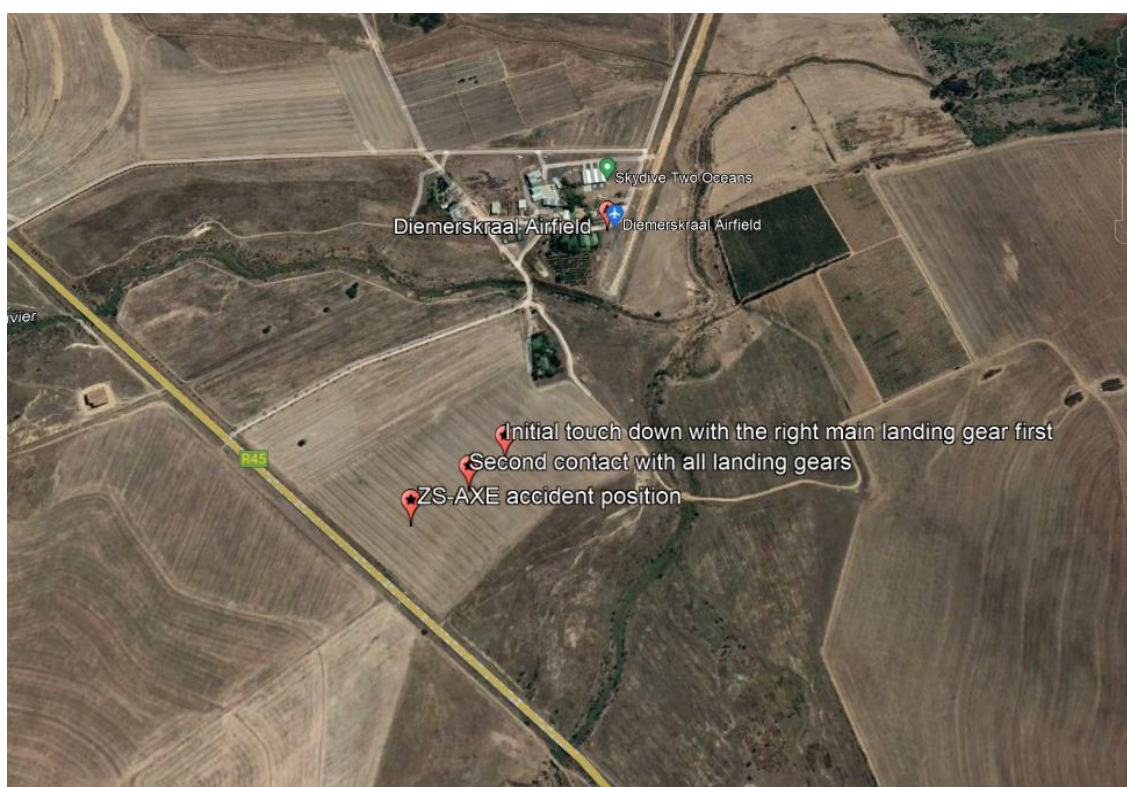
1.12.1. The accident occurred on a private farm, about 540m from the threshold of Runway 04 at Diemerskraal Aerodrome.

Figure 3: Aerial view of the accident site. (Source: Google)

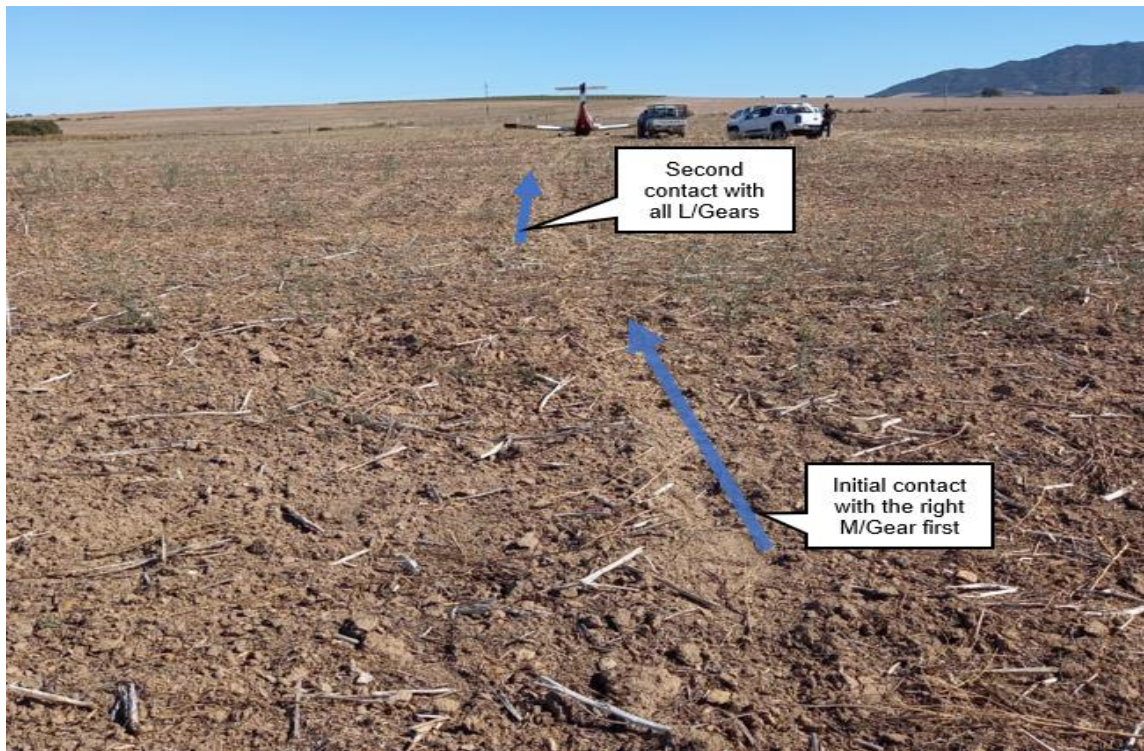
- Initially, the aircraft touched down on its right main landing gear first and rolled for approximately 17 metres, followed by the left main landing gear, and then the nose landing gear; all three gears remained in contact with the ground for approximately 7m. Thereafter, the aircraft subsequently bounced and contacted the ground, then bounced again, but this time, touching the ground with the nose gear first.

Figure 4: The aircraft's ground markings during the accident. (Source: Operator)

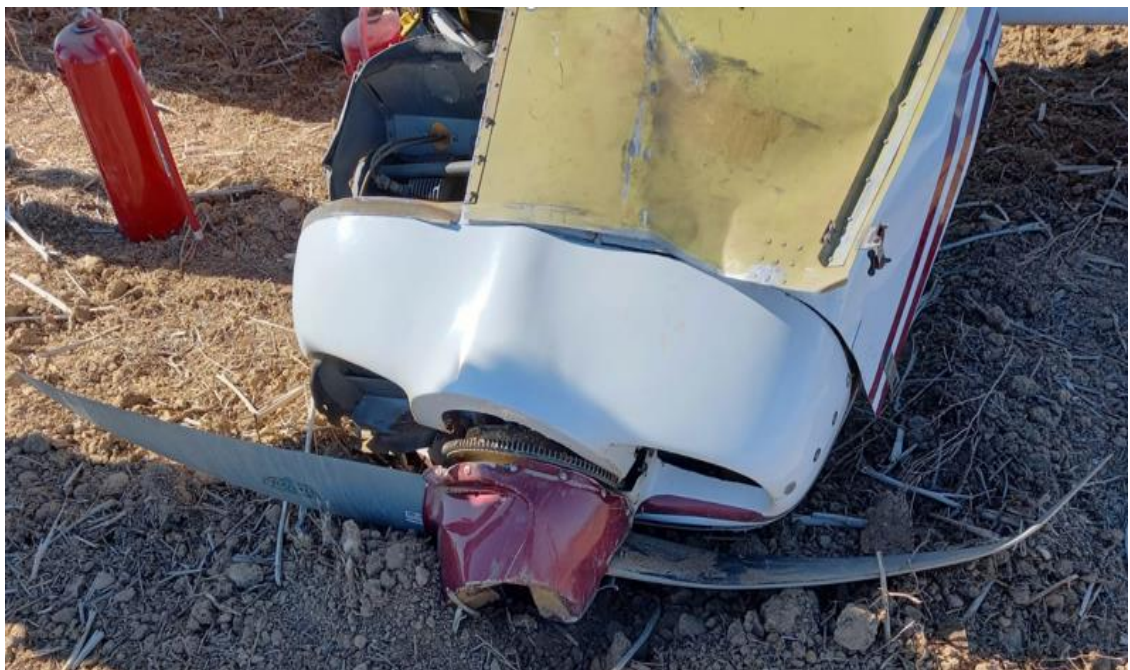
- The nose landing gear bent backwards, causing the aircraft's nose to drop. This led to the propeller hub and the propeller contacting the ground, followed by the nose section.

Figure 5: The damaged propeller hub and propeller blades.

- The propeller hub was destroyed during the accident sequence, and one of the propeller blades was damaged. The damage on the propeller blade was consistent with the propeller that was not turning or either wind-milling at the time of impact with the ground.

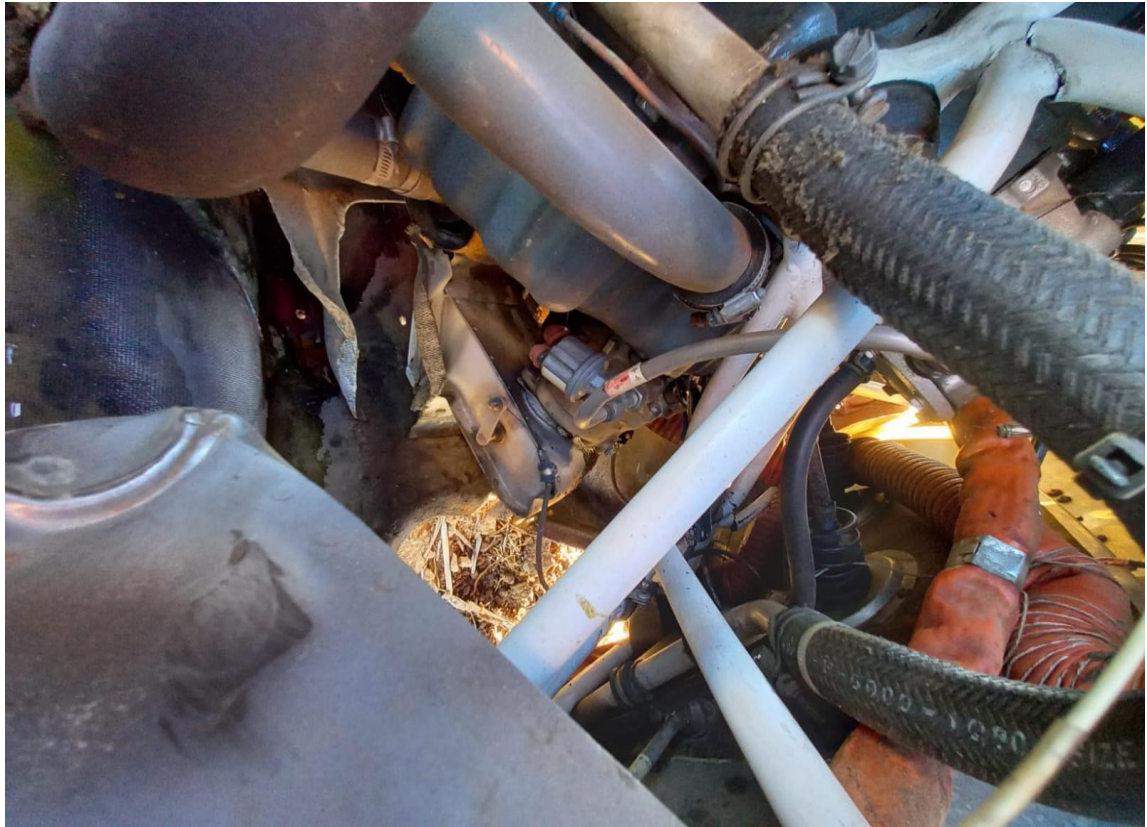
Figure 6: Damages sustained in the engine compartment and bent engine mountings.

- The engine compartment and engine mountings sustained impact damages. The nose landing gear caused damages to the bottom engine compartment.
- There was evidence of fuel leak from the bottom of the fuselage. The damage around the part where fuel was leaking could be associated with damage caused during the accident sequence.
