PRELIMINARY ACCIDENT REPORT

Accident and Incident Investigations Division

Accident
 - Preliminary Report -
 AIID Ref No: CA18/2/3/10160

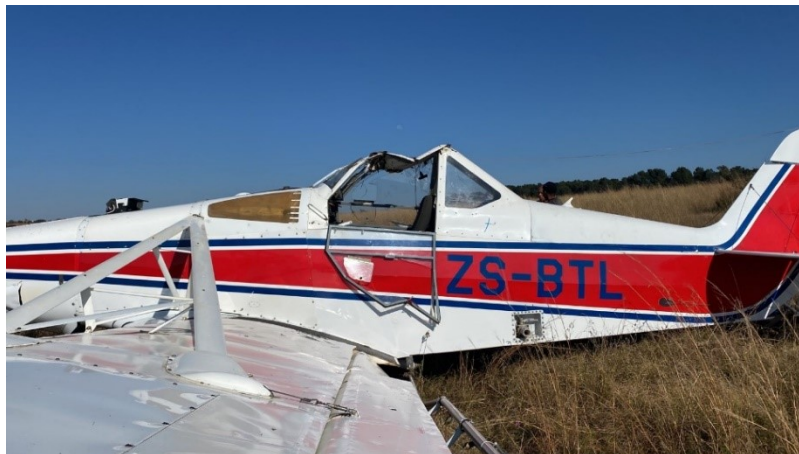
Figure 3: The aircraft post-accident. (Source: AMO)

1.3.1. The aircraft sustained substantial damage.

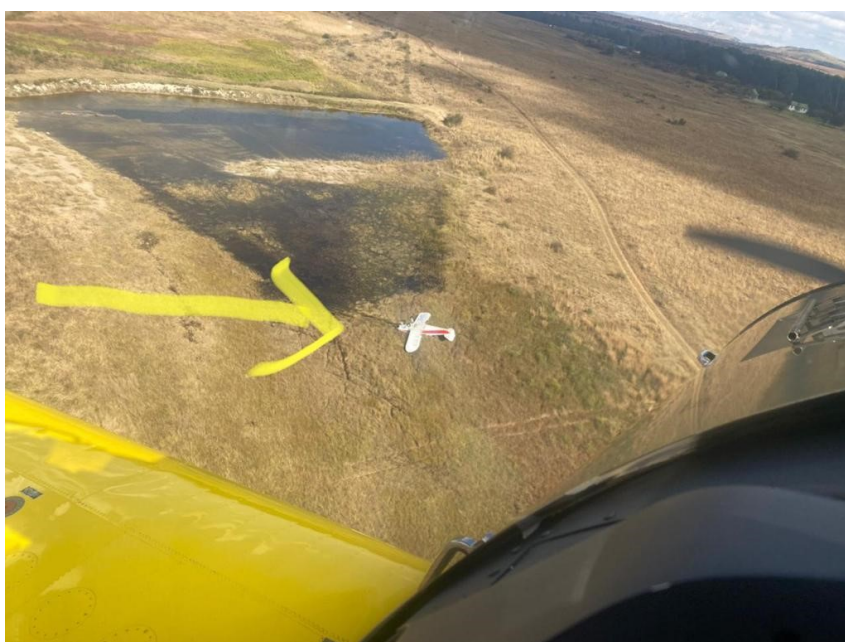
Figure 4: Wreckage location picture taken by another pilot on an aircraft. (Source: Pilot)

1.12.1. The accident occurred on a private farm, approximately 910 metres (m) north-west of the threshold of Runway 21 at FAPS on a grass field.

1.12.2. Due to the type of terrain the aircraft landed on, after touchdown, the aircraft ran over a body of water which led to the main wheels sinking into the muddy soil, bringing the aircraft to an abrupt stop. The aircraft nosed over and came to rest in an inverted position.

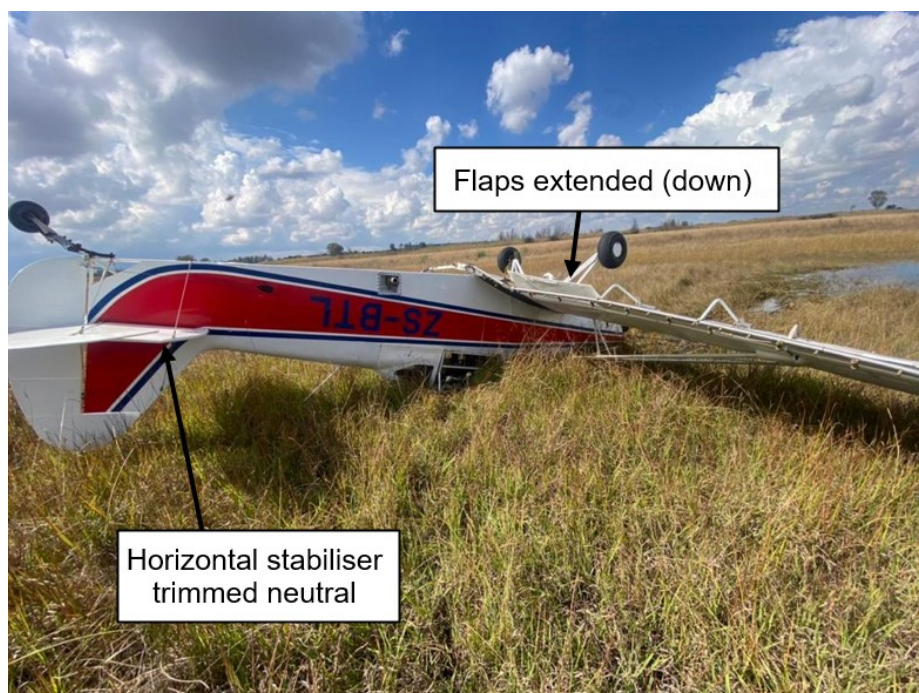
Figure 5: The aircraft as it came to rest in the grass field. (Source: Pilot)

1.12.3. The aircraft's wings and vertical stabiliser were damaged.
