PRELIMINARY ACCIDENT REPORT

Accident
- Preliminary Report -
AIID Ref No: CA18/2/3/10030

Reference Number : CA18/2/3/10030
Name of Owner/Operator : Simon Bennett
Manufacturer : Piper Aircraft Company
Model : PA-18A-150 (Super Cub)
Nationality : South African
Registration Marks : ZS-CKP
Place : Port Alfred (FAPA), Eastern Cape province
Date : 23 August 2021
Time : 1035Z

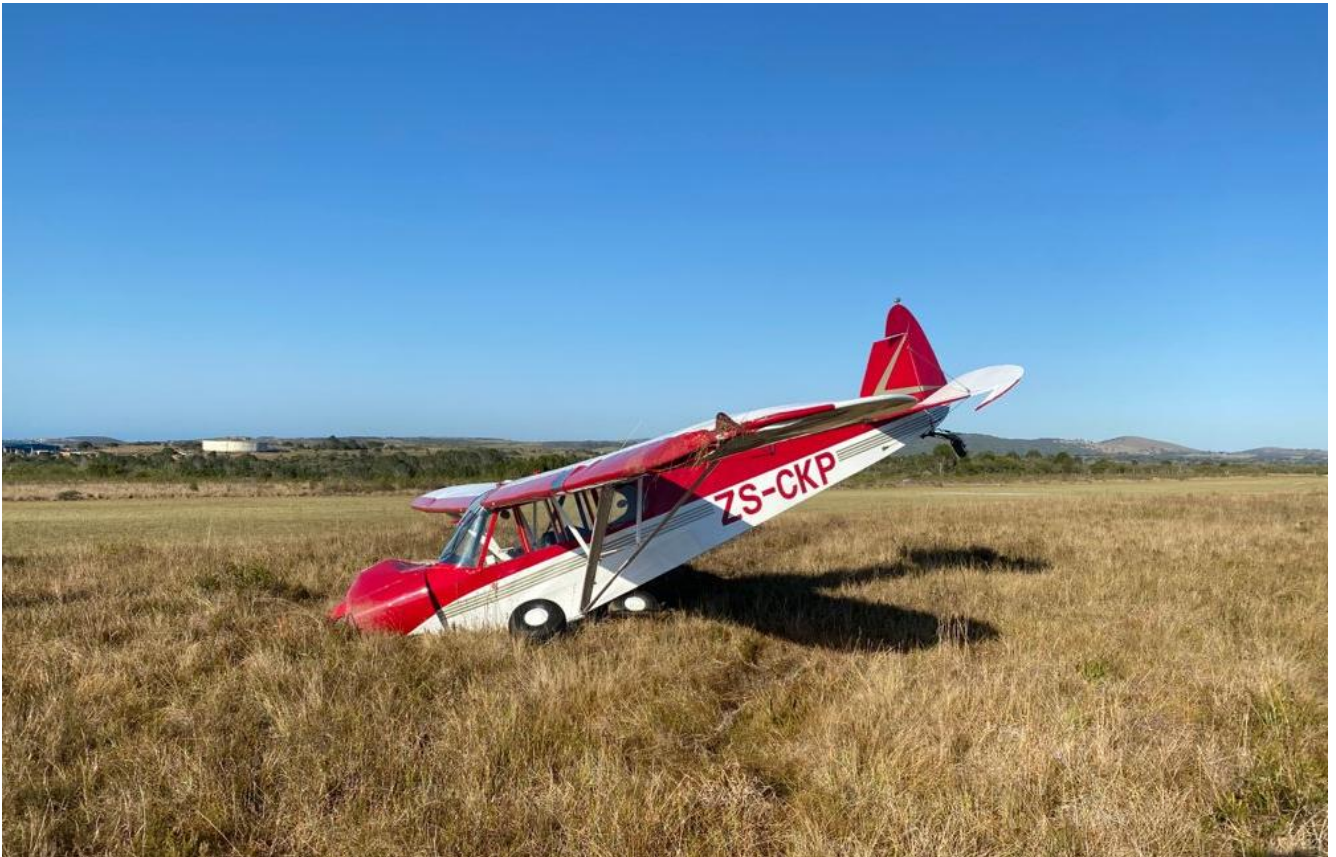
Figure 1: The aircraft as it came to rest. (Source: Pilot)

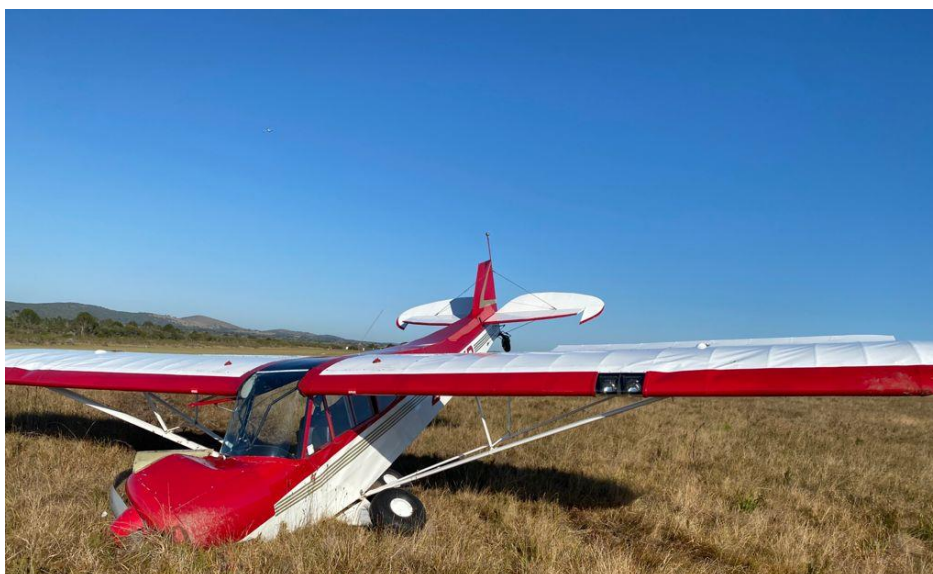
1.3.1 The aircraft sustained substantial damage to the propeller, landing gear and fuselage.

Figure 3: The aircraft sustained damage to the propeller, landing gear and fuselage.

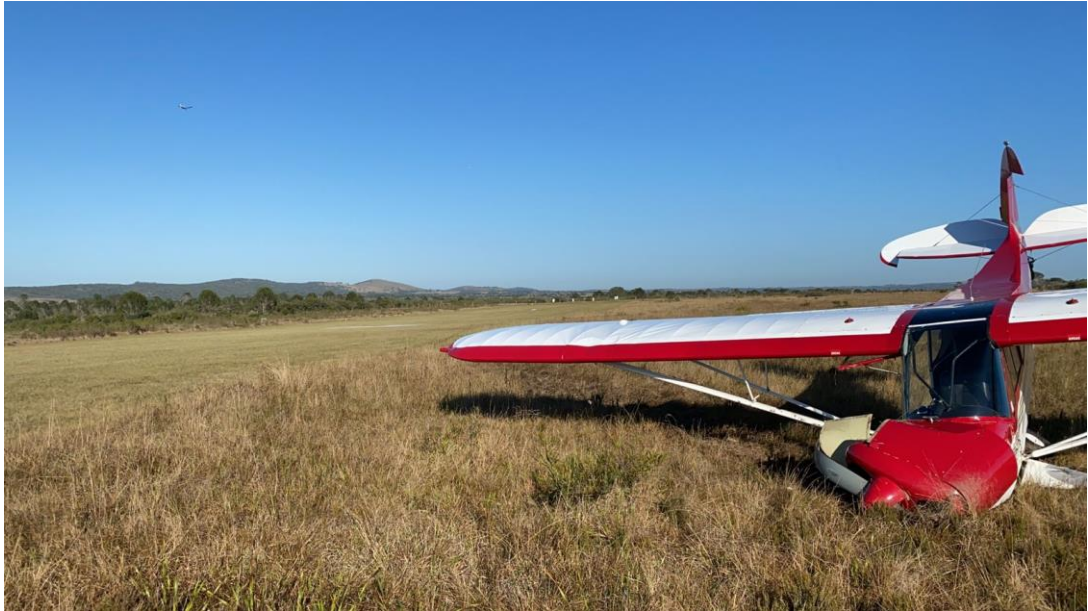
1.12.1 The pilot executed a forced landing on RWY10L at FAPA, however, the aircraft overshoot the runway. The aircraft landed hard with the main landing gear first on the left-side of the runway, sustaining damage to the main landing gear, propeller and fuselage.

Figure 4: The aircraft as it came to rest.
