PRELIMINARY ACCIDENT REPORT

Accident
- Preliminary Report -
AIID Ref No: CA18/2/3/10165

Reference Number : CA18/2/3/10165
Occurrence Category : Category 2
Type of Operation : Private (Part 91)
Name of Operator : Private
Aircraft Registration : ZS-CSL
Aircraft Make and Model : Piper PA-24-250
Nationality : South African
Registration Marks : ZS-CSL
Place : Panorama Airfield
Date and Time : 26 May 2022 at 1520Z
Injuries : Serious
Damage : Substantial

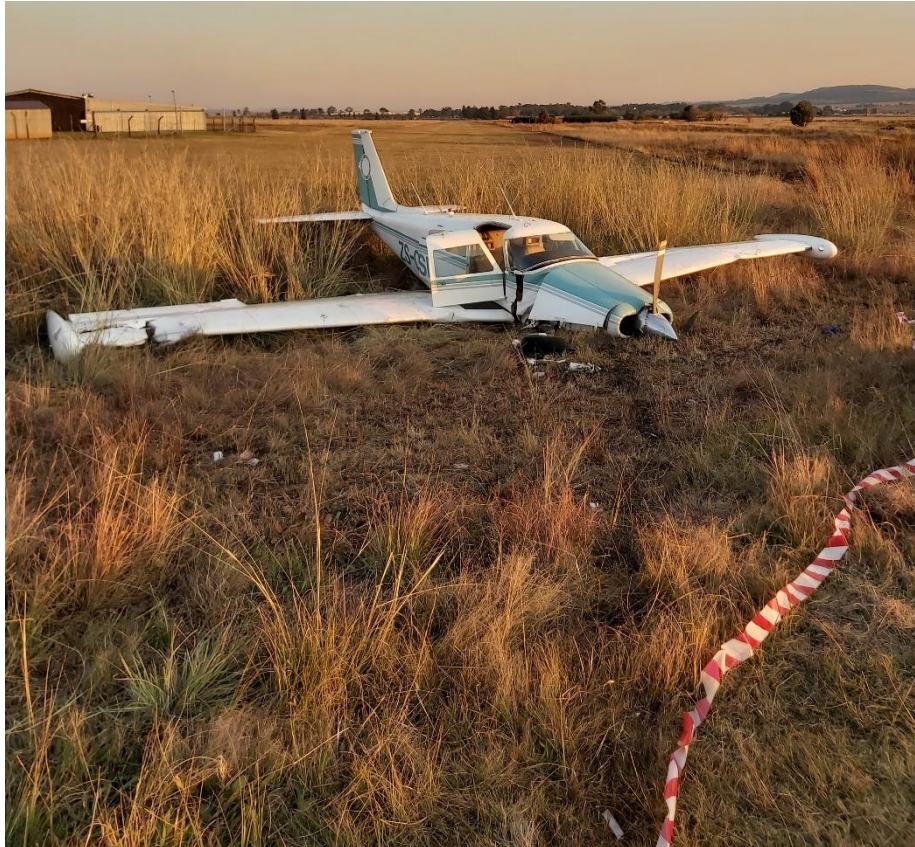
Figure 1: The aircraft after the accident.

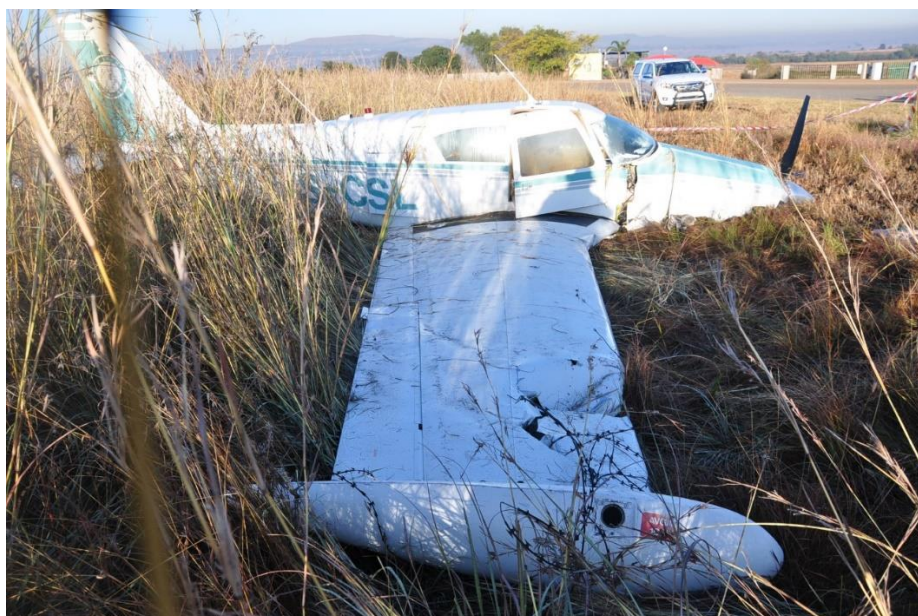
1.3.1. The aircraft sustained substantial damage to the propeller blades, both wings, underbelly, landing gear and the cockpit.

Figure 3: The aircraft at the scene post-accident.

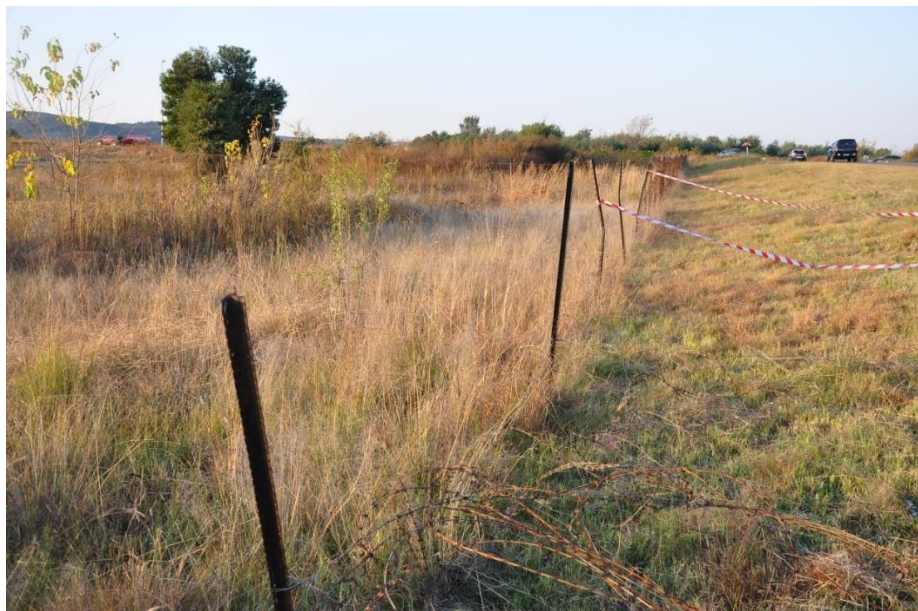
1.4.1. The perimeter fence opposite the FAKR was damaged.

Figure 4: The perimeter fence that the main undercarriage got caught on.

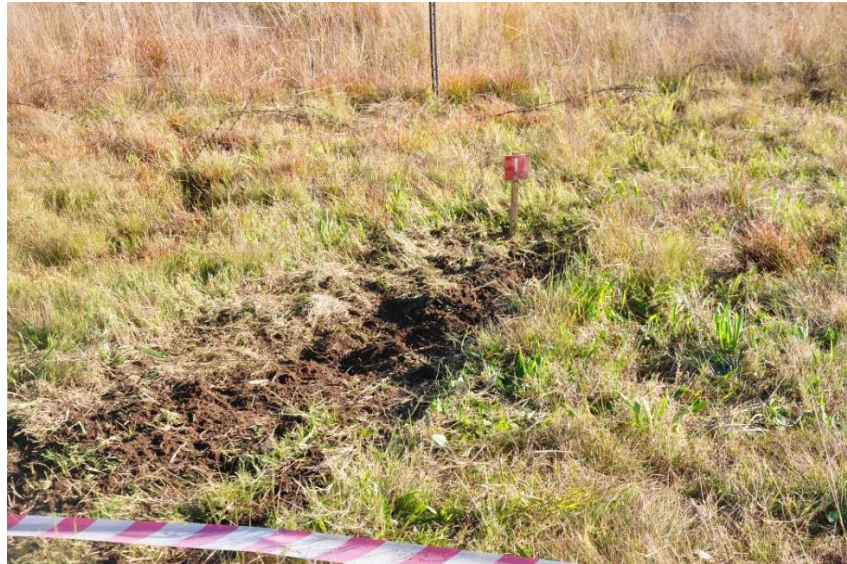
1.12. Wreckage and Impact Information

Figure 5: The first impact with the ground just beyond the barbed wire fence.

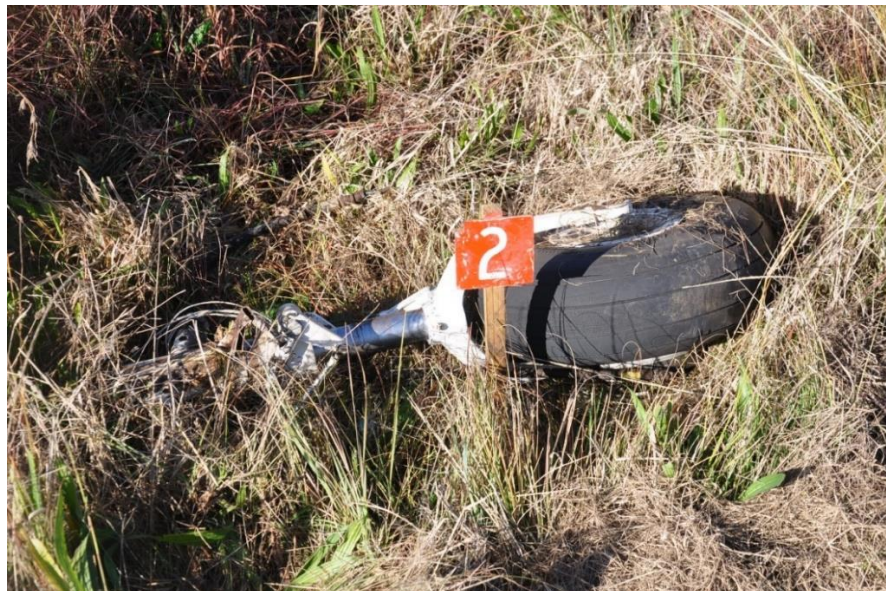
Figure 6: The main undercarriage strut and the wheel that broke off.

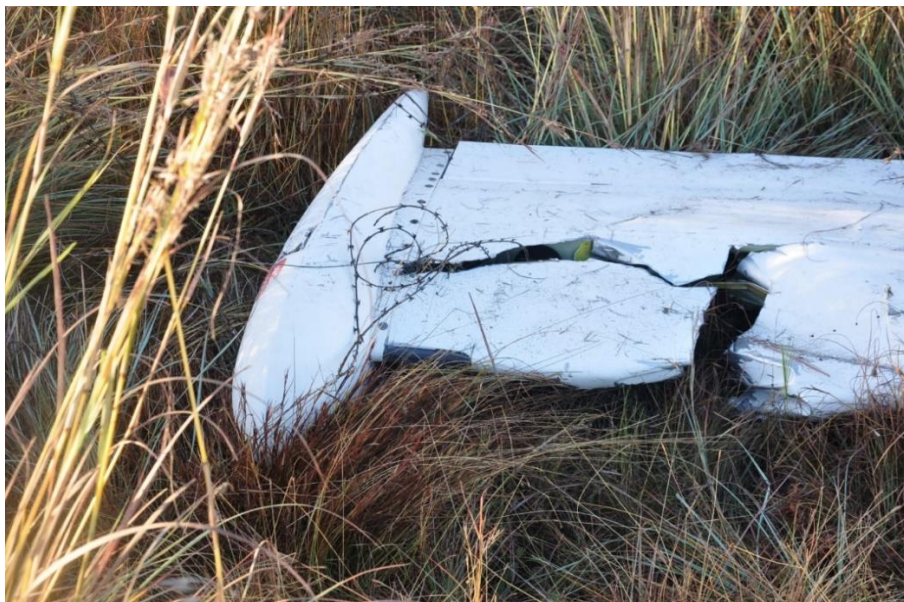
Figure 7: The right wing that hit the fence post.

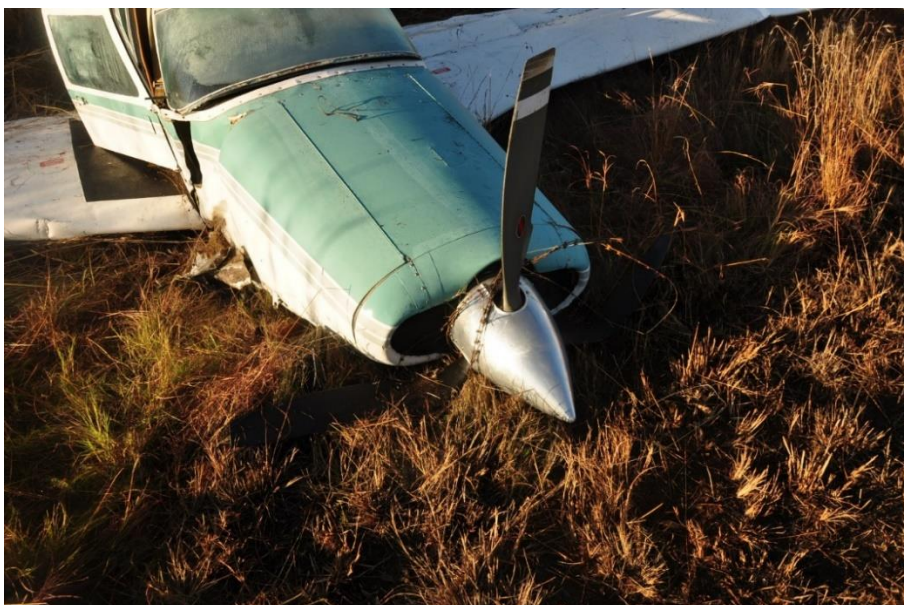
Figure 8: The propeller with the barbed wire fence around it. The propeller blades indicate that the engine was not under power during impact.
