**PRELIMINARY ACCIDENT REPORT****Accident and Incident Investigations Division**

Accident  
- Preliminary Report -  
AIID Ref No: CA18/2/3/9891

**Figure 1:** The ZS-EBC aircraft. (<https://www.jetphotos.com>)

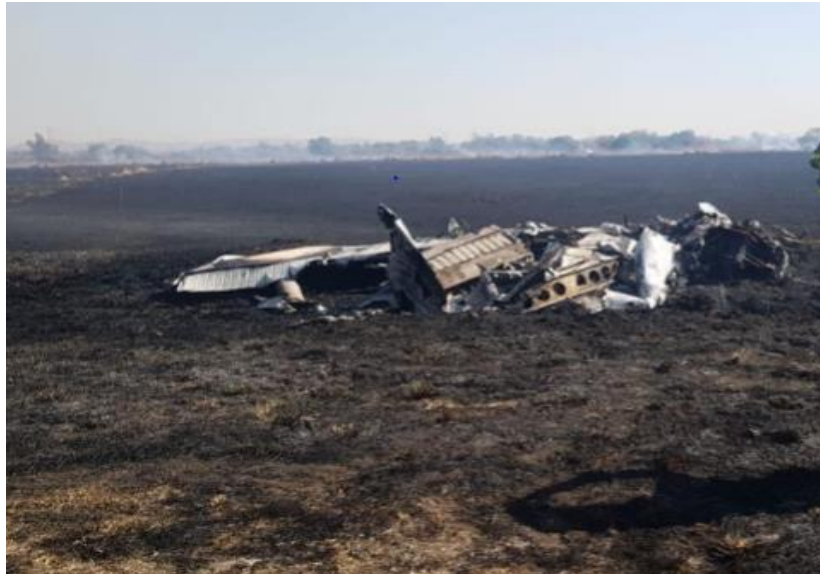
1.3.1 The aircraft was destroyed during the accident sequence.

**Figure 3:** The wreckage at the accident site.

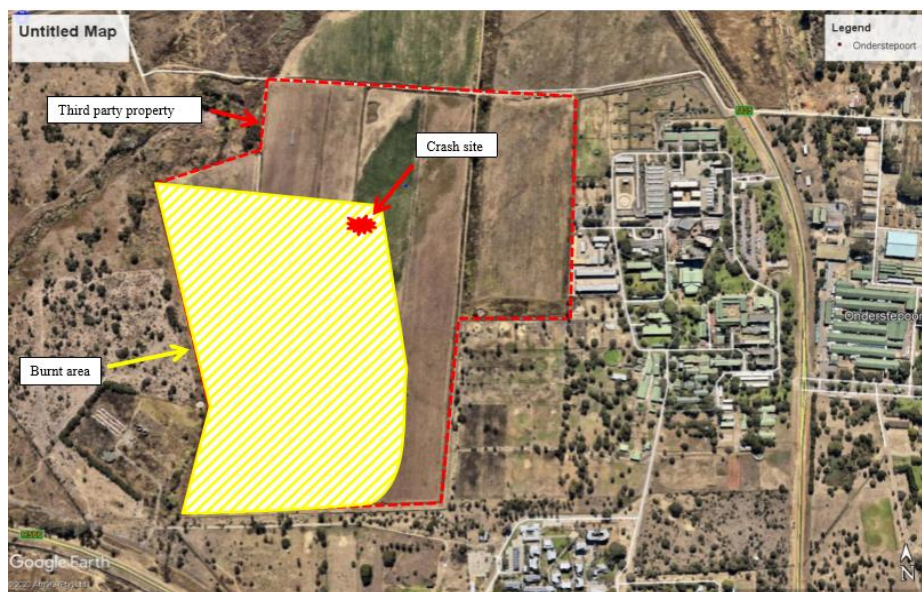
1.4.1 The farmer estimated that approximately 130 bales of Teff hay were burnt and approximately 4 unharvested Teff hay (potentially 400 bales) were also burnt.

**Figure 4:** The burnt portion of the farm after the accident. (Source Google Earth)

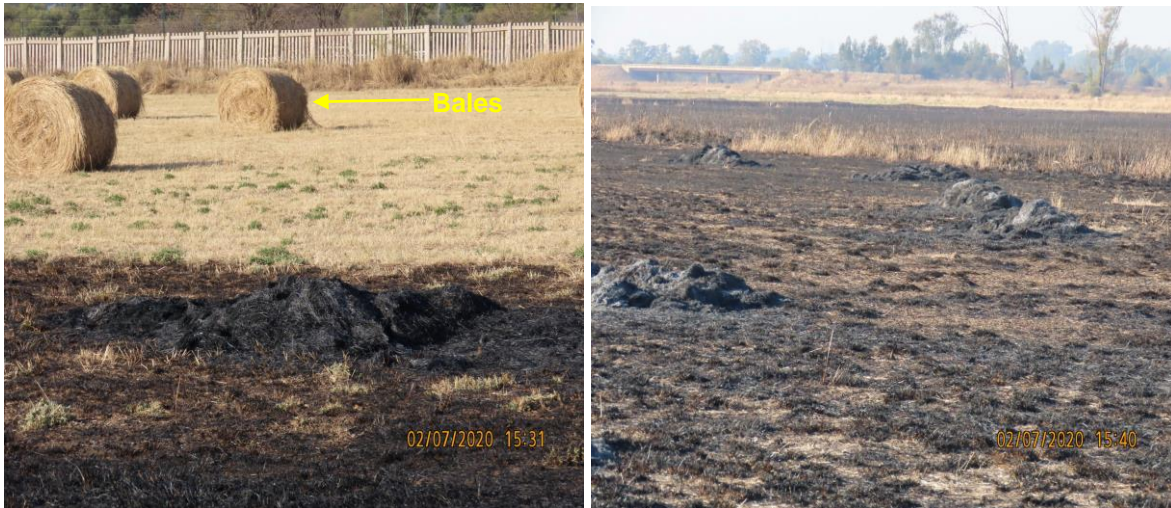
**Figures 5/6:** Bales that survived the fire and some that burnt to ashes.

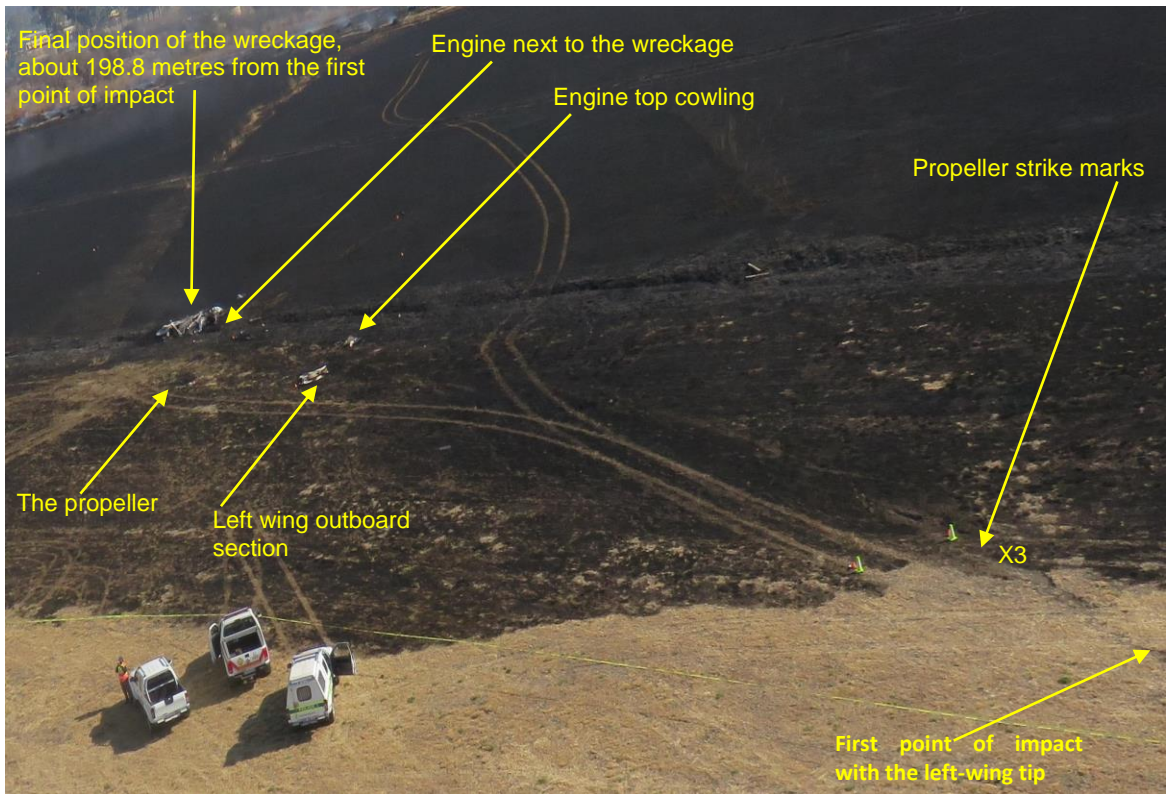
1.12.1 The examination of the accident site confirmed that the aircraft was in a left-wing low nose-down attitude when it crashed. The accident happened on a privately-owned farm located behind the university campus at 230° magnetic heading. The aircraft came to rest approximately 98.8 metres from the first point of impact. The fuselage was destroyed by impact and fuel-fed fire that erupted post impact. The distribution of the aircraft parts indicated that the aircraft had little forward momentum on impact. All the aircraft control surfaces were identified at the accident site and the flaps were found in a retracted position. There was no evidence of in-flight break-up or post-impact fire. The left-wing outboard section broke-off during the accident sequence, coming to rest about 65 metres from the main wreckage; fuel from the left wing ignited.

1.12.2 Three propeller strike marks were noticed at the first point of impact, followed by a shallow impression made by the forward edge of the bottom of the engine cowling. The aircraft nosed over, and the right-wing fuel tank ruptured; and the engine separated from the cradle during the accident sequence. The propeller also separated from the crankshaft flange and was located about 12 metres from the left side of the main wreckage. (See Figures 8 to 11)

**Figure 8:** The aircraft's first point of impact and the wreckage layout.

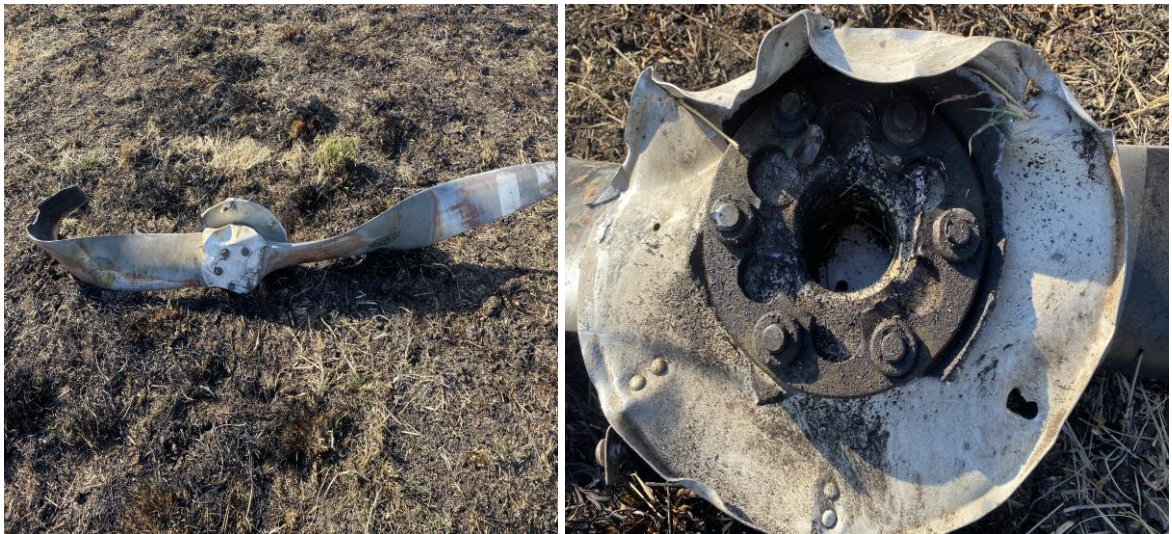
**Figures 9/10:** The condition of the propeller and the crankshaft flange found at the accident site.

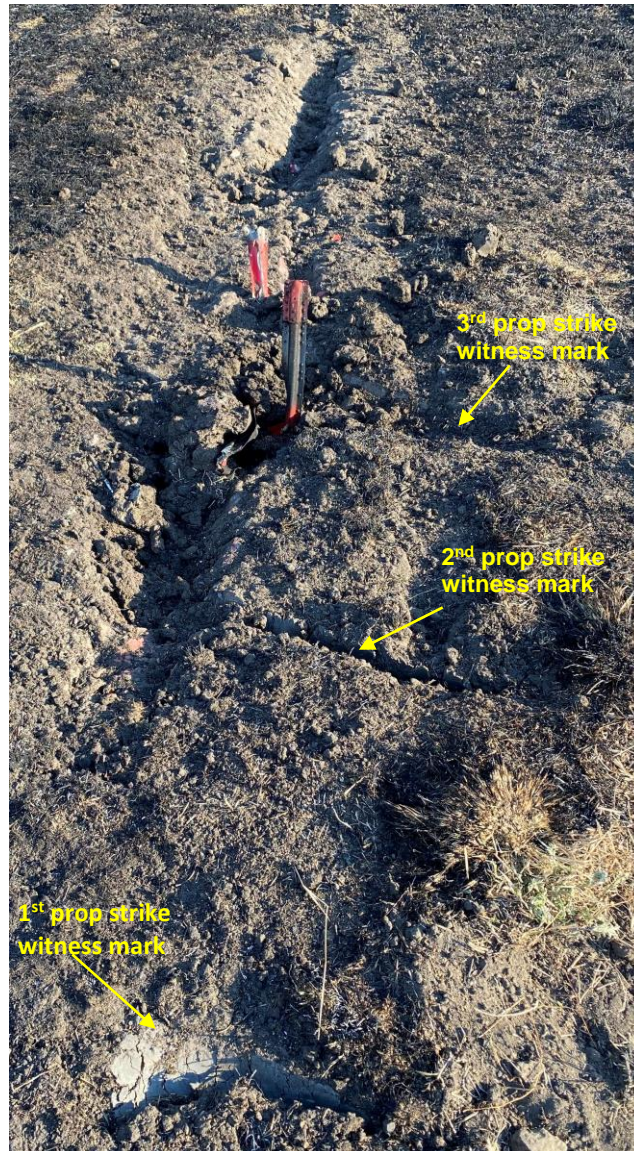
**Figure 11:** Ground marks left by the aircraft's blades.
