PRELIMINARY ACCIDENT REPORT

Accident
- Preliminary Report -
AIID Ref No: CA18/2/3/10087

Reference Number : CA18/2/3/10087
Type of Operation : Private
Manufacturer : Cessna Aircraft Company
Model : Cessna 177, Cardinal
Nationality : South African
Registration Mark : ZS-EZM
Place : 300m east of Baragwanath Aerodrome (FASY), Gauteng Province
Date : 7 December 2021
Time : 0635Z

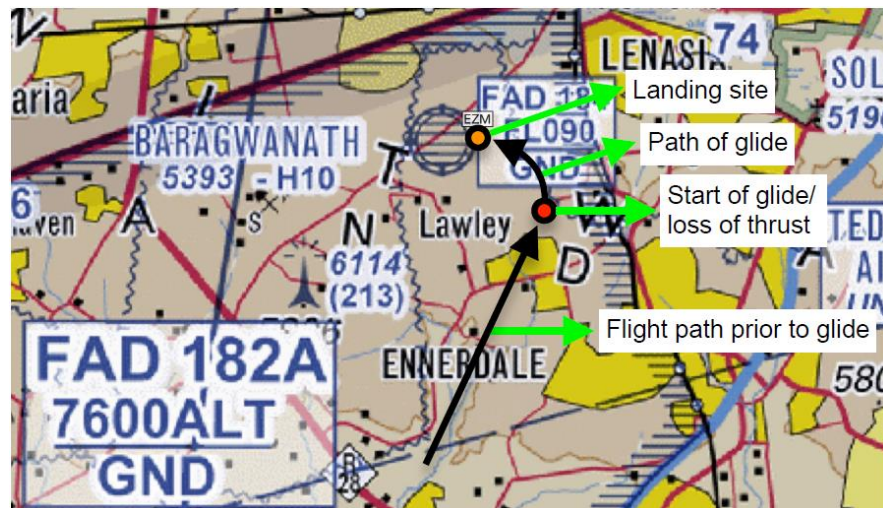
- 1.1.3. The pair took off on a private flight from FAGC at approximately 0600Z. The flight was estimated to be 1.3 hours long. However, at 0635Z, approximately 35 minutes into the flight at 7000 feet (ft) whilst flying north overhead Lawley residential area, which is located on the south of Lenasia in Johannesburg, the engine started to run rough.

Figure 2: Global Positioning System information of flight stages. (Source: Pilot)

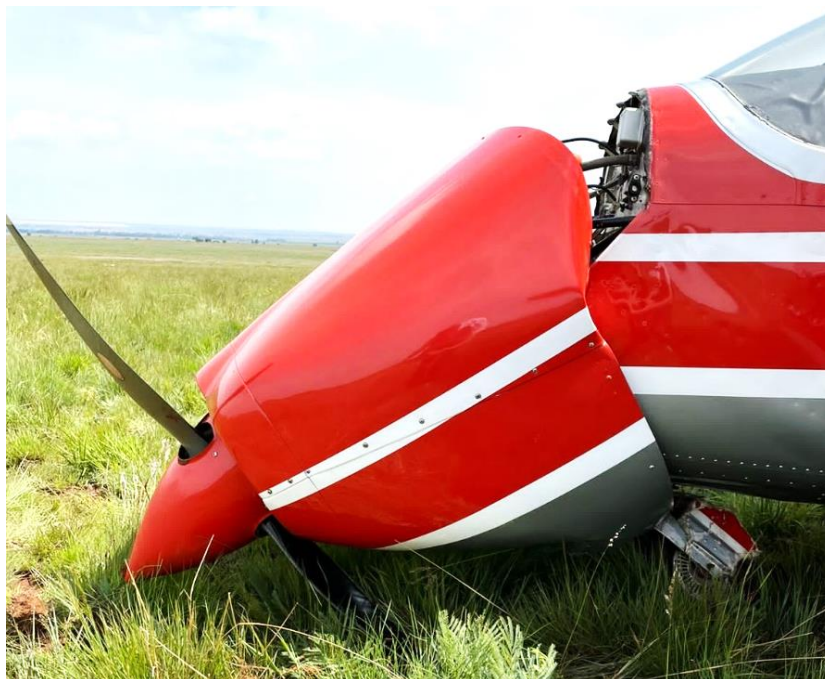
1.3.1. The aircraft was substantially damaged.

Figure 4: The aircraft post-accident. (Source: Pilot)

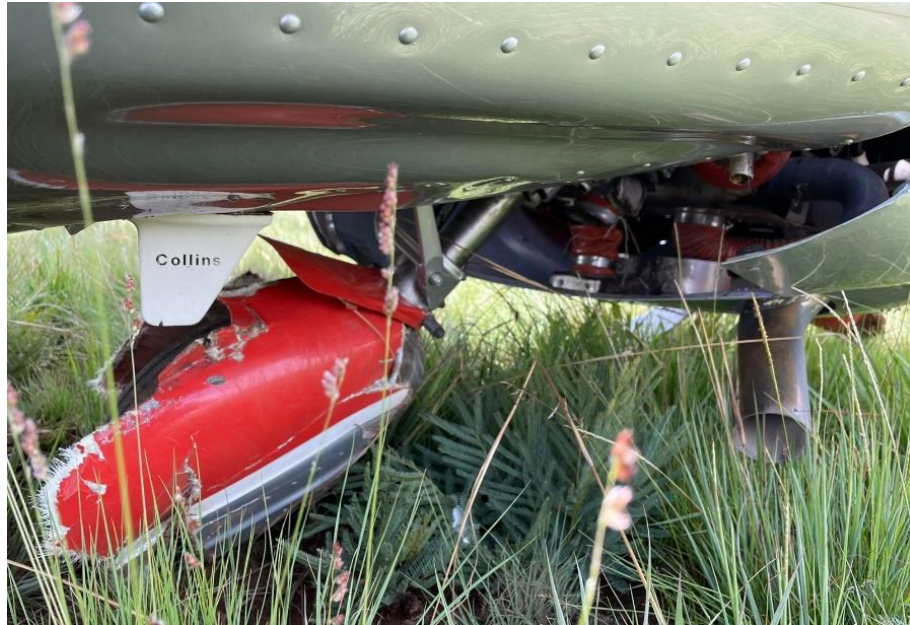
1.12.1. According to the pilot, after the engine had stopped, he glided the aircraft towards FASY; however, the aircraft lost height rapidly, resulting in the aircraft undershooting RWY 31 and landing approximately 300m before the threshold on the hard rugged terrain. The nose gear impacted the hard rugged soil, which brought the aircraft to an abrupt halt.

1.12.2. The cradle separated from the engine. The firewall was damaged, whilst the nose landing strut broke off.

Figure 5: Damaged nose landing gear strut. (Source: Pilot)

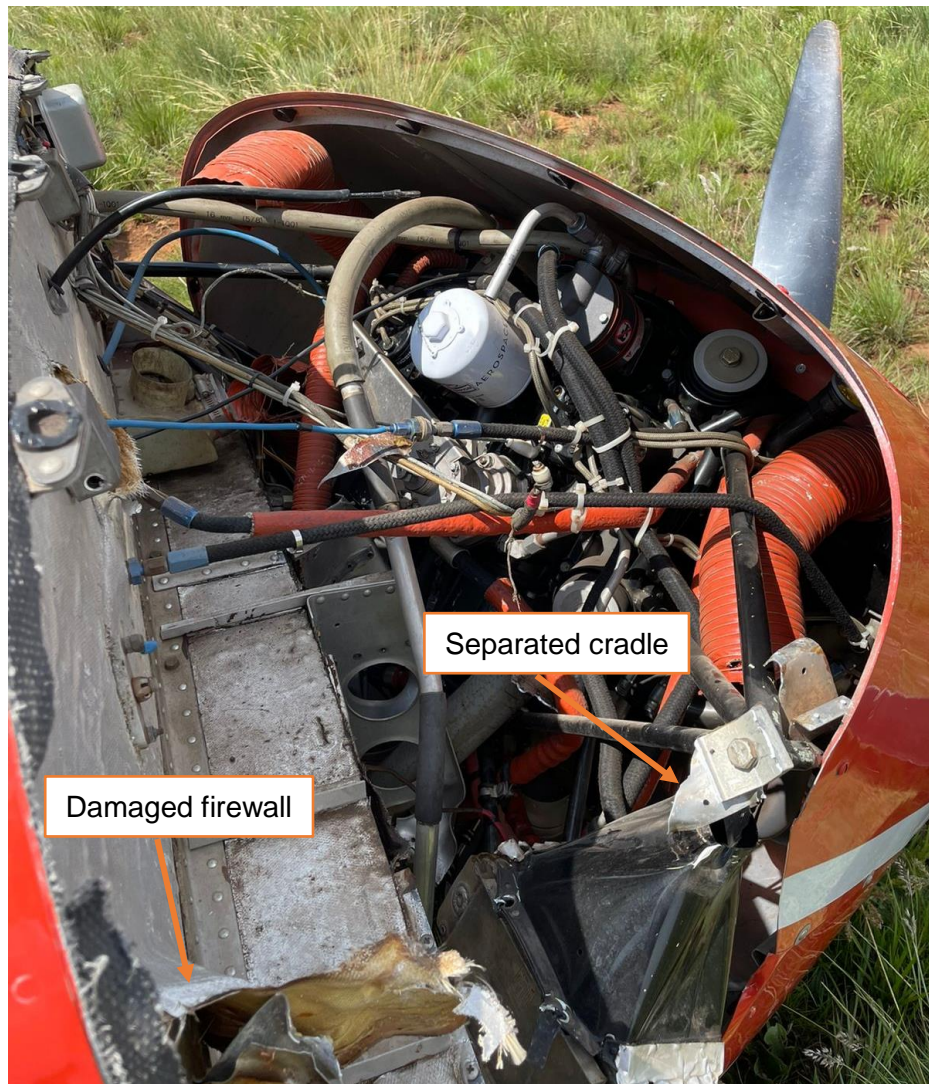
Figure 6: Damaged firewall and separated cradle from the engine. (Source: Pilot)

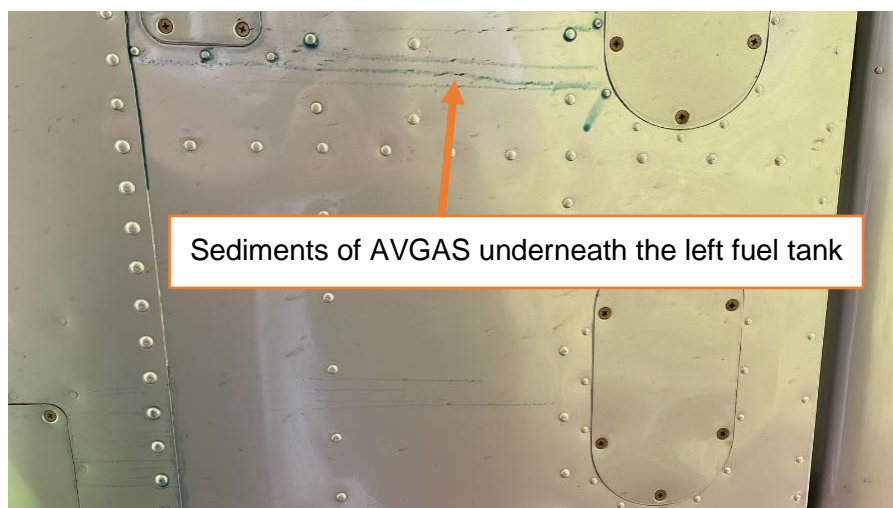
1.12.3. Post-accident, the pilot noticed residue of fuel, characterised by its blue colour, underneath the left fuel tank.

Figure 7: Sediments of AVGAS underneath the left fuel tank. (Source: Pilot)
