PRELIMINARY INCIDENT REPORT

Incident
- Preliminary Report -
AIID Ref No: CA18/3/2/1344

Reference Number : CA18/3/2/1344
Name of Owner/Operator : J.J. Human
Manufacturer : Cessna Aircraft Company
Model : 182L
Nationality : South African
Registration Marks : ZS-FIY
Place : Ermelo, Mpumalanga Province
Date : 22 May 2021
Time : 1145Z

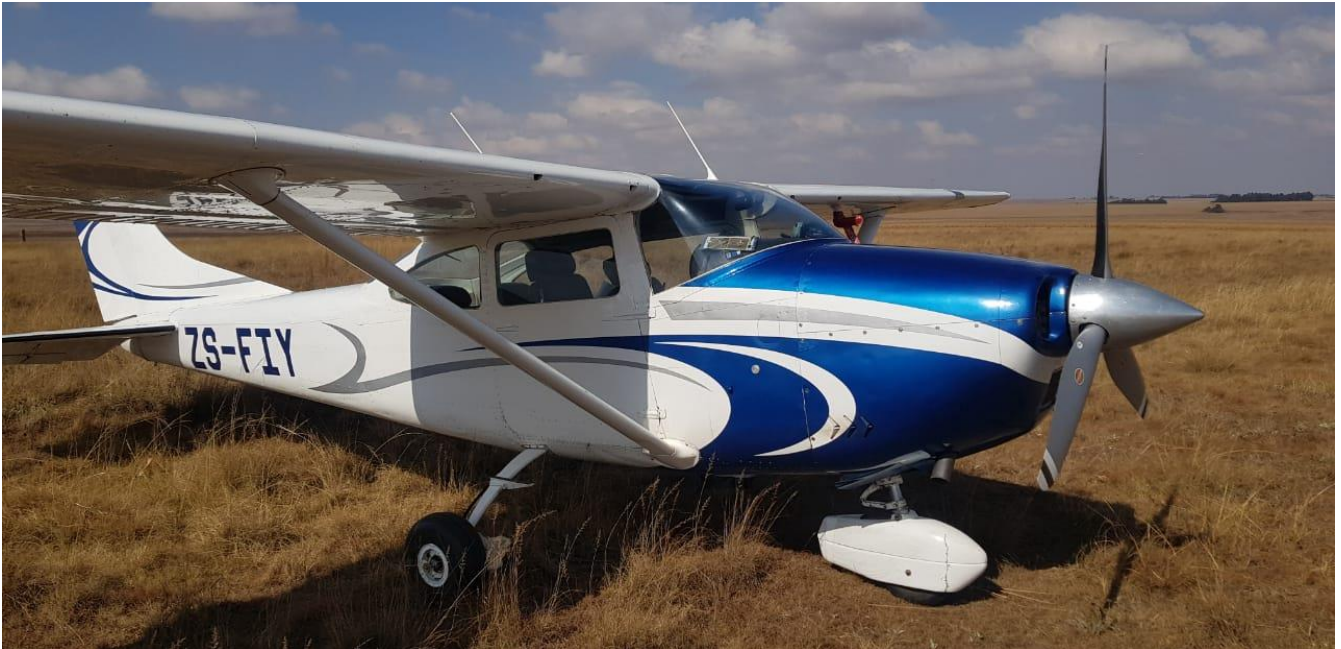
Figure 1: The ZS-FIY aircraft at the incident site. (Source: Pilot)

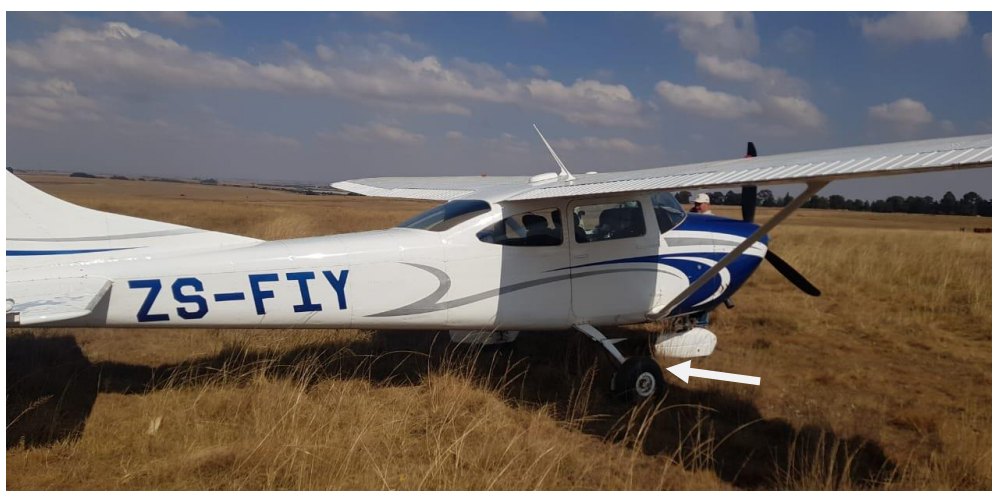
1.3.1. The aircraft sustained substantial damages during the incident sequence.

Figure 3: Damaged wheel fairing post-incident.

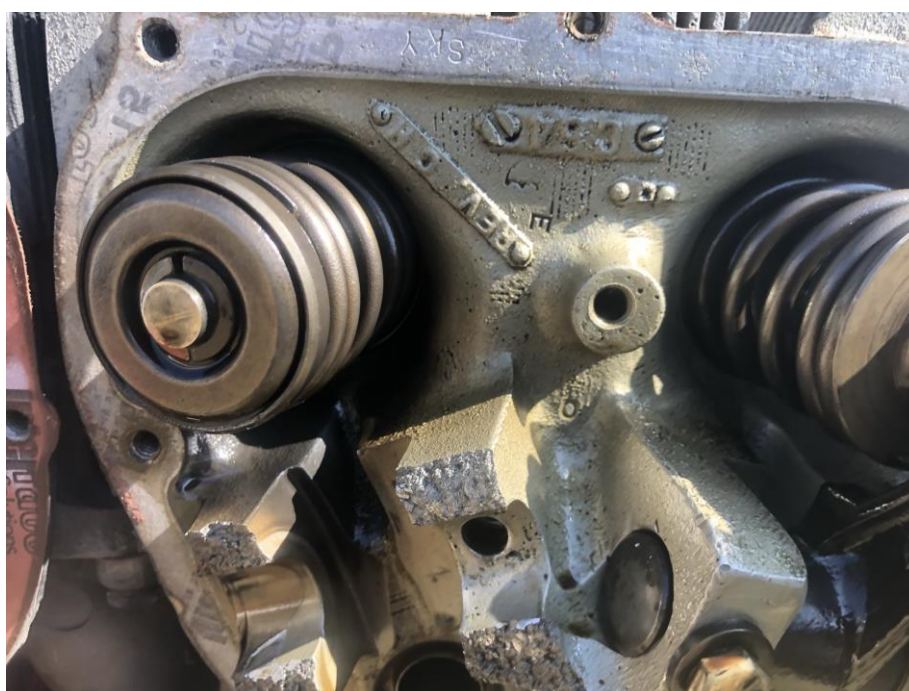
1.12.2 During the emergency landing, the right main landing gear fairing as well as the number 5 cylinder boss were damaged.

Figure 4: Damaged caused to the number 5 cylinder boss.

1.15.1 The incident was considered survivable due to the moderate speed of the aircraft before touch down and during emergency landing. The aircraft's damages were limited to the right main landing gear fairing and the number 5 cylinder.
