PRELIMINARY ACCIDENT REPORT

Accident
- Preliminary Report -
AIID Ref No: CA18/2/3/10188

Figure 1: The Piper PA-28-140 aircraft, registered ZS-FWR (Source: FlightZone Aviation Photography)

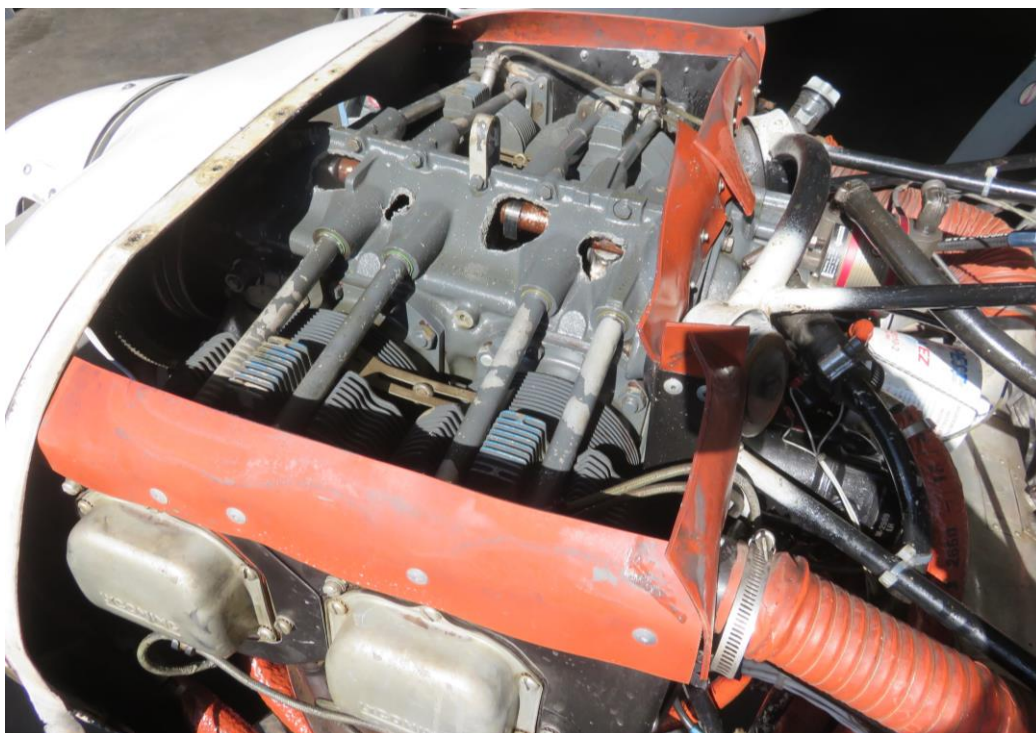
- 1.3.1 Apart from the uncontained engine failure, the only other damage was caused to the left wing and the left main gear that broke off during impact with the anthill.

Figure 3: Damage to the engine crankcase.

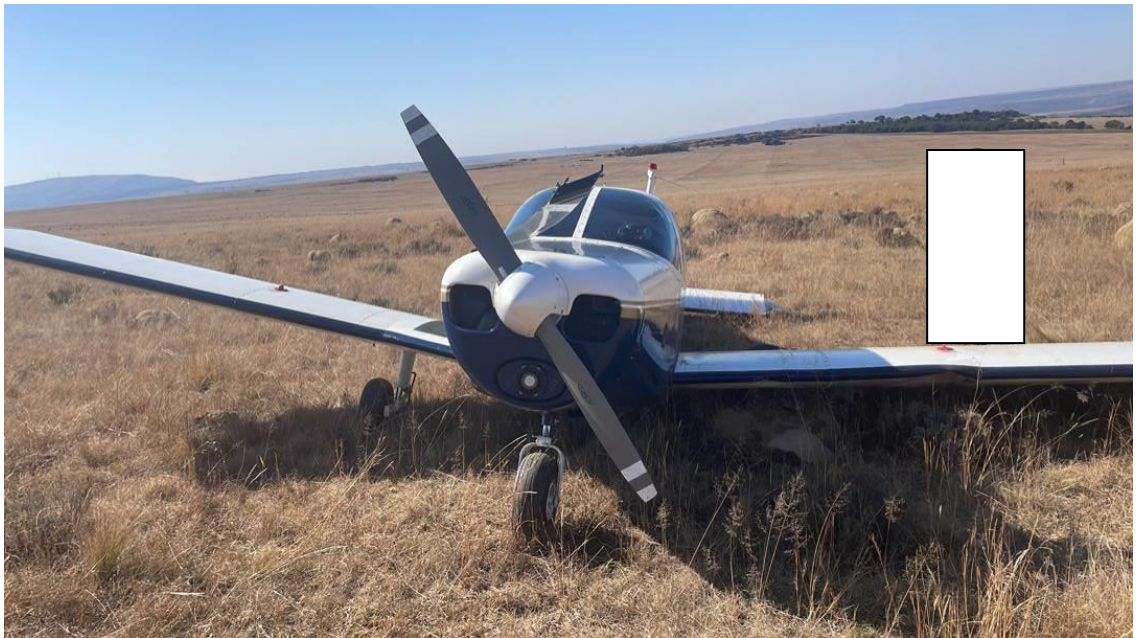
1.12.1 The crew had identified an open field on which they elected to execute a forced landing. The touch down and initial ground roll went without difficulty, but later, the left main landing gear impacted an anthill and broke off, causing substantial damage to the left wing. The engine was also extensively damaged.

Figure 4: The aircraft as it came to rest. (Source: Pilot)

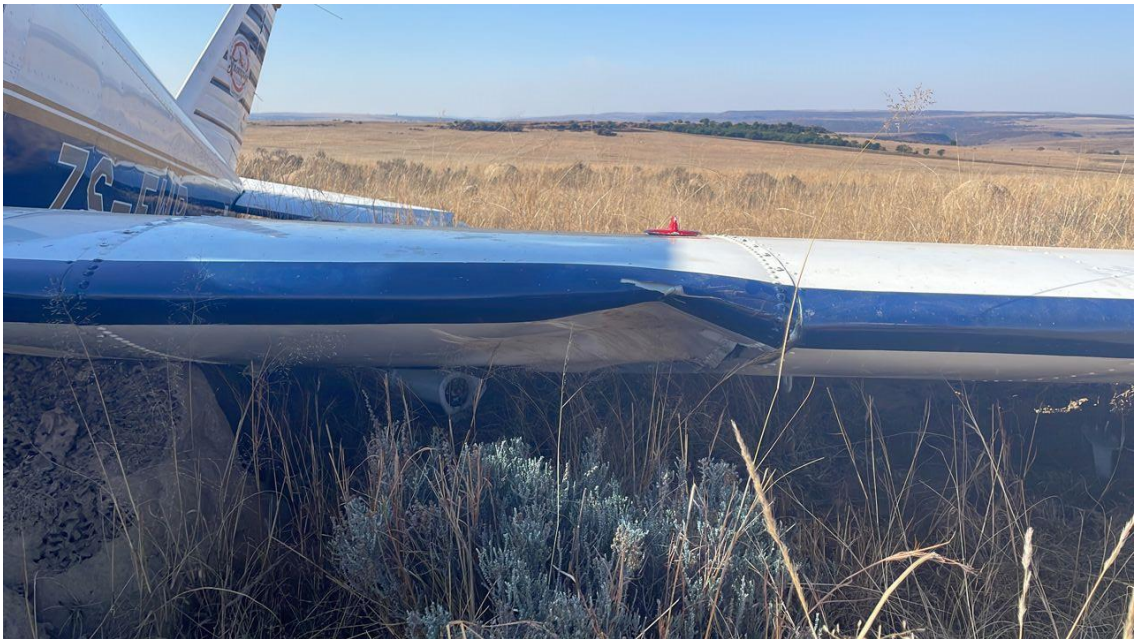
Figure 5: Damage to the left wing caused by the main gear strut that broke off. (Source: Pilot)

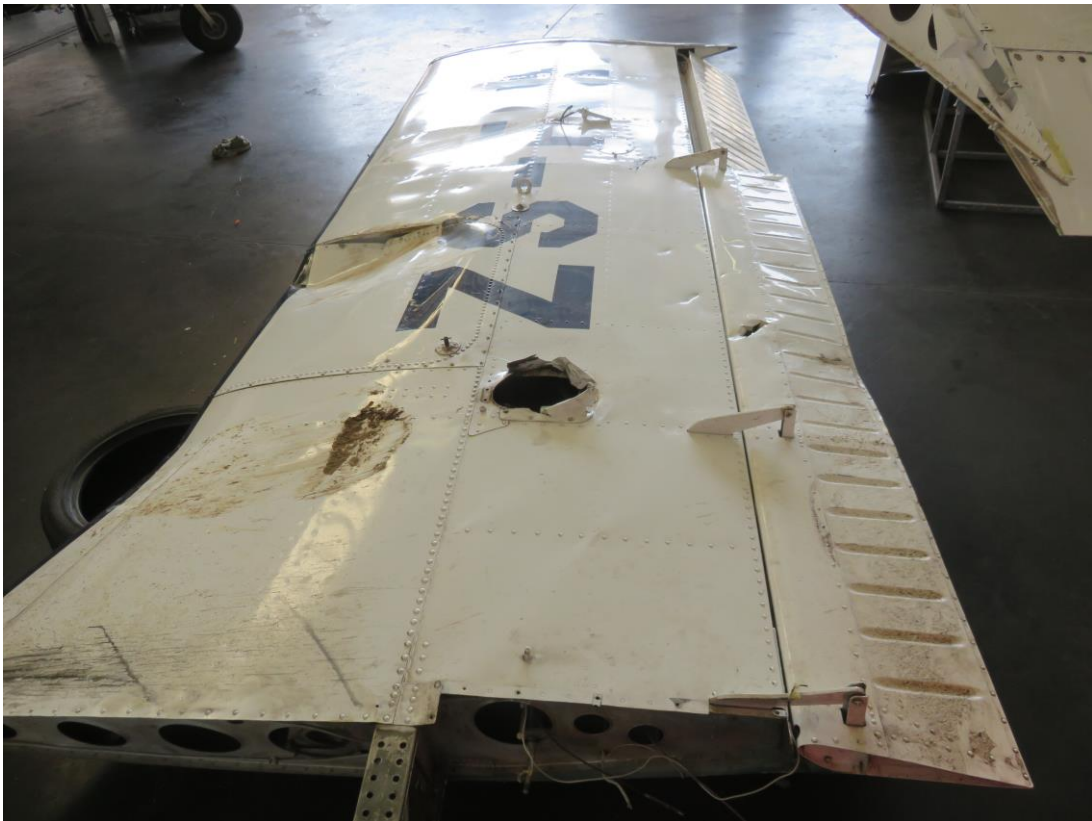
Figure 6: A view of the lower surface of the left wing post-recovery.

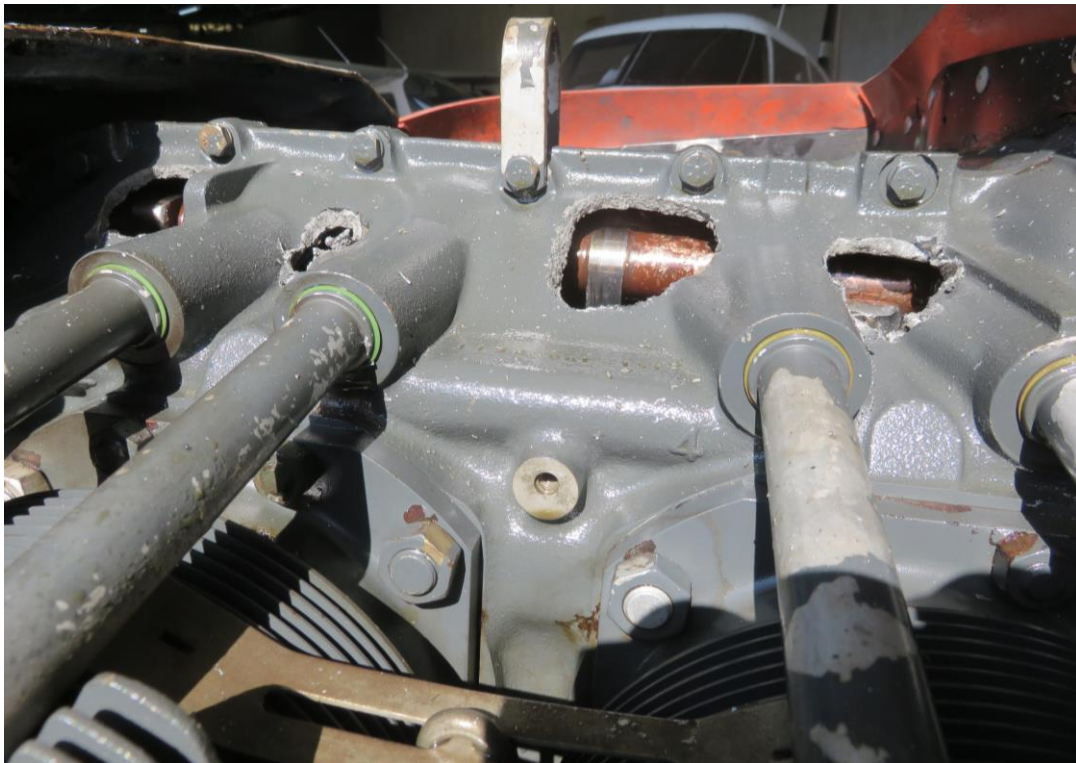
Figure 7: A closer view of the damaged crankcase.
