PRELIMINARY ACCIDENT REPORT

Accident
- Preliminary Report -
AIID Ref No: CA18/2/3/9944

The Bell 206B Jet Ranger II helicopter with registration ZS-HUC collided with high-tension electrical cables (the top earth conductor) during a fruit fly baiting operation. The helicopter crashed, and the pilot was fatally injured during the accident.

Reference Number : CA18/2/3/9944
Name of Operator : Heli X Charters (Pty) Ltd
Manufacturer : Bell Helicopter Textron
Model : Bell 206B Jet Ranger II
Nationality : South African
Registration Marks : ZS-HUC
Place : Silverstroom Farm, Wolseley, Western Cape
Date : 19 January 2021
Time : 0550Z

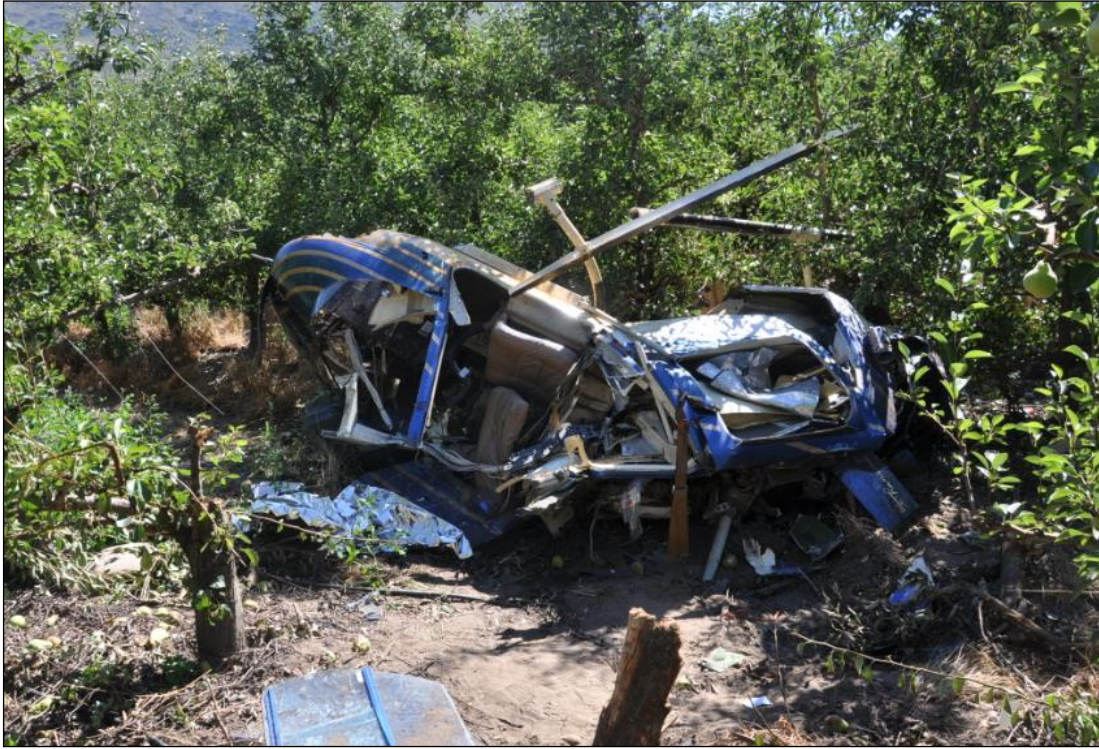
1.3.1. The helicopter was destroyed during the accident sequence.

Figure 3: The helicopter post-accident.

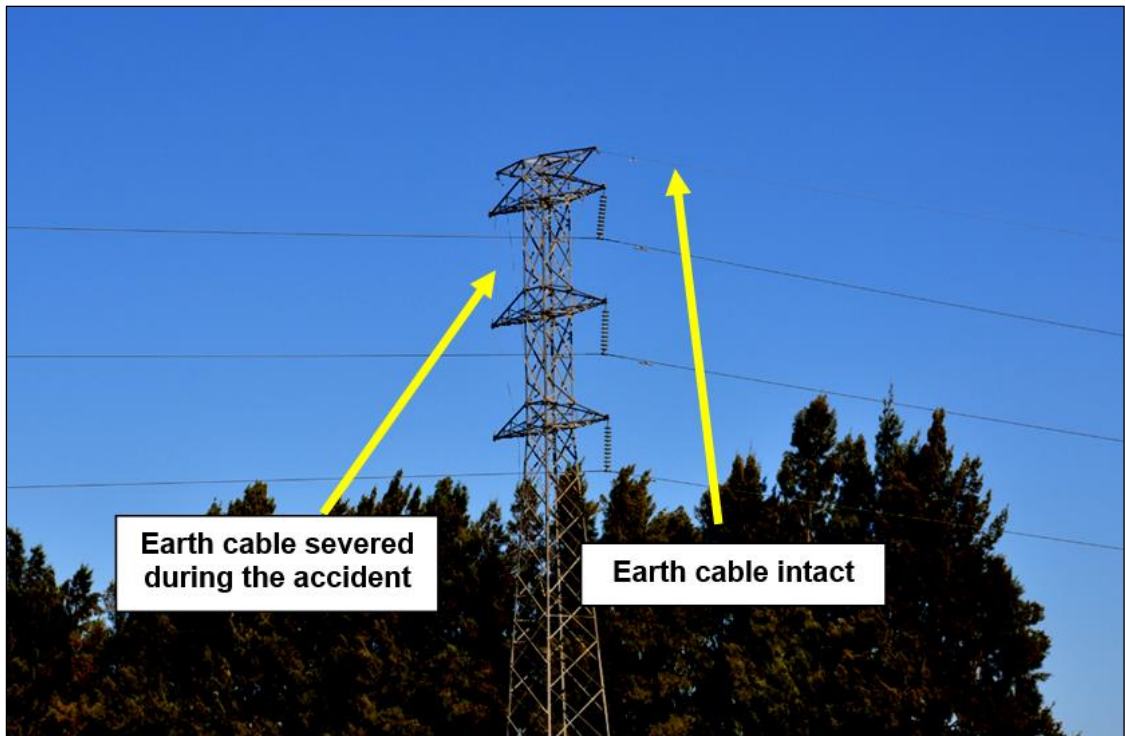
1.4.1. The helicopter collided with the earth electrical cable, and later crashed on a butternut field and pear orchard.

Figure 4: An electrical pylon with the severed earth cable (left) and the intact earth cable (right).

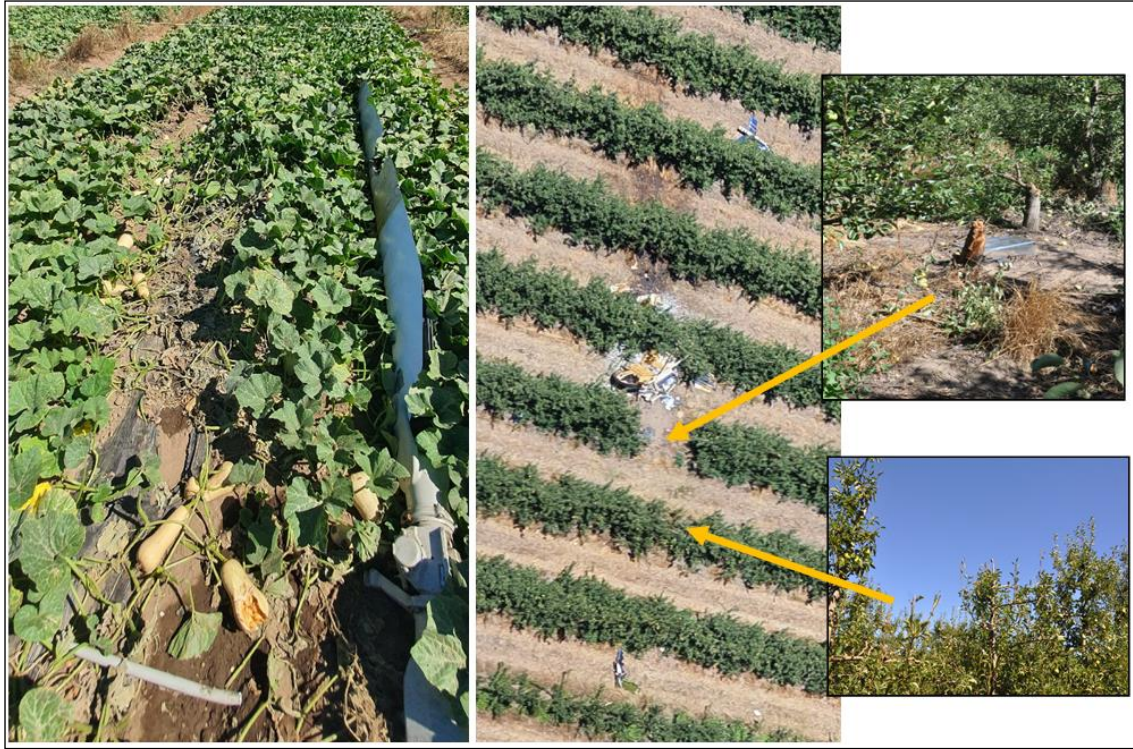
Figure 5: Damage on the butternut field and pear trees.

1.12.5. Numerous pear trees spanning approximately 2m in one row of the orchard (close to the main wreckage) were damaged. The helicopter had also clipped the top branches of a couple of trees in another row, west of the wreckage (see Figure 5).

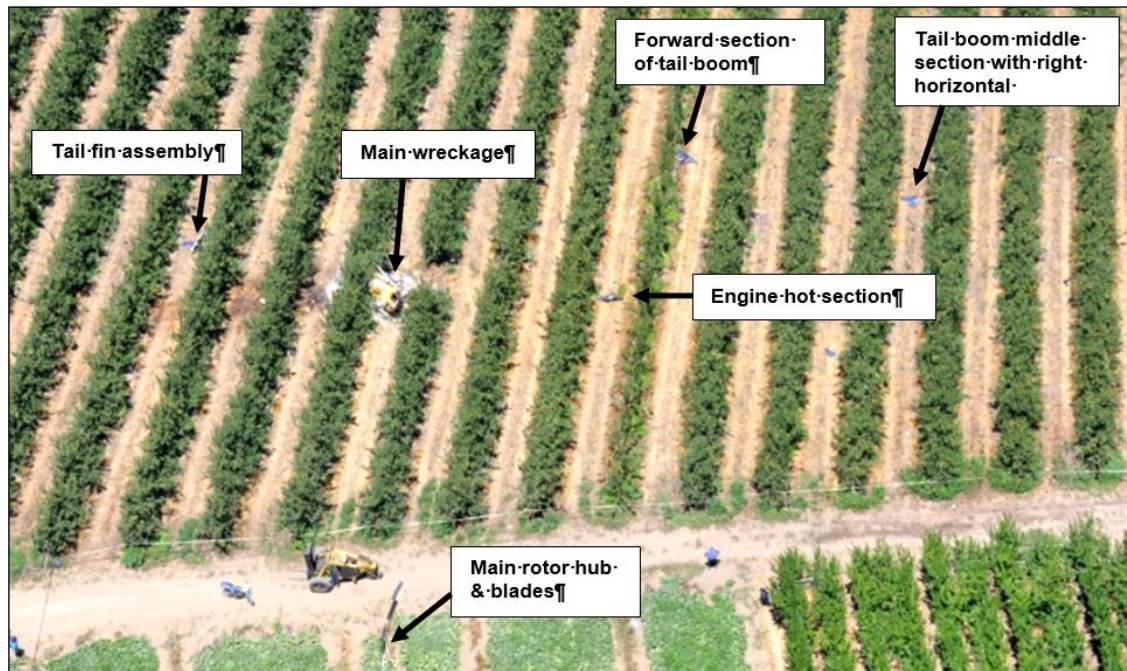
1.12.3. The wreckage distribution consisted of numerous fragments of the helicopter that were found scattered at a radius of approximately 80m (around the main wreckage), which was indicative of an in-flight break-up of the helicopter after colliding with the earth cable.

Figure 8: Wreckage distribution of main components.

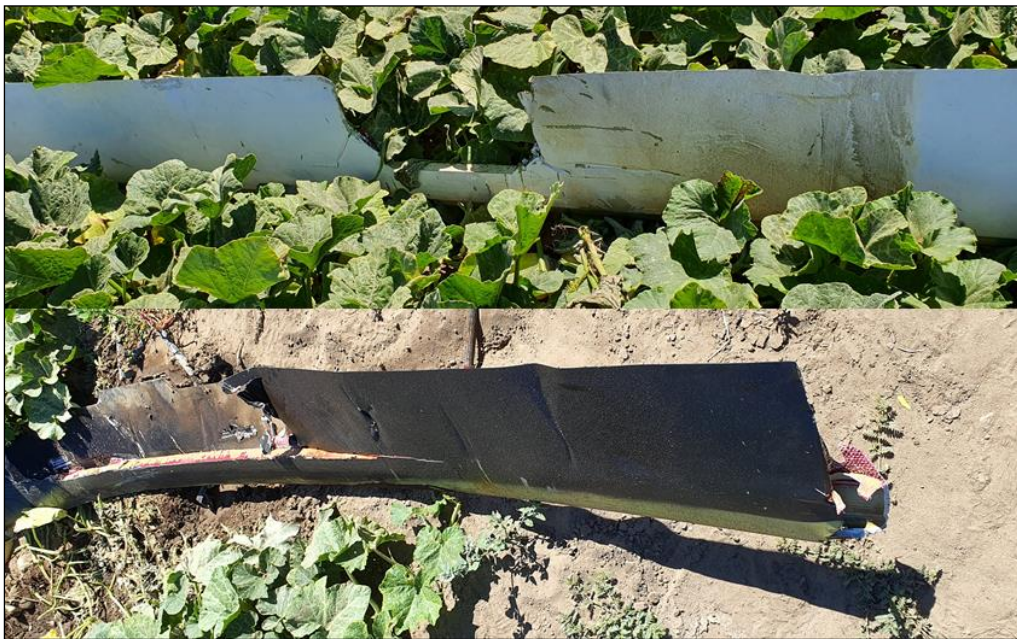
- 1.12.9. One of the main rotor blades exhibited deformation along its fractured surface, which occurred halfway through the blade; this blade was also broken towards the tip and a piece was located south-west of the main wreckage. The other main rotor blade had a section missing in the middle, which had broken off; its fractured surface was indicative of instantaneous separation exhibited by its brittle nature.

Figure 9: Damage to the main rotor blades.

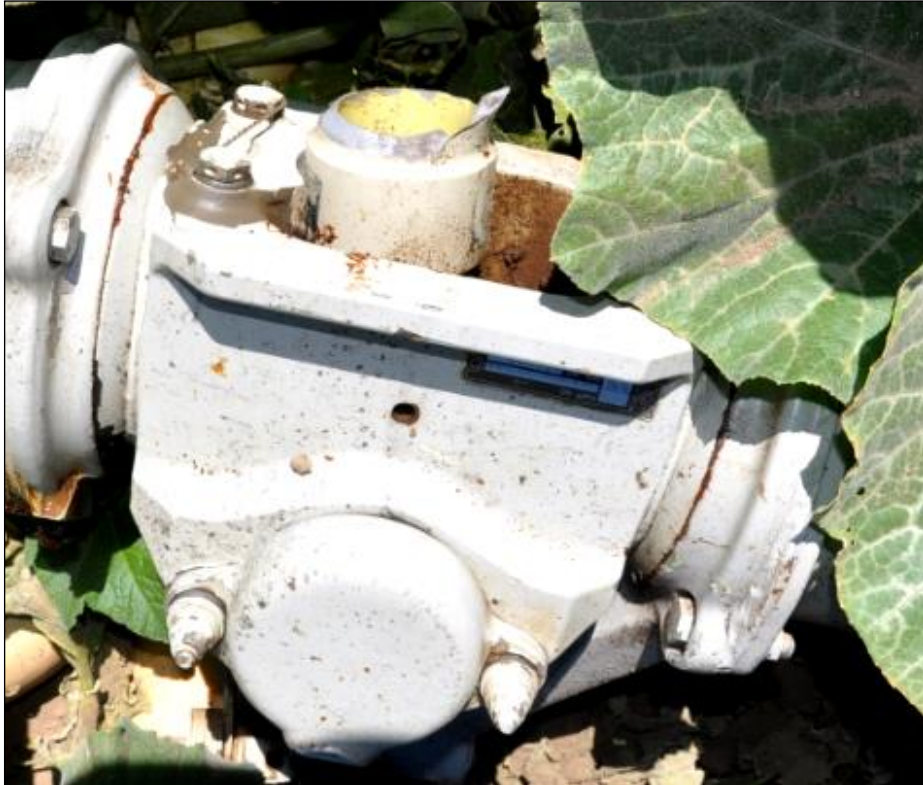
- 1.12.10. The shear lip fracture of the mast was indicative of a sudden stoppage due to overload (shear lip is indicative of rotation at high-speed at the time of separation). The main rotor control tubes were severed and had failed at an extreme point. Continuity was not possible to conduct due to the missing major components (main rotor blades assembly and swash plate assembly) and sustained damage. The main transmission was still attached to the transmission deck although the attaching hardware was heavily disturbed.

Figure 10: Damage to the main rotor mast.

- 2.4.9. The helicopter impacted the ground hard following collision with the earth conductor (top high-tension wire). The helicopter was destroyed by impact forces and the pilot was fatally injured. The shear lip failure of the rotor mast was indicative of a sudden stoppage of the main rotor blades which were turning at high speed. The damaged and separation of engine turbine wheel was an indication of a dynamic failure while rotating at nominal speed.

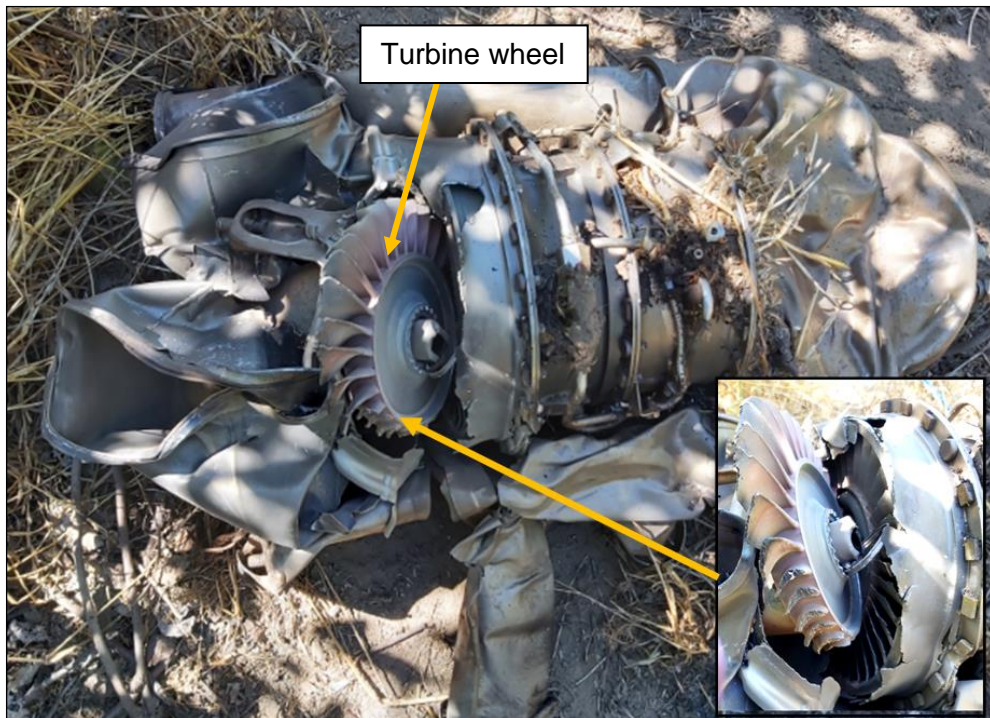
1.12.11. The engine had dislodged and was found south of the main wreckage. The impact mark on the ground indicated that the engine had bounced and landed 3m from the impact point. The inspection of the engine on site indicated that it was powered at the time of impact, showed by the power turbine disk with broken blades. The fuel control unit (FCU) was located near the engine. The engine exhaust duct was located forward of the engine position and was damaged.

Figure 11: Damaged engine assembly.

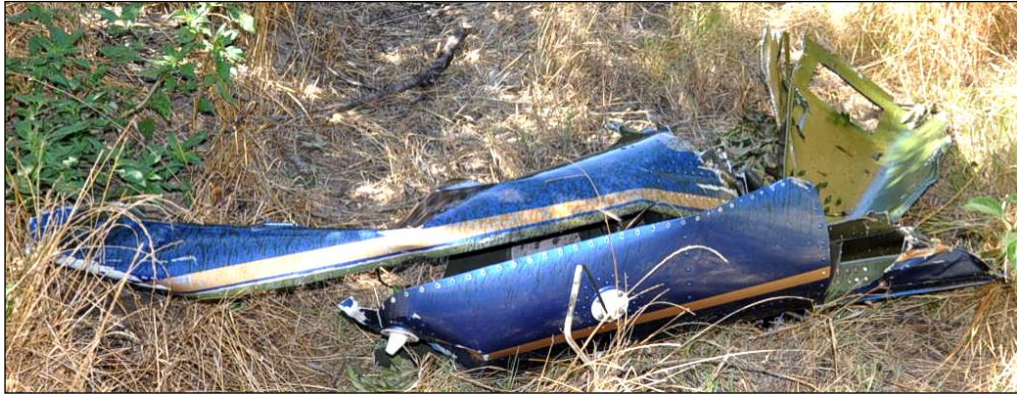
1.12.12. Sections of the tail boom were found scattered along the wreckage trail with the middle section located 20m west of the main wreckage. The vertical fin assembly, with the tail gearbox and blades attached, was located 5m north of the main wreckage. The tail boom assembly had impact damage similar to the damage observed on the leading edge of the main rotor blade (Figure 9). The forward section of the tail boom that attaches to the airframe was located 10m west of the main wreckage. The tail drive shaft's middle section was detached from tail boom bearings and was located 10m south-west of the main wreckage.

Figure 12: Tail boom middle section (original position).

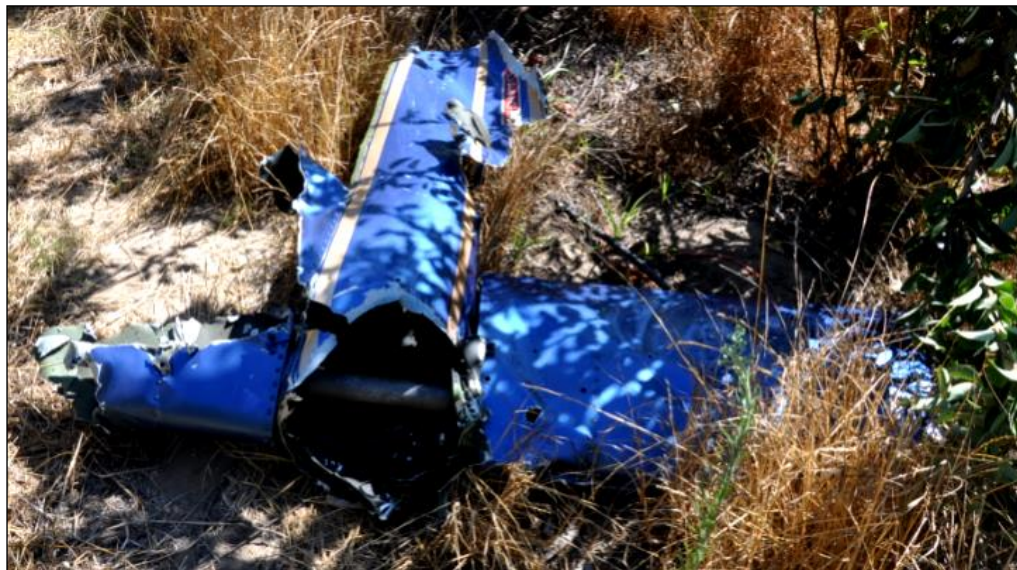
Figure 13: Horizontal stabiliser section (original position).

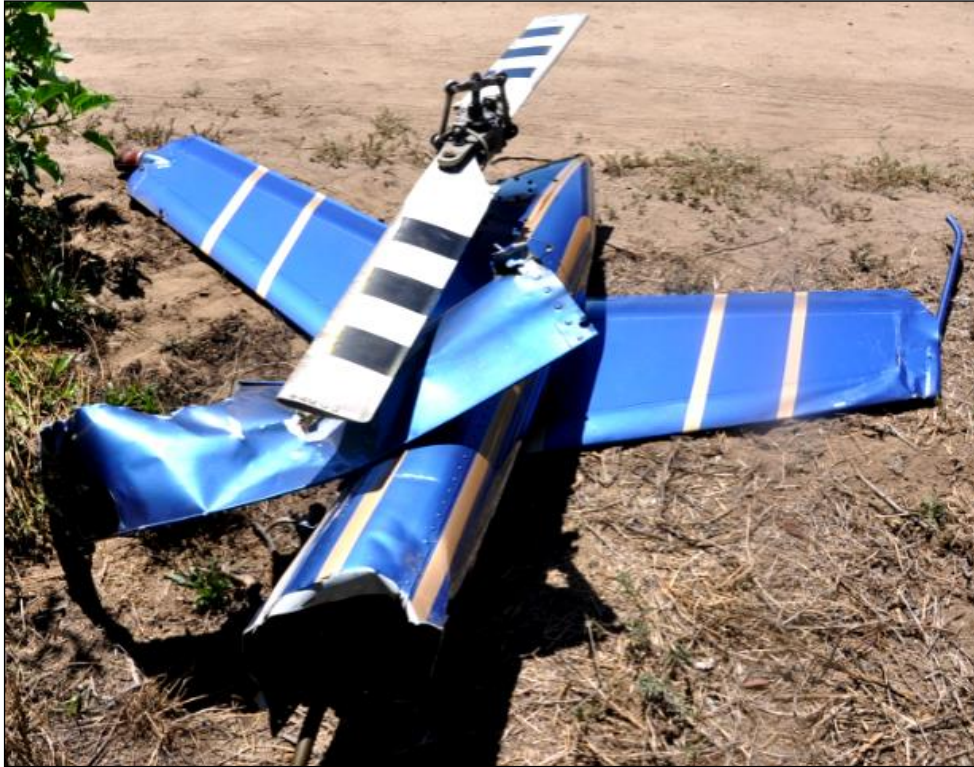
Figure 14: Vertical fin assembly (repositioned).

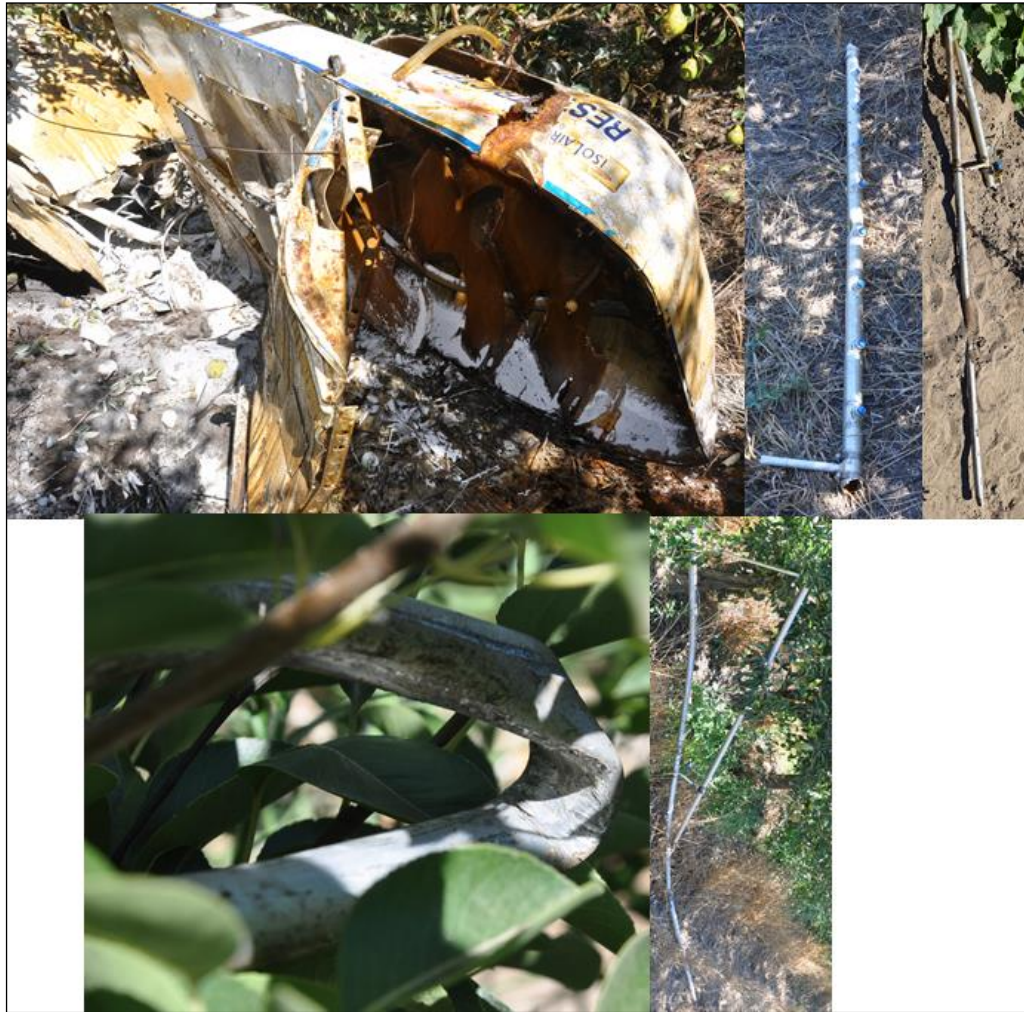
- 1.12.14. The IsoLair tank assembly had detached from the helicopter and was found lying open next to the main wreckage. This resulted in the chemical spilling over a large area, east of the main wreckage. The IsoLair boom assembly got detached from the helicopter's high skid gear; half of the boom was located near the high-tension cables while the other half was found near the main rotor blade, 20m north-west of the main wreckage.
- 1.12.15. A section for the spraying boom mounting assembly had bent 180° with striation marks similar to those observed on the front section of the right skid, which indicated that this section of the boom assembly was in contact with the earth cable during collision. It was found 20m north-west of the main wreckage.

Figure 15: Damaged and scattered IsoLair spray system components.

- 2.4.3. A section of the boom mounting assembly which had bent 180° indicated that the electrical cables disturbed the IsoLair spraying assembly, causing it to fail.

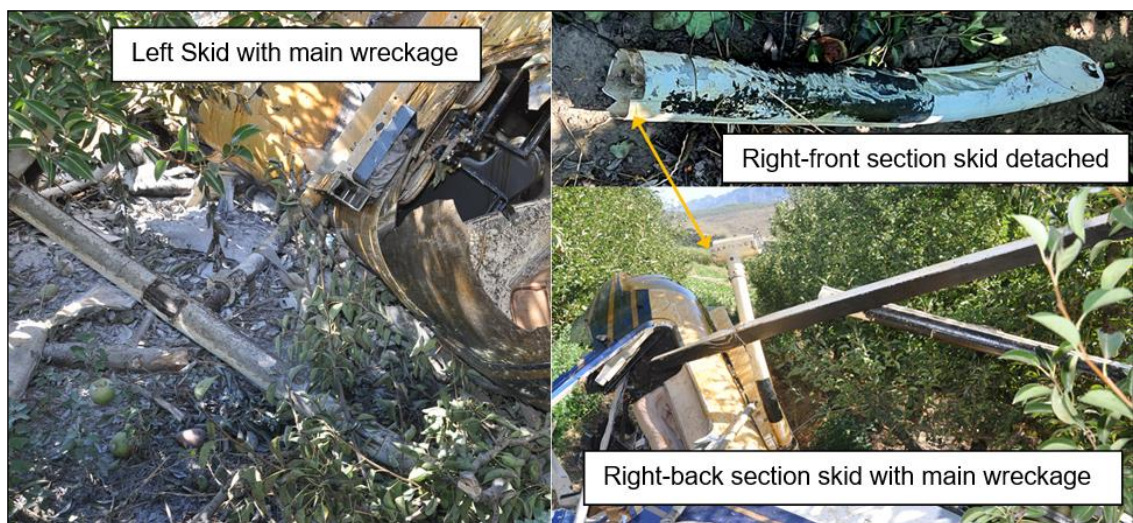
1.12.16. The helicopter's skid gear had broken off at different positions with some pieces scattered near the main wreckage. The left skid was found mostly still attached to the main wreckage. The right skid forward section was found lying 25m west of the main wreckage, with striation marks observed on the upper surface of the skid, an indication of a wire strike.

Figure 16: Left image: The left skid still attached to the main wreckage. Top-right image: The front section of the right skid showing striations marks. Bottom-right image: The right skid after the accident.

- 2.4.1. There were no eyewitnesses when the accident occurred, however, the farm owner who was located 650m north of the area of operation heard a loud 'popping' sound before the helicopter's engine sound stopped. Soon after, he heard another loud 'crash' sound and immediately took his fire extinguisher and rushed to the scene. However, upon arrival, he found that the helicopter had crashed between pear orchards, but there was no fire.
- 2.4.2. Post-accident on-site investigation revealed that the helicopter collided with the top earth conductor of the high-tension electrical cables before crashing. Damage observed on the wreckage indicated that the helicopter was caught on its right skid by the cable, which was exhibited by the metallic striation marks, indicative of a wire strike on the upper surface of the skid's front section.

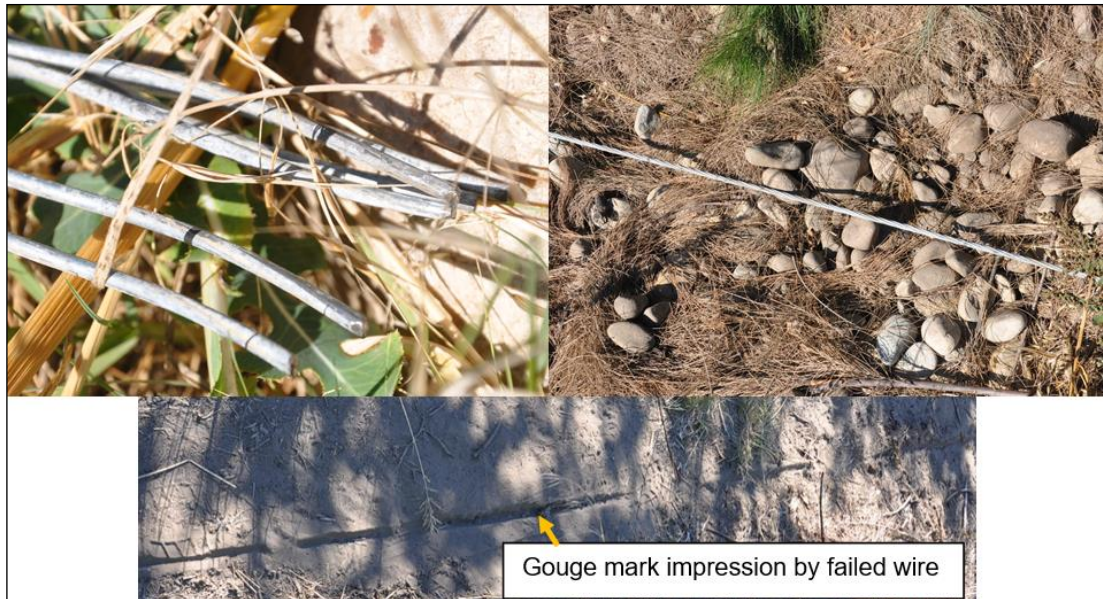
1.12.17. The earth conductor wires showed tension-like failure.

Figure 17: Top-left image: The failed earth conductor. Top-right image: The earth conductor found near the trees. Bottom image: The gouge mark made by the earth conductor after failure.
