PRELIMINARY ACCIDENT REPORT

Accident
- Preliminary Report -
AIID Ref No: CA18/2/3/10080

Reference Number : CA18/2/3/10080
Name of Owner/Operator : George Chettle
Manufacturer : Cessna Aircraft Cooperation
Model : Cessna 421B Golden Eagle
Nationality : South African
Registration Marks : ZS-IGG
Place : On an open field, north of Middleburg Aerodrome (FAMB)
Date : 26 November 2021
Time : 1150Z

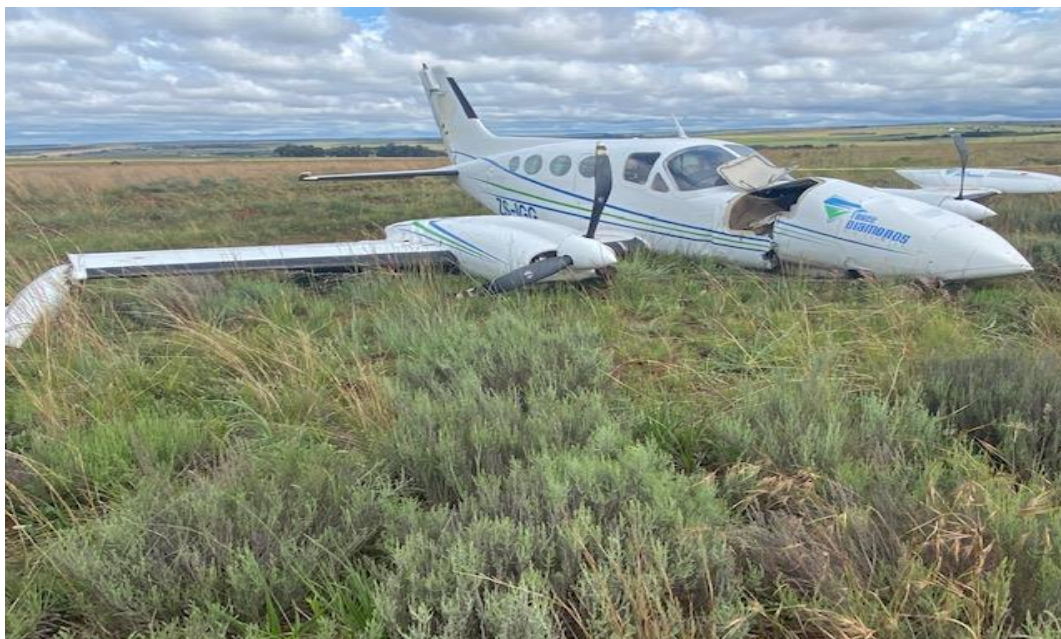
1.3.1 The aircraft sustained substantial damages during the accident sequence.

Figure 3: A view of the aircraft at the accident side.

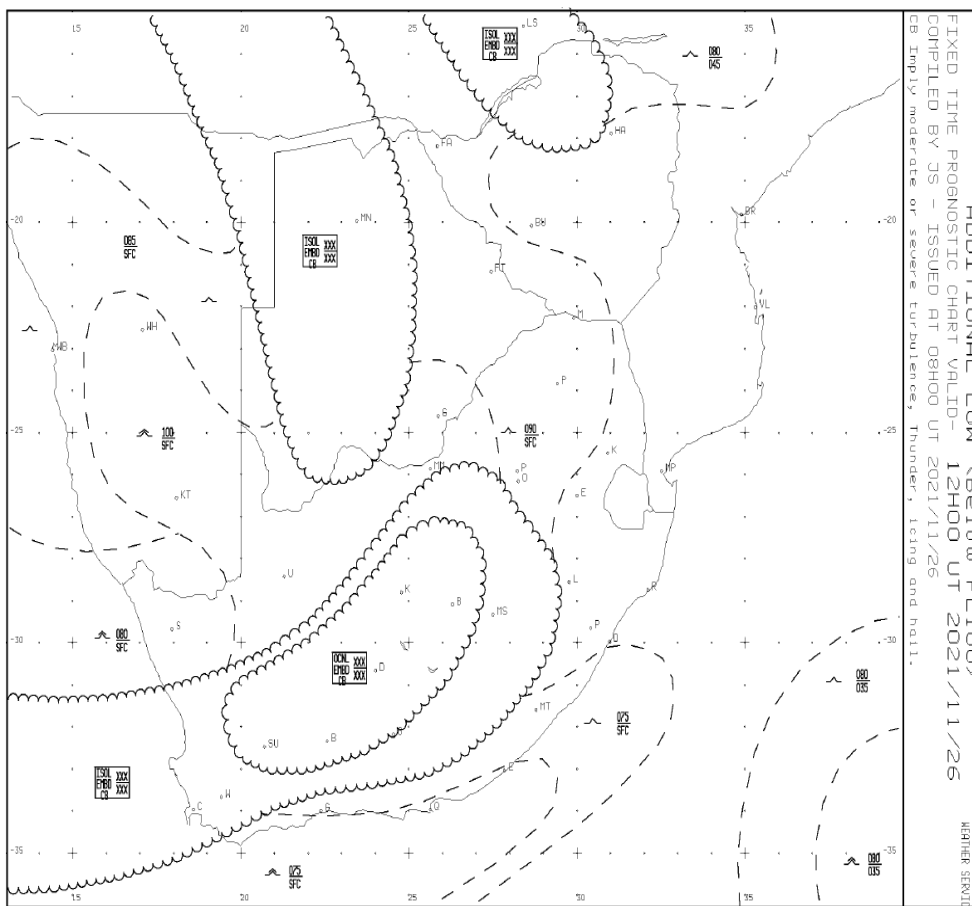
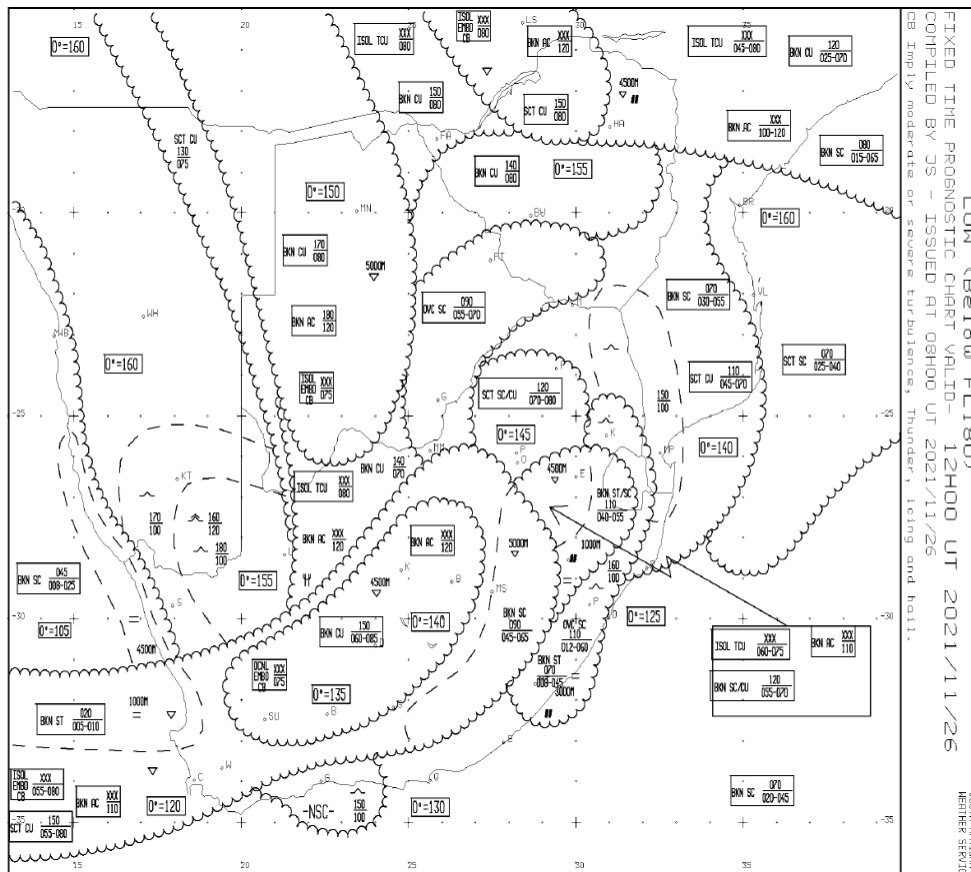
Figure 5: A satellite image showing icing conditions at the time of flight.

Figure 6: A satellite image showing the icing conditions at the time of flight.

- 2.1.4 The aircraft was issued a Certificate of Registration on 12 December 2016.
- 2.1.5 A review of the weather report specified icing conditions between 8 000 to 12 000ft around the time of the accident as well as the intended route of flight. The weather had a bearing to the accident.

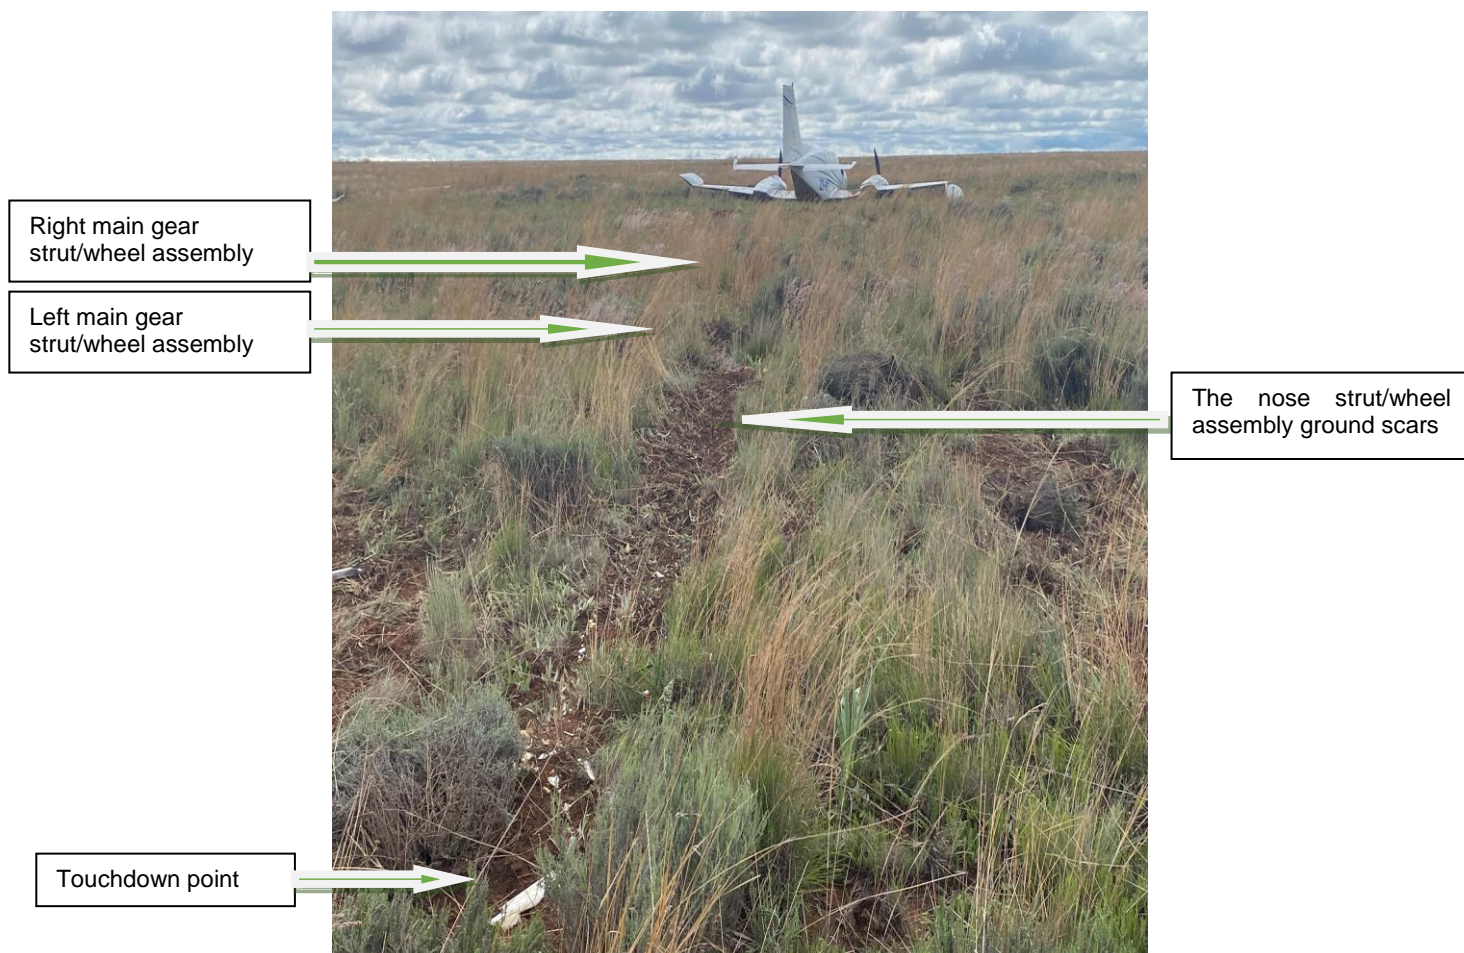
1.12.1 Examination of the accident site indicated that the aircraft landed hard on an open field. The main landing gear doors separated from their respective struts and all three landing gears broke off at the struts during landing. The aircraft then skidded on the belly with flaps extended to 45° setting and stopped approximately 65 metres from the first point of impact. The pitot probe/tube mounted underneath the nose section broke off. The bottom fuselage skin and the antennas were damaged. The nose gear strut/wheel assembly was found approximately 12m from the first point of impact, followed by the left main gear strut/wheel assembly on the left approximately 16m, and the right main gear strut/wheel assembly, which was further away approximately 22m from the first point of impact. All three landing gear struts oleos and the tyres contained pressure. The fuselage nose-section collapsed in compression and separated on the right-side nose-cargo compartment area. The right-side main (tip) tank suffered overload failure at its attachment area, however, the fuel pipe feeding the engine was still intact. The wing structure, including the auxiliary fuel tanks and the locker tanks, was intact.

Figure 7: First point of impact and the final position of the aircraft.

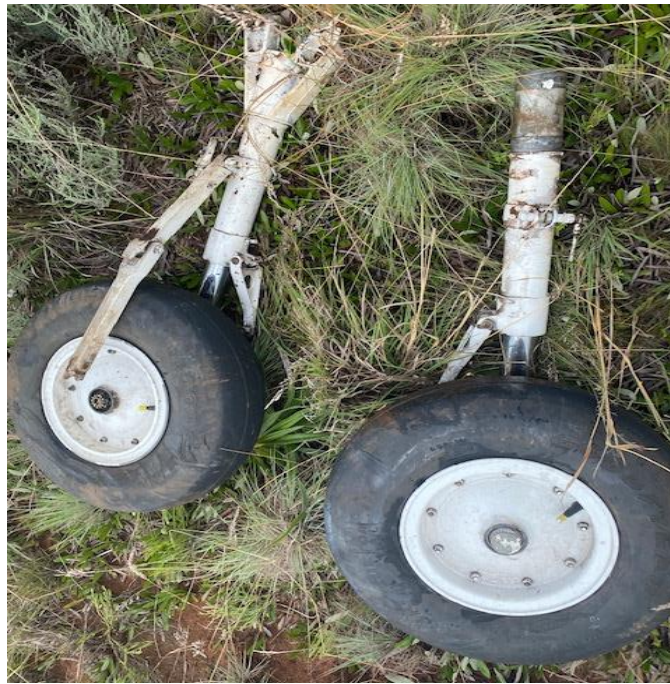
Figure 8: View of the broken main landing gear struts with the wheel assemblies still attached.

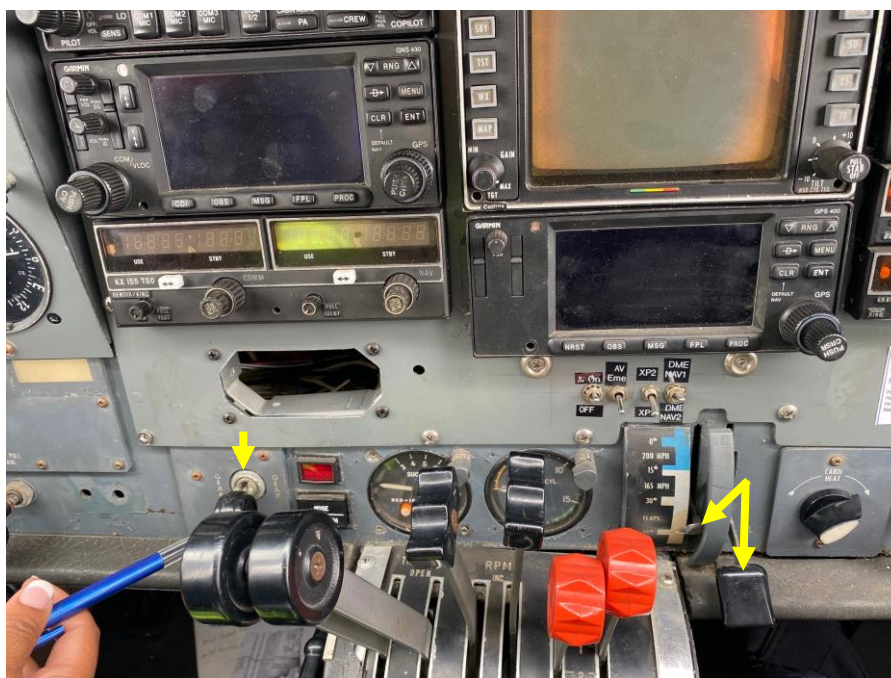
1.12.2 Examination of the cockpit area showed both throttle levers in a closed position. The mixture levers were both in the idle cut-off position. All instruments, radios and switches were intact. The landing gear handle in the cockpit was found in an extended position. None of the circuit breakers were pulled. *The manually operated T-handles on the left pilot side below the control column that operates the alternate air source were found in a closed position and the auxiliary pump switches on the left pilot side-panel were selected to HIGH mode.*

Figure 9: View of the aircraft console showing the landing gear lever selected in an extended position and the flap lever at 45° setting.

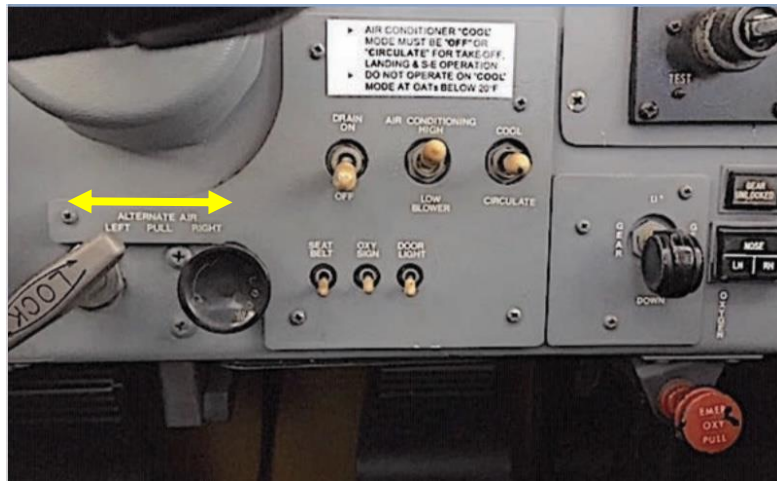
Figure10: The left and right ALTERNATE AIR levers in a pressed position.

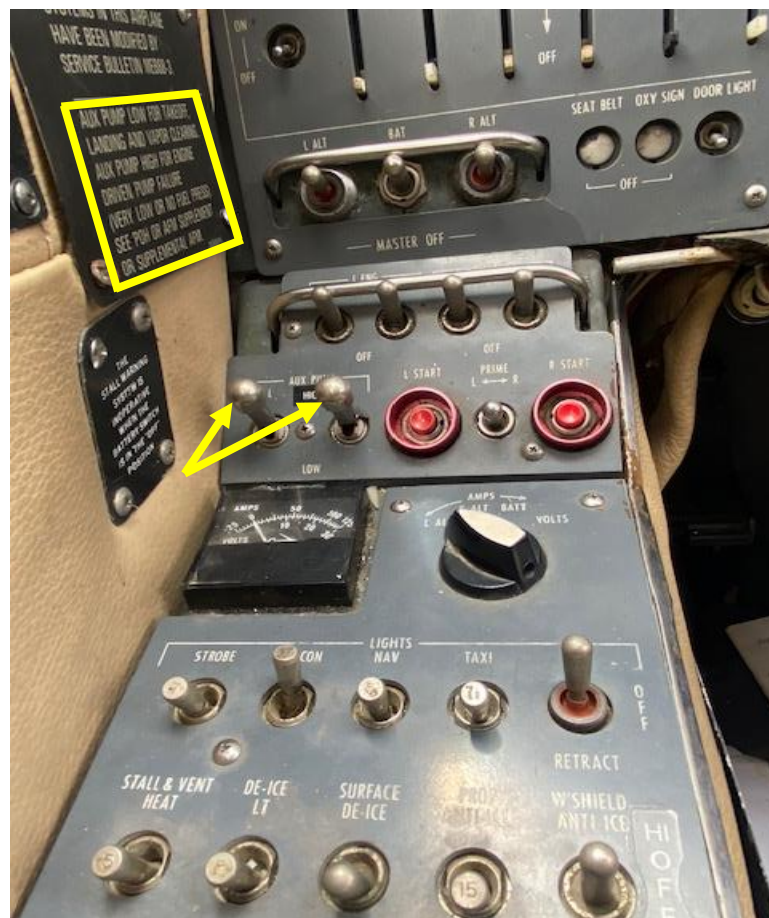
Figures 11/12: View of the auxiliary pumps in a HIGH mode setting. There is a placard (yellow window above) installed on the left pilot side panel indicating AUX PUMP HIGH FOR ENGINE DRIVEN PUMP FAILURE (VERY LOW OR NO FUEL PRESSURE).

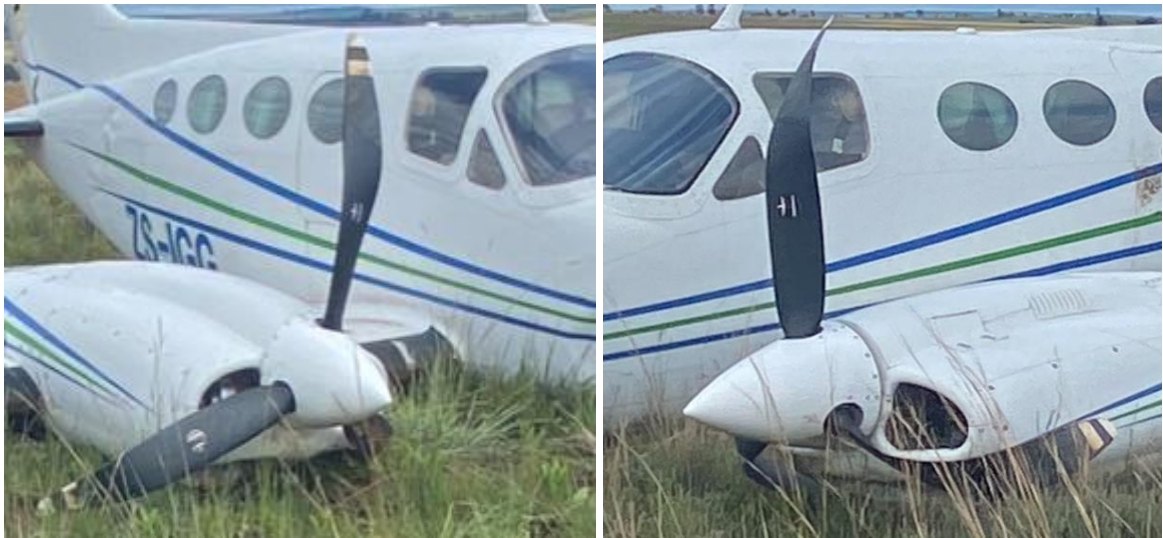
1.12.3 The engines were found still attached to their respective mountings and the propellers secured to their engine flanges. Examination of the aircraft's propellers showed that the engines were not operational during landing. Neither of the propellers was feathered.

Figures 13/14: Pictures showing neither of the propellers feathered.

- 2.1.12 Neither of the propellers was feathered.

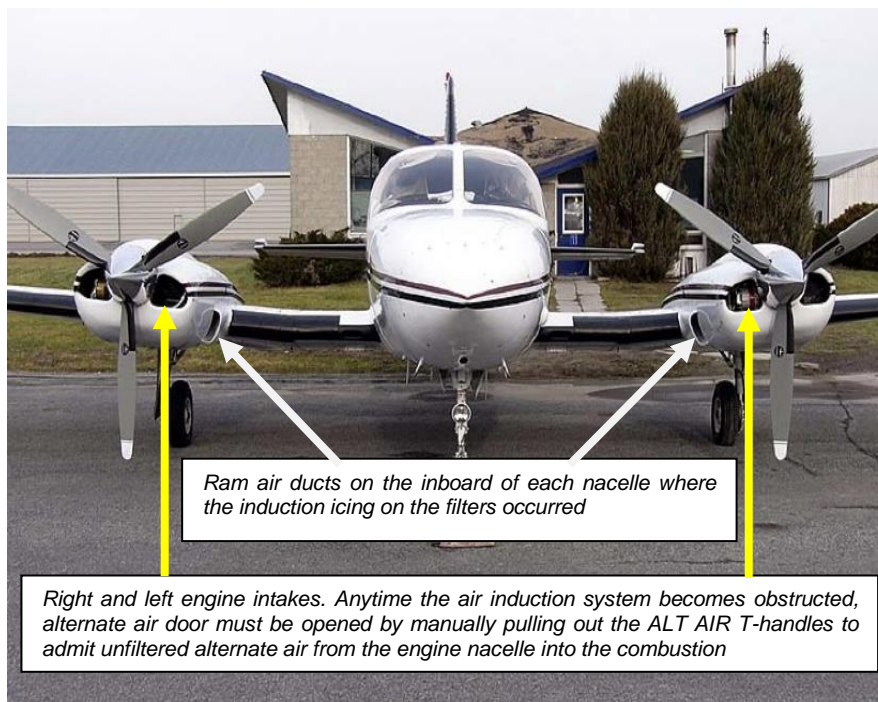
1.16.1 A preliminary finding revealed that the rough-running engines were caused by the induction icing (intake icing). The air filter's primary function on the engines is to remove dust and other foreign objects from the induction air. However, if they become obstructed or blocked by ice, the engines are starved for air, and would ultimately draw air from their respective engine intake manifolds with rapidly decreasing induction air pressure. There is no gauge in the cockpit to indicate induction icing except for the development of rough-running engines as the obstruction chokes the air flow. The alternate air (ALT AIR) T-handles on the left pilot side must be pulled out IAW the AFM to bypass the engine air filters, thus, allowing the unfiltered alternate air to be taken from inside of each engine nacelle into the combustion.

Figure 16: File picture of the Cessna 421B model aircraft (not ZS-IGG) — (Source: <https://www.jetphotos.com>). The picture shows the ram air ducts on the in-board of each nacelle and the alternate air entry point through the nacelles into the combustion.
