PRELIMINARY ACCIDENT REPORT

Accident  
- Preliminary Report -  
AIID Ref No: CA18/2/3/9942

**Reference Number** : CA18/2/3/9942  
**Name of Owner** : Mbega Trust  
**Name of Operator** : Carel Jacobsz  
**Manufacturer** : Piper Aircraft Corporation  
**Model** : PA-46-350P  
**Nationality** : South African  
**Registration Marks** : ZS-JJJ  
**Place** : Koedoesberg Game Farm-Pongola, KwaZulu-Natal Province  
**Date** : 13 January 2021  
**Time** : 05:15Z

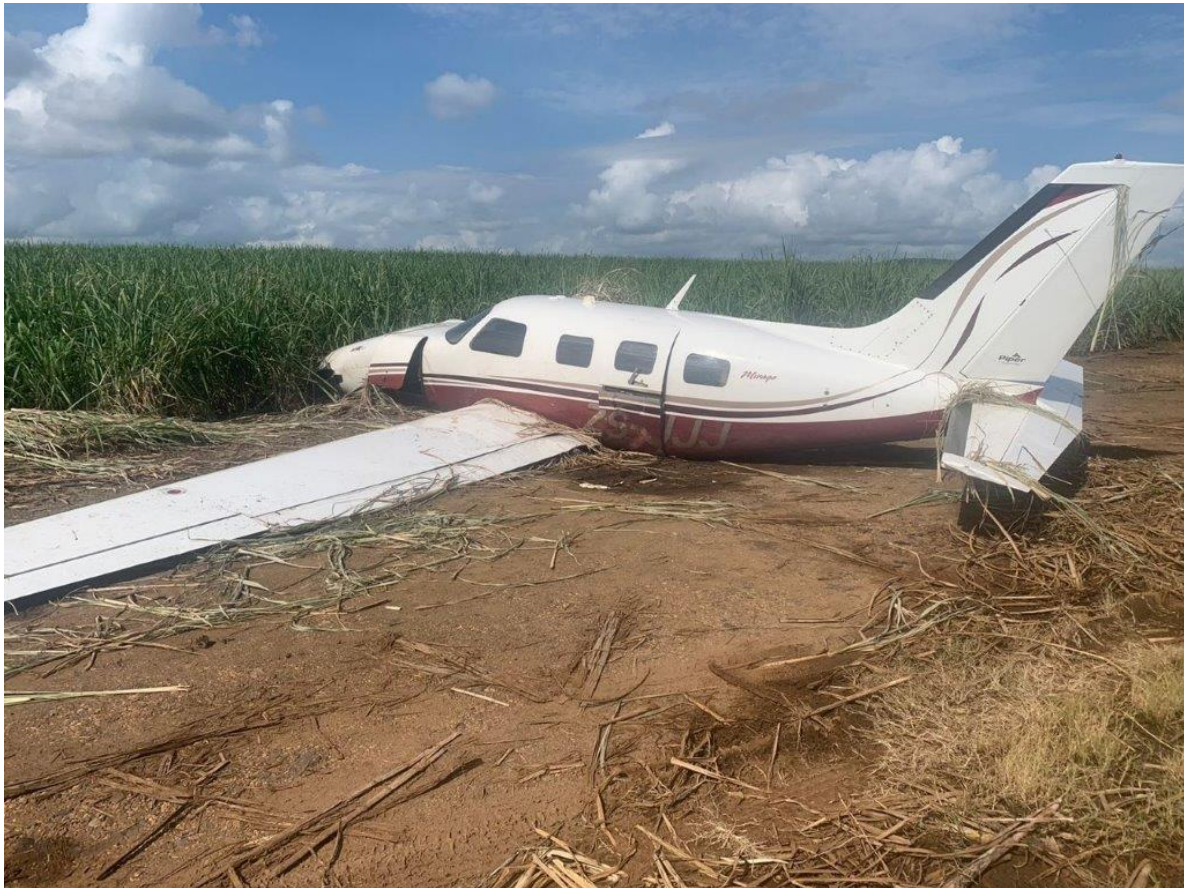
**Figure 1:** The aircraft as it came to rest. (Source: Owner)

**Description:** The pilot reported that the engine stopped shortly after take-off; as a result, he executed a forced landing on a gravel road approximately 500 metres (m) from the take-off flight path. On touch down, the undercarriage collapsed and the aircraft veered off to the right-side of the road.

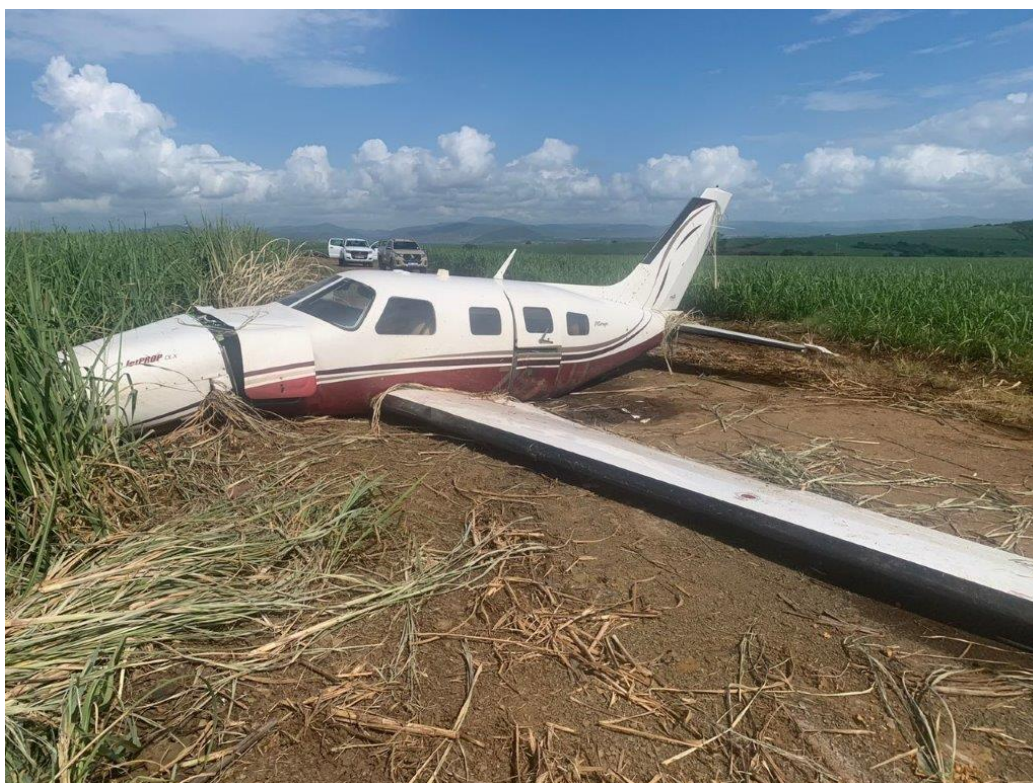
1.3.1 The aircraft sustained substantial damage during the accident sequence.

Figure 3: The damaged aircraft post-accident. (Source: Owner)

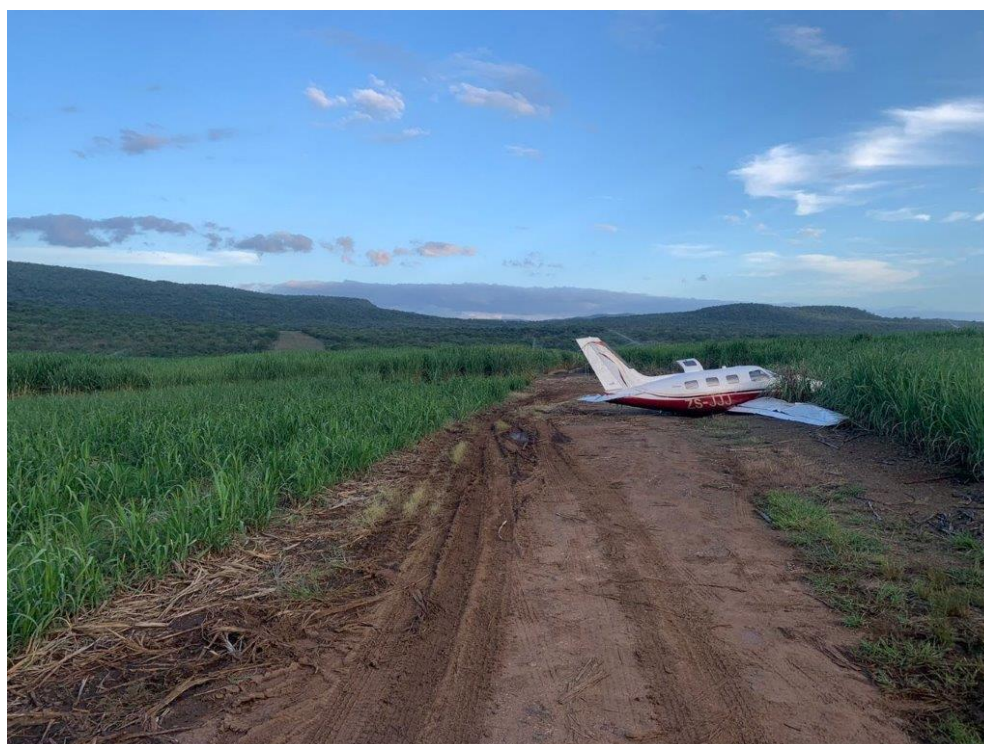
1.12.1 The accident occurred shortly after take-off from Runway 34 during a forced landing on a gravel road approximately 500m from the take-off runway following an engine stoppage. The aircraft veered off to the right-side of the road and came to rest on the verge of it (the road).

**Figure 4:** The aircraft as it came to rest. (Source: Owner)
