PRELIMINARY ACCIDENT REPORT

Accident
- Preliminary Report -
AIID Ref No: CA18/2/3/10033

Reference Number : CA18/2/3/10033
Name of Operator : Mach 1 Aviation
Manufacturer : Piper Aircraft Corporation
Model : PA-34 200T Seneca II
Nationality : South African
Registration Marks : ZS-KFG
Place : Springs Aerodrome (FASI)
Date : 26 August 2021
Time : 0900Z

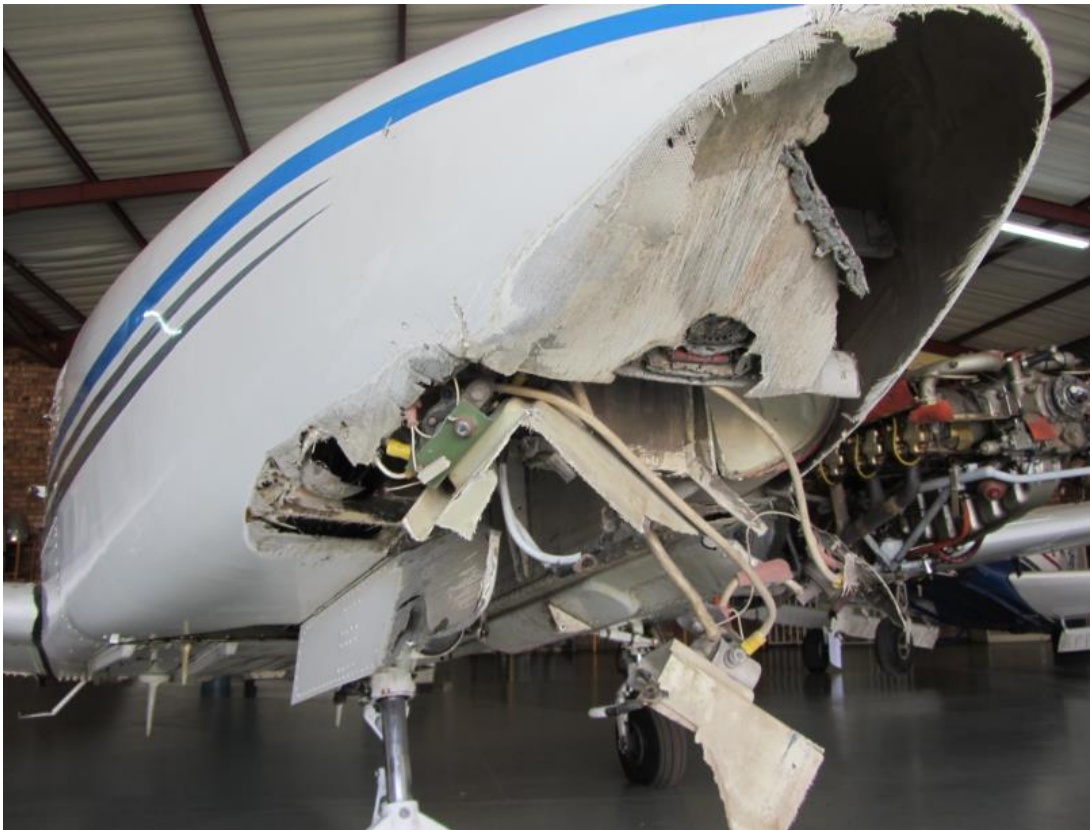
1.3.1 The aircraft sustained substantial damage during the accident sequence.

Figure 3: The damaged nose section.

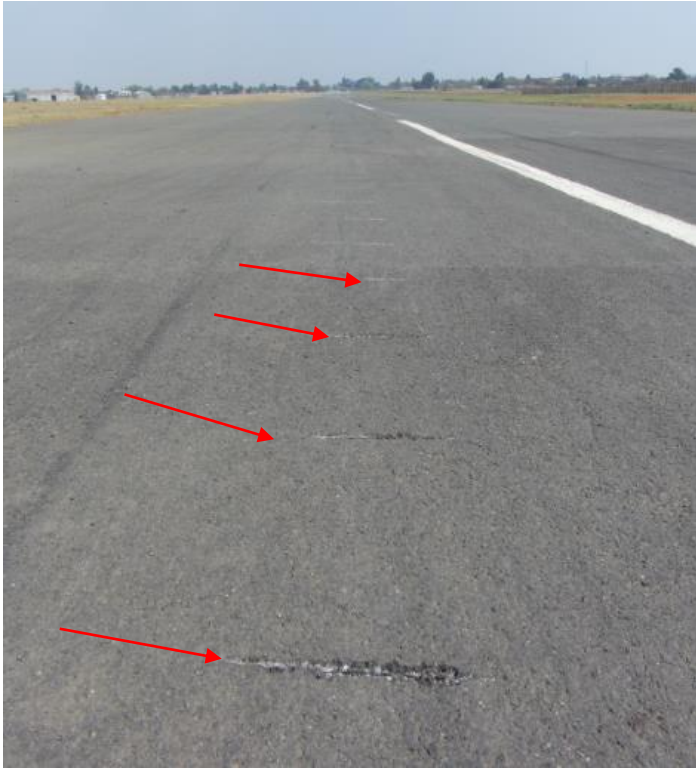
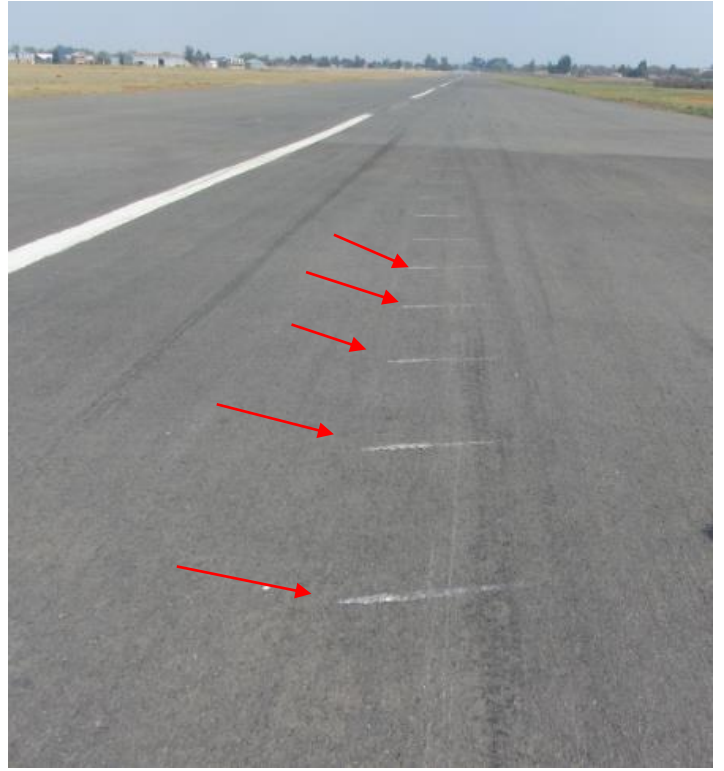
1.12.2 As evidenced by the propeller marks on the asphalt surface, the first impact marks of both propeller tips were approximately 255m from the runway threshold. Both propeller tip marks continued for approximately 20m. It was evident that towards the end of the propeller marks on the asphalt, the nose cone made contact with the runway surface and the aircraft skidded on its nose cone and propeller tips for a further 282m before coming to a halt just after the second taxiway intersection. The distance from the threshold to the end of the nose cone scraping marks was 557m.

Figures 4 and 5: Arrows showing left- and right-side propeller tip marks on the asphalt runway.

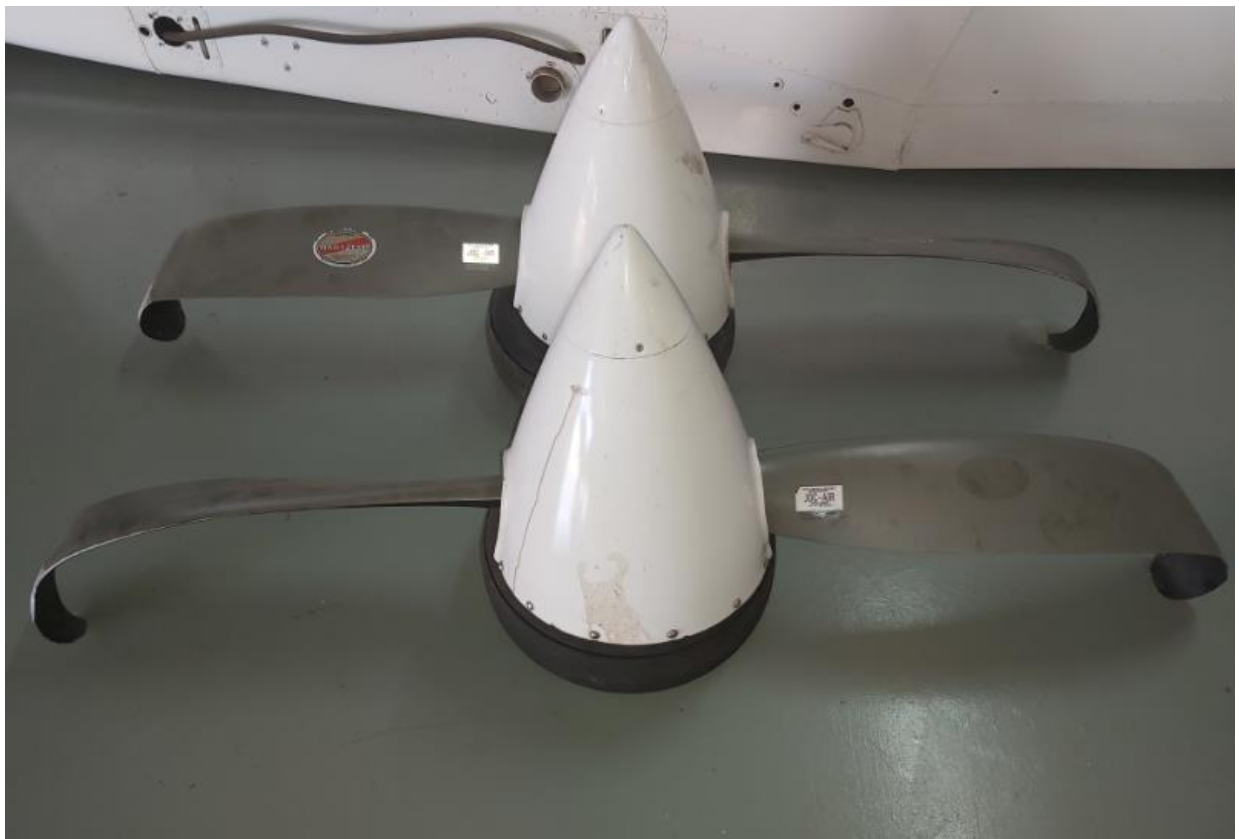
1.12.1 The aircraft approached the runway from the north-east and touched down just after the threshold. During landing, the nosewheel collapsed and the propeller tips from all four blades impacted the ground and, as a result, curled inward.

Figure 6: Left- and right-side propeller assemblies.

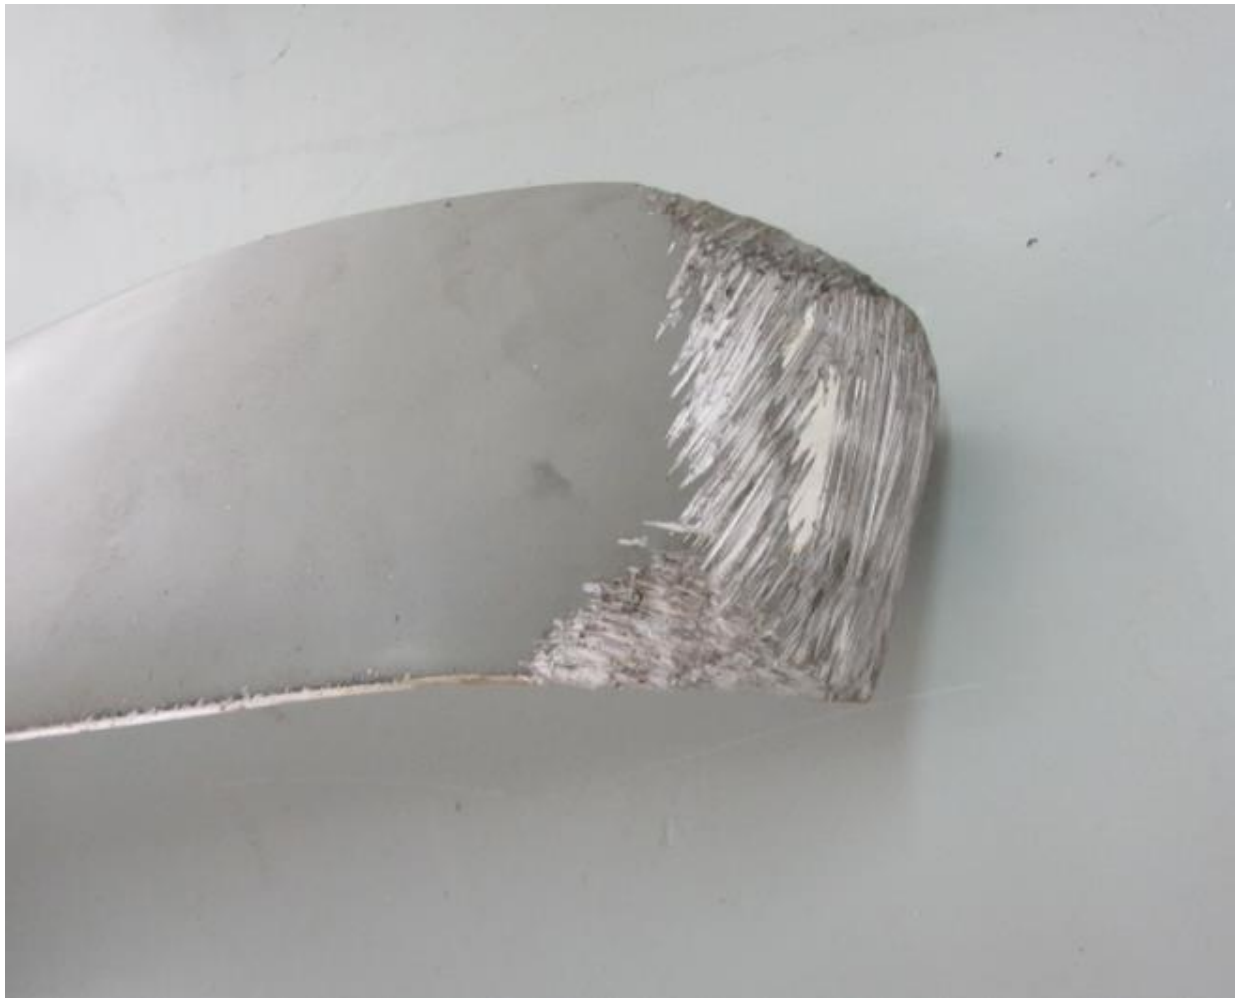
Figure 7: A propeller tip with scrape marks.

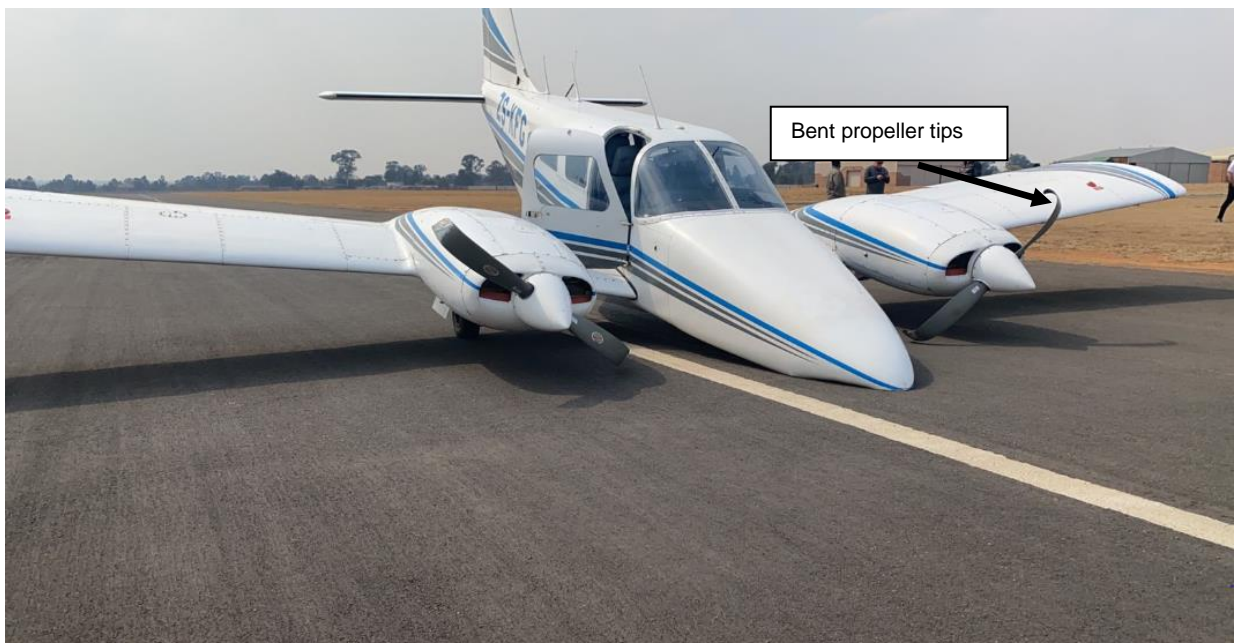
Figure 8: The aircraft after coming to a halt. (Source: ATO)

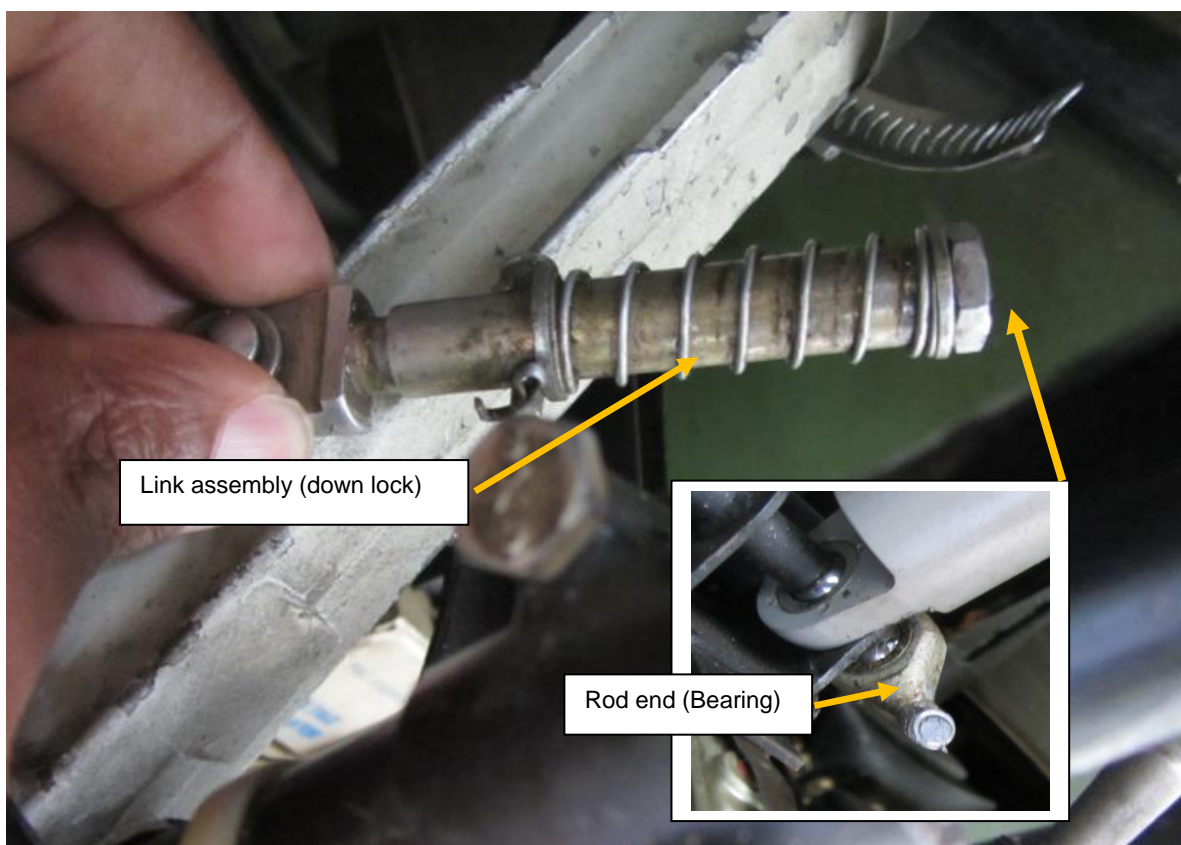
1.16.1 Post-accident, it was discovered that the nosewheel link assembly (down lock) had broken off and separated from the rod end bearing. The cause of the damage to the link assembly is yet to be determined in the final report.

Figure 9: Failed link assembly down lock.

- 2.2.10 The aircraft sustained substantial damage during the accident; however, no persons were injured.
- 2.2.11 Preliminary findings revealed that the nose gear link assembly down lock mechanism had failed, resulting in the collapse of the nose gear during landing.
