PRELIMINARY ACCIDENT REPORT

Accident and Incident Investigations Division

Accident
- Preliminary Report -
AIID Ref No: CA18/2/3/10180

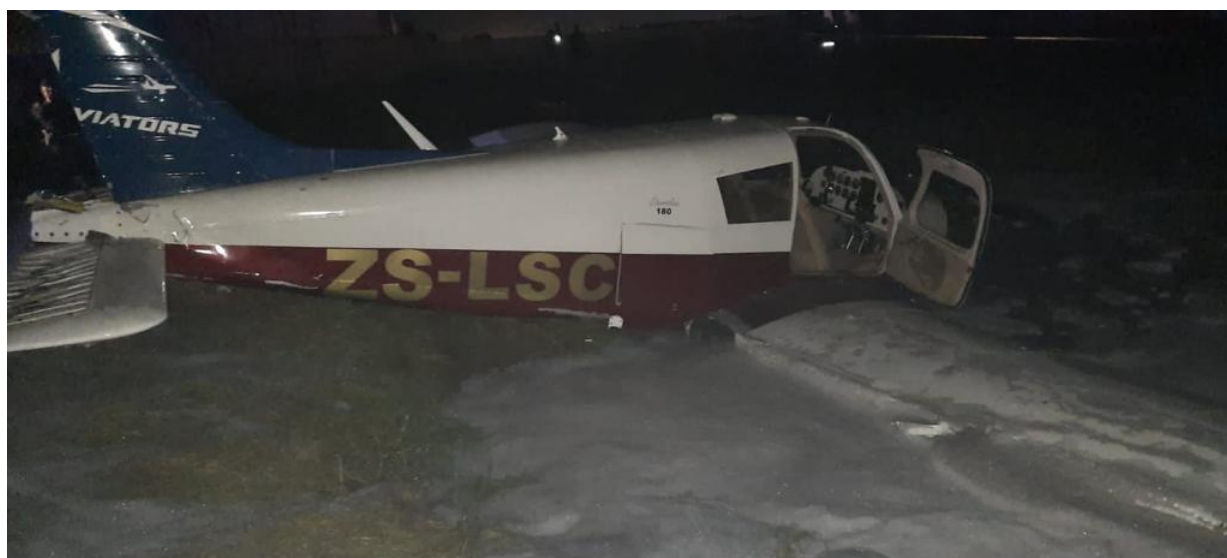
Figure 1: A picture of the accident aircraft, a Piper PA28-180 Cherokee.

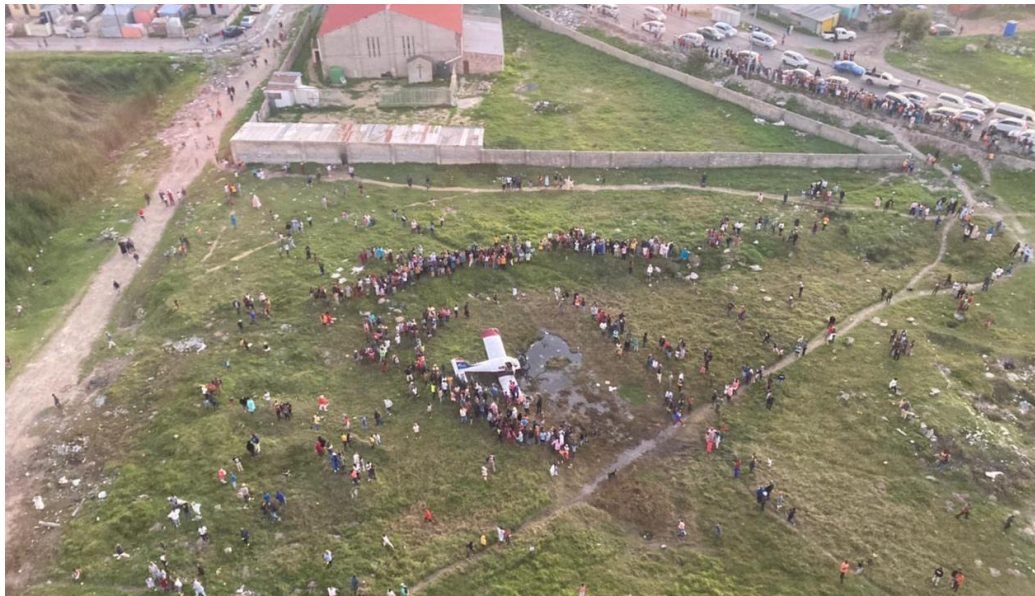
- 1.1.4 During landing, the aircraft's undercarriage broke off as a result of an uneven field, approximately 5 nm from the threshold of Runway 01. The accident attracted many onlookers and some of them climbed on the aircraft while others stole some aircraft parts that were easy to remove. The aircraft sustained substantial damages during the accident sequence, and the instructor and the student pilot suffered minor injuries.

Figure 2: The accident aircraft swamped by locals. (Source: Operator)

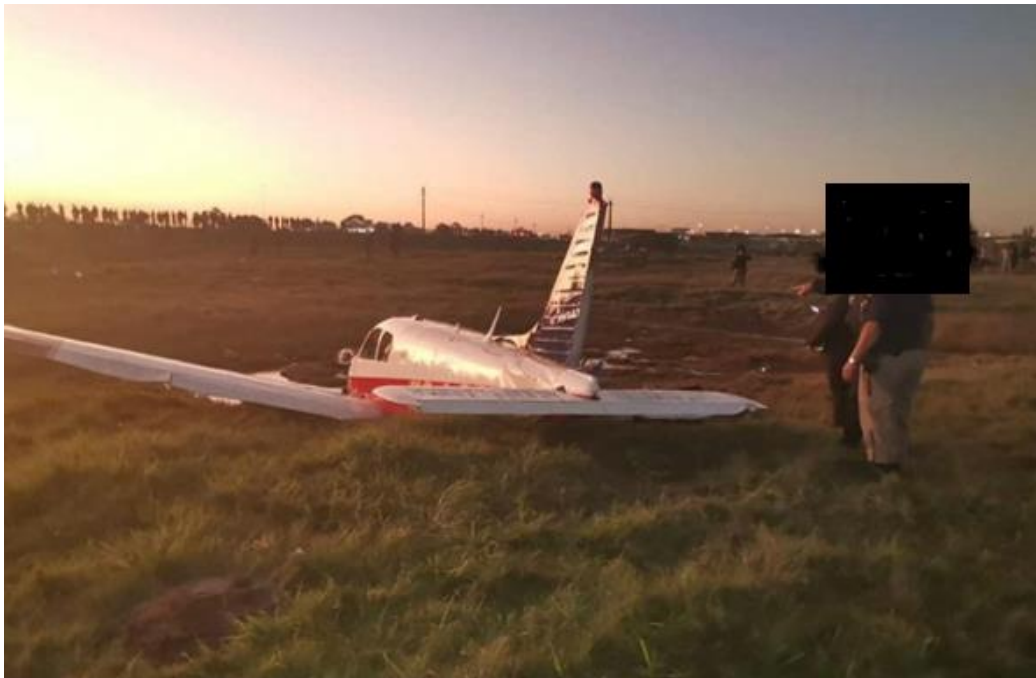
1.3.1. The aircraft was substantially damaged.

Figure 3: The aircraft resting on its belly at the accident site. (Source: Operator)

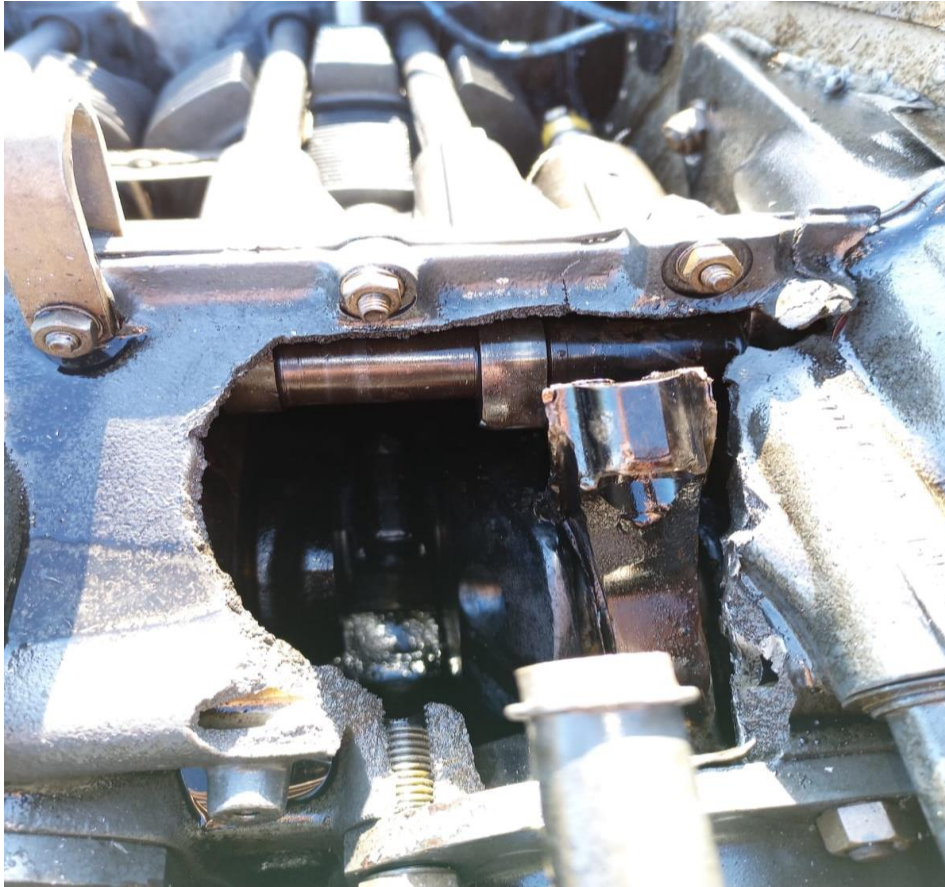
1.12.3. The engine upper casing, engine cowling and the underbelly of the aircraft were damaged.

Figure 4: Damage on the engine upper case. (Source: Operator)

- 2.2.8 The instructor and the student pilot heard a few loud bangs and noticed smoke emanating from the engine compartment before it stopped in-flight, resulting in a forced landing.
- 2.2.8 The engine sustained damage to the upper casing; further tests and inspections are to be conducted.
- 2.2.9 After the accident, some community members from a nearby informal settlement ran to the accident scene and helped themselves in some of the aircraft's components, contaminating the accident scene in the process.

1.16.1. The engine is set to be tested to determine the cause of its stoppage.
