PRELIMINARY ACCIDENT REPORT

Accident
- Preliminary Report -
AIID Ref No: CA18/2/3/10017

Reference number : CA18/2/3/10017
Name of owners : Mike Zulu Victor (Pty) Ltd
Type of operation : Private (Part 91)
Manufacturer : Cessna Aircraft Company
Model : Cessna 182P
Nationality : South African
Registration marks : ZS-MZV
Place : Swampland area in Wadeville, Gauteng Province
Date : 28 June 2021
Time : 0925Z

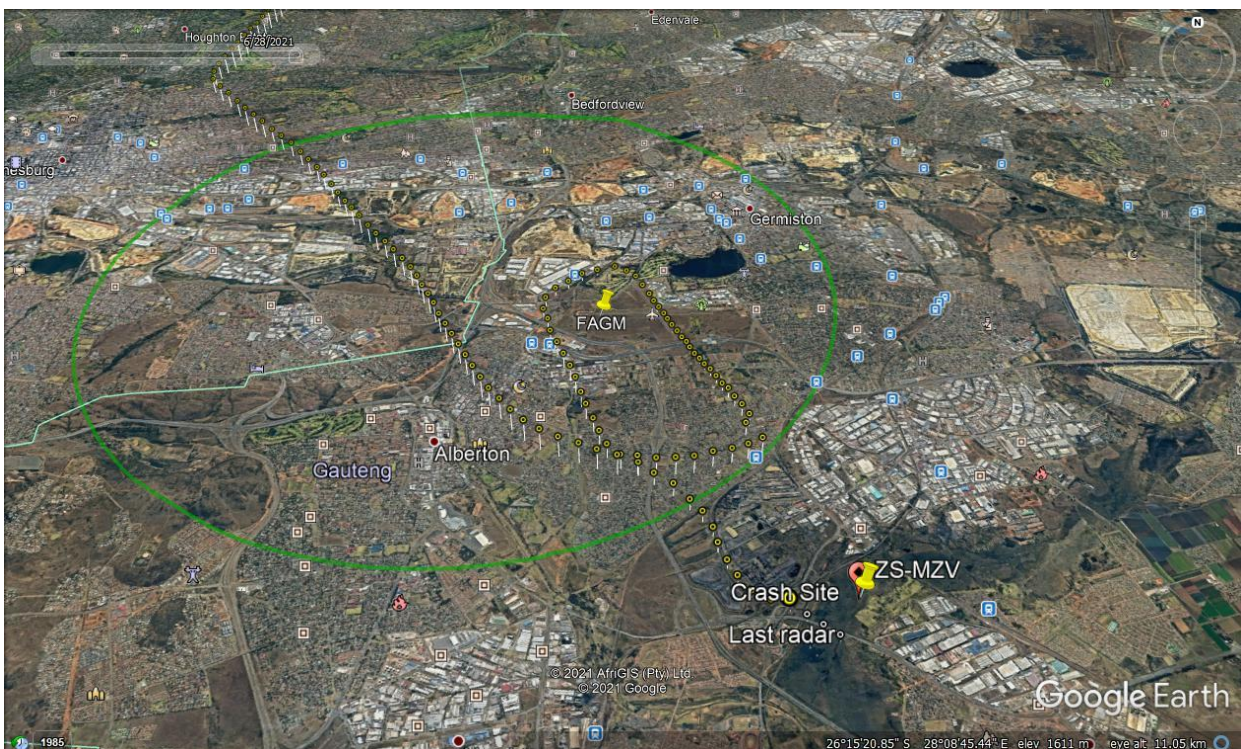
Figure 2: Google Earth overlay with the yellow dots indicating the radar track flown by ZS-MZV.

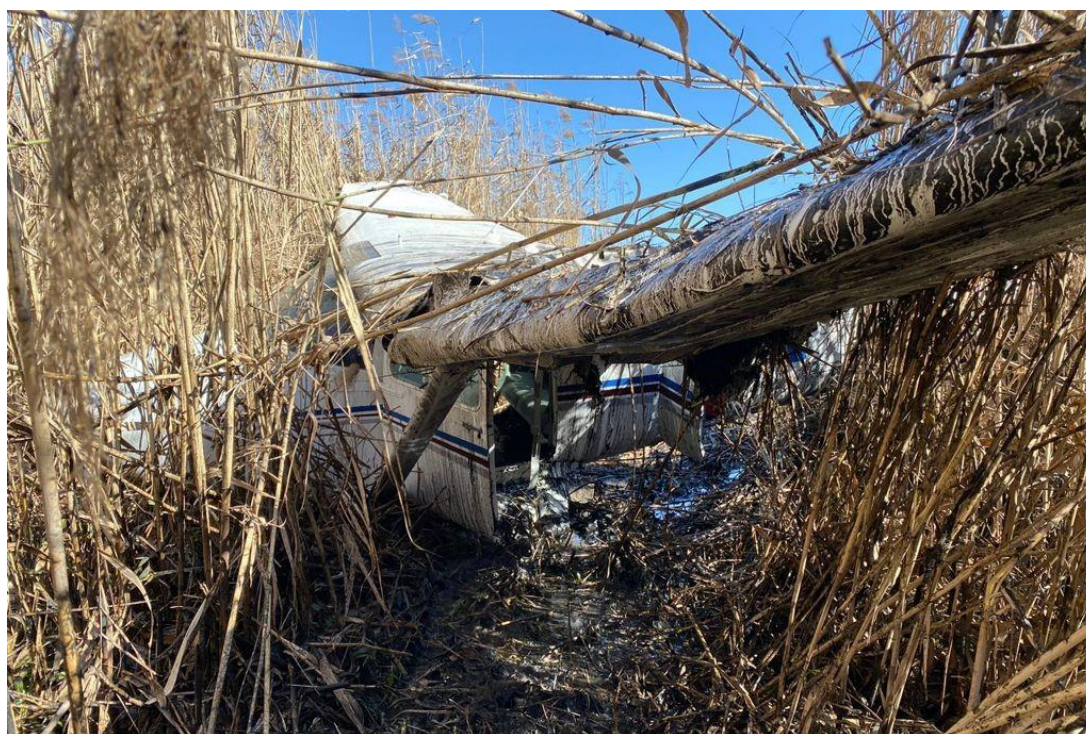
1.3.1 The aircraft was substantially damaged during the accident sequence.

Figure 3: The aircraft as it came rest on a swampland.

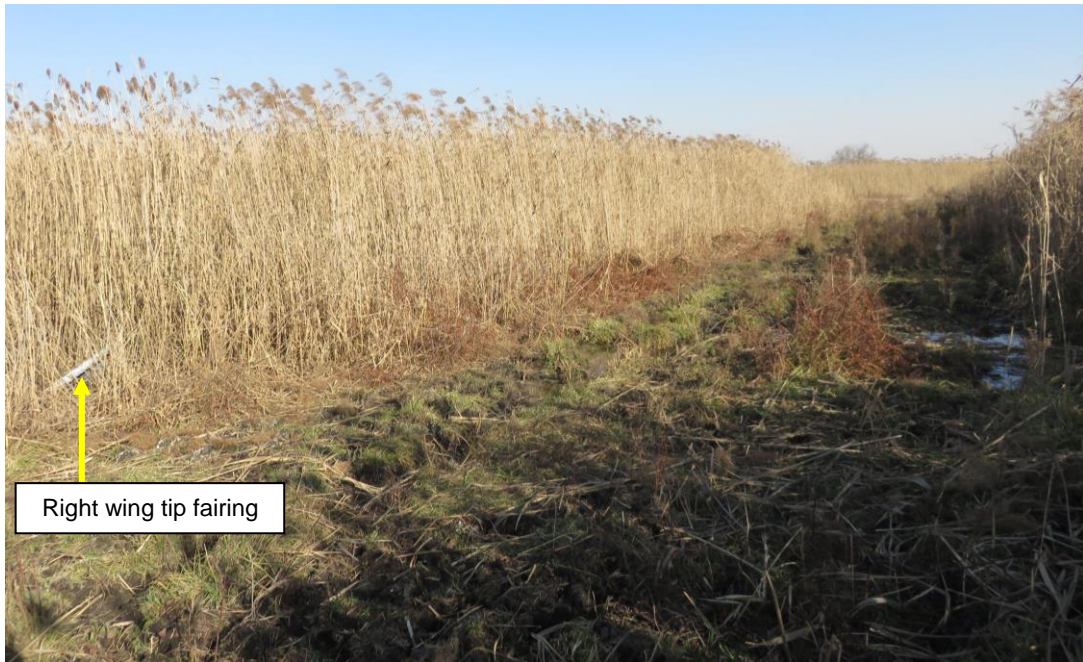
1.12.1 The pilot landed in a swampland on an open area between dense reed facing north-east. The pilot was unable to maintain directional control and the aircraft veered off to the right, approximately 80m after touchdown and came to rest in a left-wing low attitude facing south.

Figure 4: The open area on which the pilot landed.

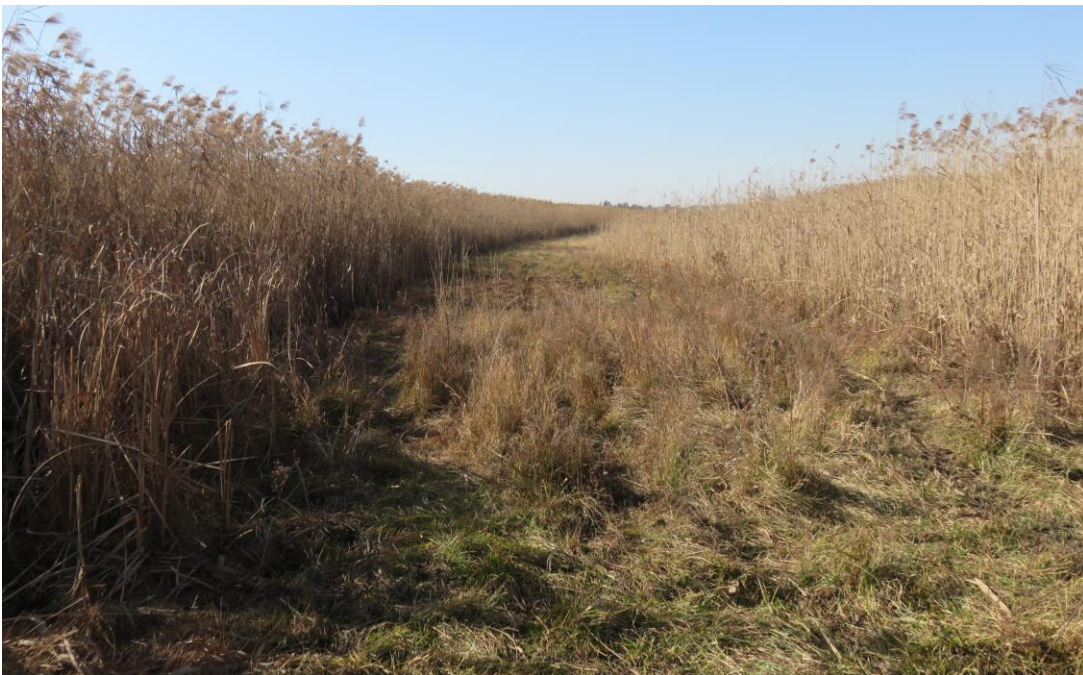
Figure 5: The open area view past the accident site.

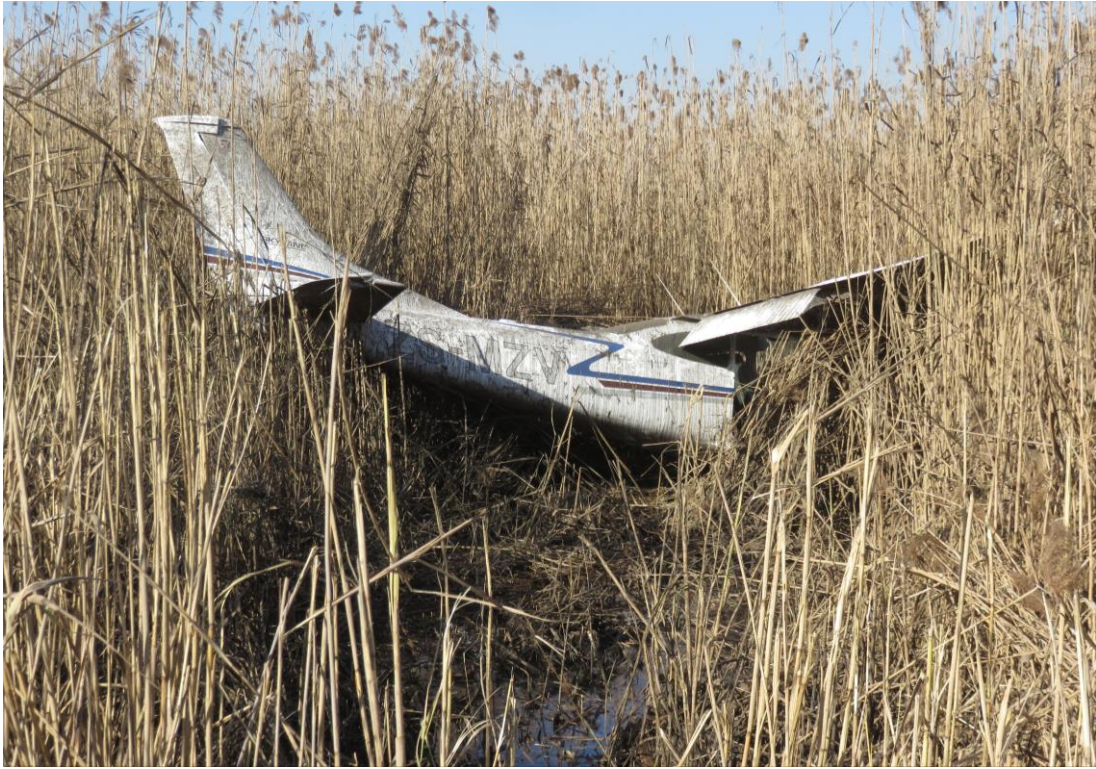
1.1.6 The aircraft came to rest in a left-wing low attitude facing in a southerly direction in a densely reed area. No persons on-board the aircraft were injured, but the aircraft was substantially damage during the accident sequence. Following the Mayday call, a helicopter that was busy with training at FAGM was dispatched to the scene by ATC. The helicopter landed near the accident site and the pilot flew the passengers and the accident helicopter pilot to FAGM, two at a time.

Figure 6: The aircraft as it came to rest.

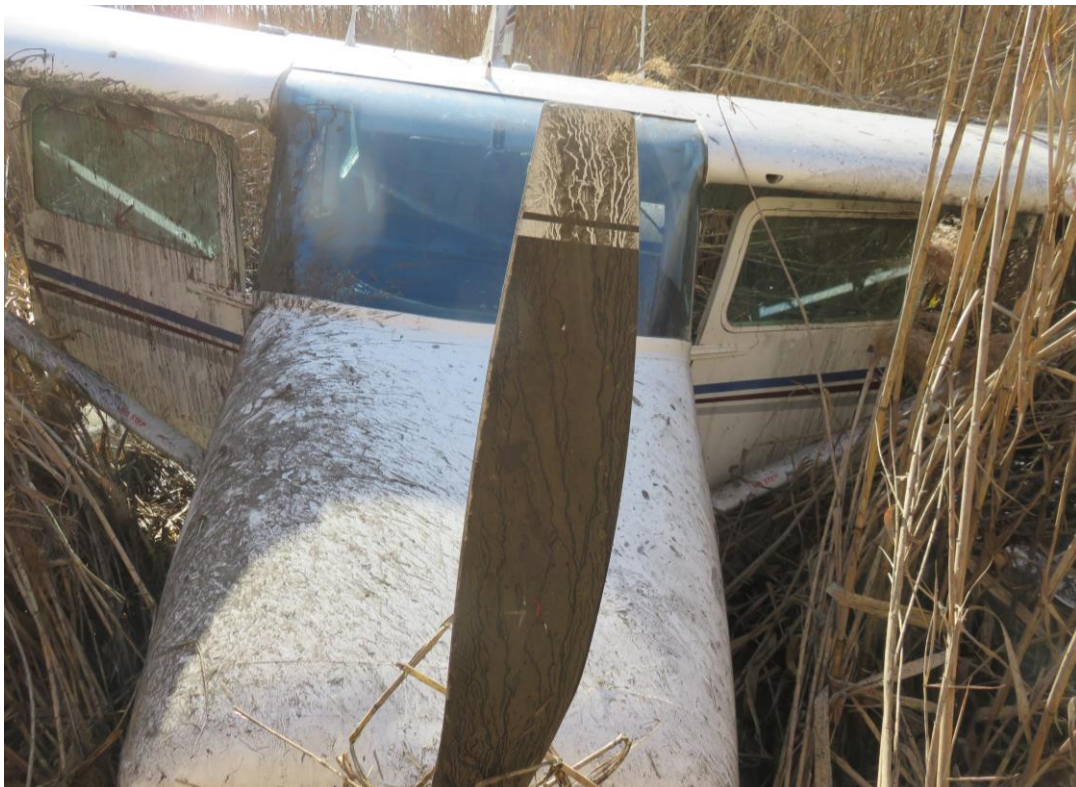
Figure 7: The front view of the aircraft showing one of the propeller blades.
